DAMAGE TO ROAD FILL BY THE 2007 NOTO-HANTO EARTHQUAKE

T. Sasaki¹, O. Matsuo², H. Sugita³ and Y. Matsuda⁴

ABSTRACT :

KEYWORDS: earthquake damage, road embankment, the 2007 Noto-Hanto Earthquake

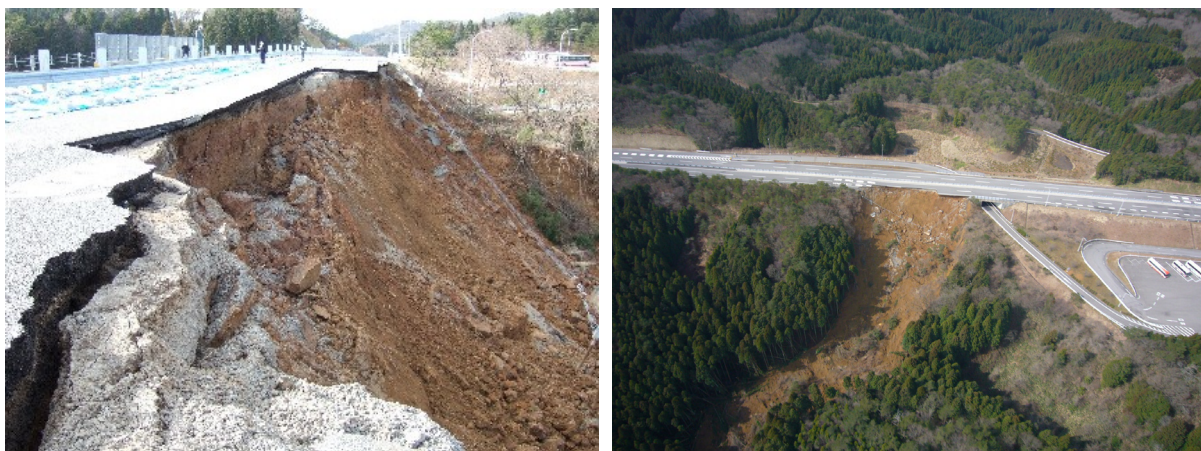
The majority of the damage to the road facilities was the failure of embankments constructed by filling valley, and failures due to the liquefaction of the foundation ground were rarely observed. Relatively large embankments were collapsed in 11 places along the Noto Toll Road, and in two places along national highway route 249. The embankment failure near the Bessho Dake Service Area located at the 17.7 km point along Noto Toll Road are shown in Photos 1.

Photos 1 Embankment failure near the Bessho Dake SA along the Noto Toll Road

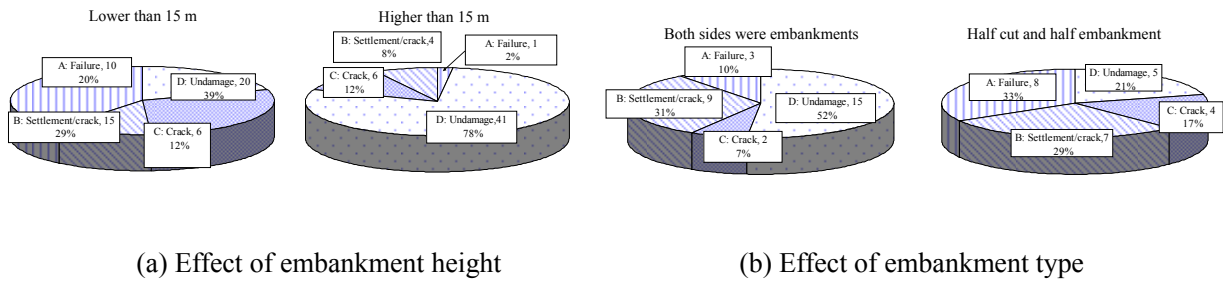
The results of field survey are summarized in Figures 2 and 3. Following trends can be seen from these figures.

- 1) The ratio of damage tends to be high in case embankments were higher than 15 meters.
- 2) The ratio of Failure tends to be high in partial embankments. This behavior suggests that damage became serious in borders between embankments and cut slopes.
- 3) No clear tendency in damage degree was observed based on the existence of swamps behind embankments or spring water on the fill slopes. This behavior indicates that it is difficult to ascertain the degree of permeation of groundwater inside embankments judging solely from the outside conditions of swamps and springs.
- 4) As for slopes of natural ground, the damaged embankments tend to increase with the increase of the value of a parameter Z defined as Figure 3(d), which is the ratio of the inclination of the natural ground at the toe of

Figures 2 Relationship between embankment shape and damage levels

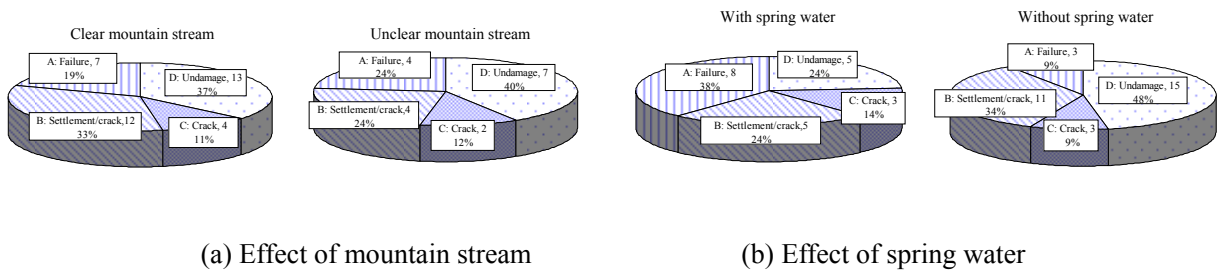
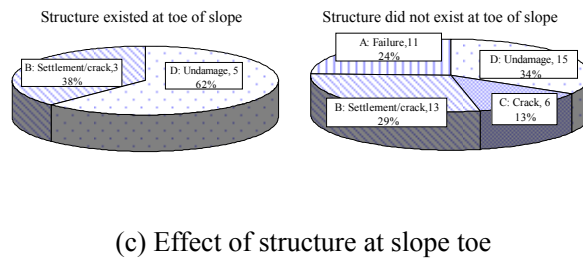
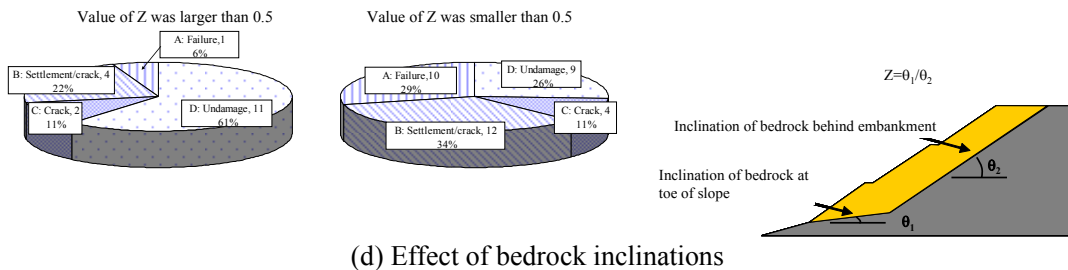
Figures 3 Relationship between ground conditions and damage level

- The ratio of damage tends to be high if no slope toe structure exists. From this fact, the structures which were constructed at the slope toe is highly effective in controlling deformation of the slope toe of an embankment.

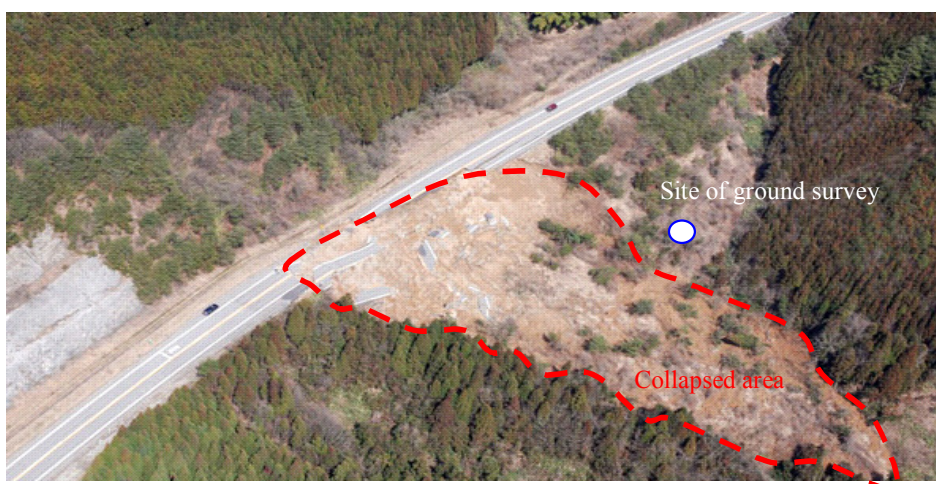
Photo 2 Embankment failure at Site 38

similar embankment shape as that in sites suffered embankment failure. The standard penetration tests were carried out at three sites: Site 22 (Settlement/crack), Site 26 (undamaged), and Site 38 (Failure). The level of groundwater was also measured using the boring holes. An aerial photo of the Site 38 suffered embankment failure is shown in Photo 2. It should be noted that the ground survey in the Site 38 was carried out at undisturbed area of the same embankment near the collapsed area (see Photo 2). Soil samples were also retrieved from the embankment by using thin wall sampling method in these sites.

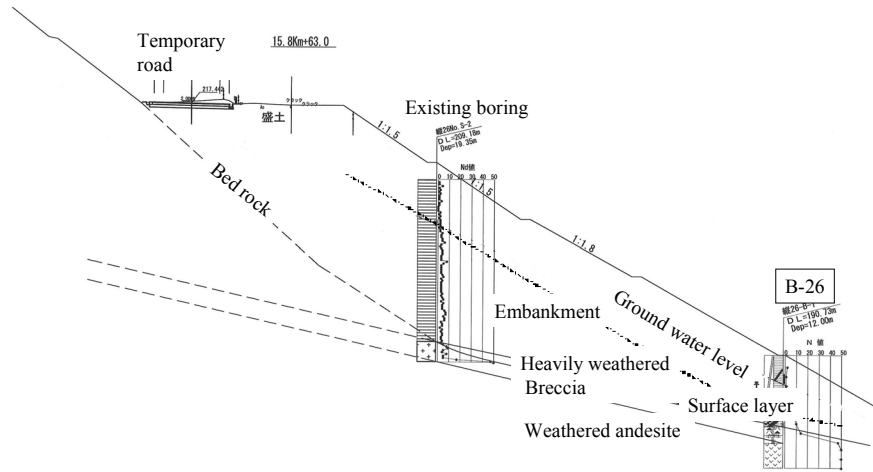
(a) Undamaged site (Site 26)

Figures 4 (a) to (c) show the soil profiles, and Figures 5 (a) to (c) show cross-sections of each boring site. Each of these boring was conducted near the toe of the embankments (B-26, B-22 and B-36 in figures 5). Boring at Site 38 (Failure) was conducted in the undisturbed area of the same embankment. These borings revealed that the N values within the embankments were lower than 5, irrespective of the damage degree in each boring site, but the water level within the embankment was low both in undamaged and settlement/crack sites, and high in failure site.

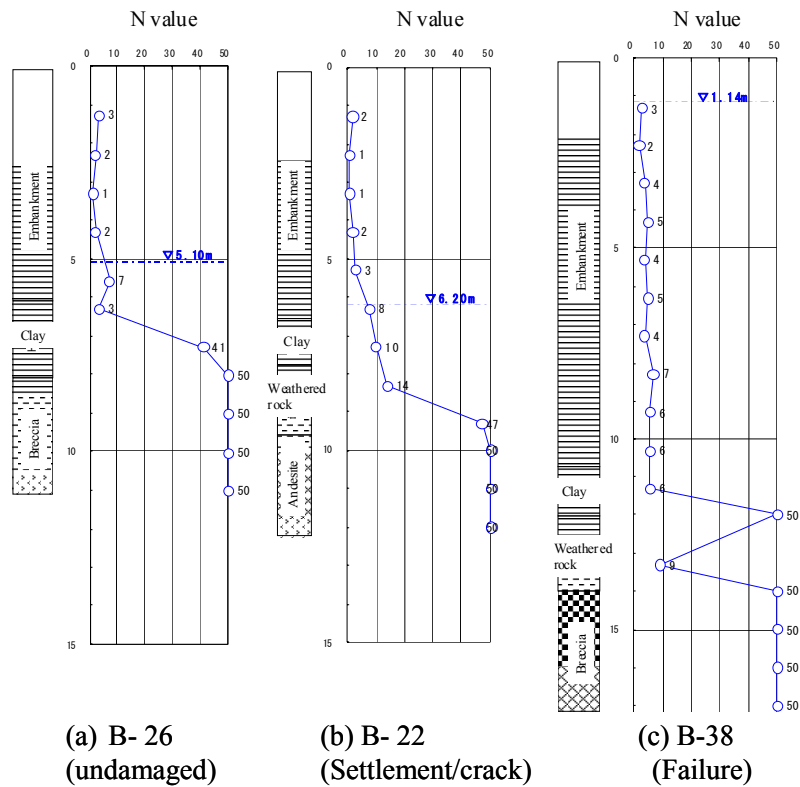
Figures 4 Soil boring logs obtained from ground survey

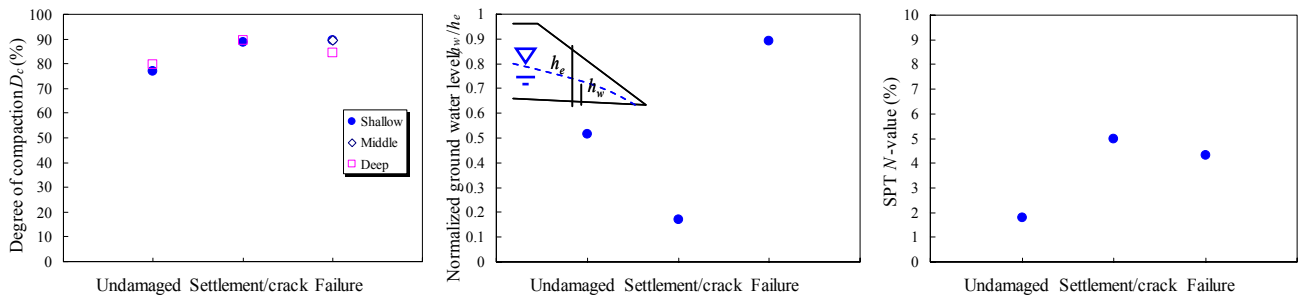
Degree of compaction D_c of the embankment in Figure 6(a) was obtained from the soil samples retrieved by thin wall sampling method and results of the compaction tests of disturbed sample obtained from near the surface of the embankment slopes. The ground water levels in Figure 6 (b) are shown as the ratio of ground water levels h_w to the thickness of the embankments h_e at boring site. The N values in Figure 6 (c) are the average N value of the embankment layers that were obtained from SPT. Although the degree of compaction D_c was high in embankment failure site, it varied within the range of 80% to 90% on the whole. No clear correlation was observed between damage level and degree of compaction D_c . The groundwater level near the slope toe of embankment reached near the surface ground in Site 36 suffered embankment failure. This behavior suggests that permeation of water into the embankment may be one of the causes of embankment failure. However, it should be noted that the water level shown in Figure 8 (b) is one in wells at the time of survey, and the water levels of Site 38 were measured value the undisturbed area of the same embankment.

As for N values, the Site 36 suffered embankment failure tends to show high N values. However, because N values are low in embankments on the whole, the difference between high N values and low N values was not significant.

Figures 6 Relationship between damage level and results from ground surveys

- 4) In site suffered embankment failure, the groundwater level tended to be high near the slope toe of the embankment, suggesting the possibility that the existence of water within the embankment might have affected the level of damage.

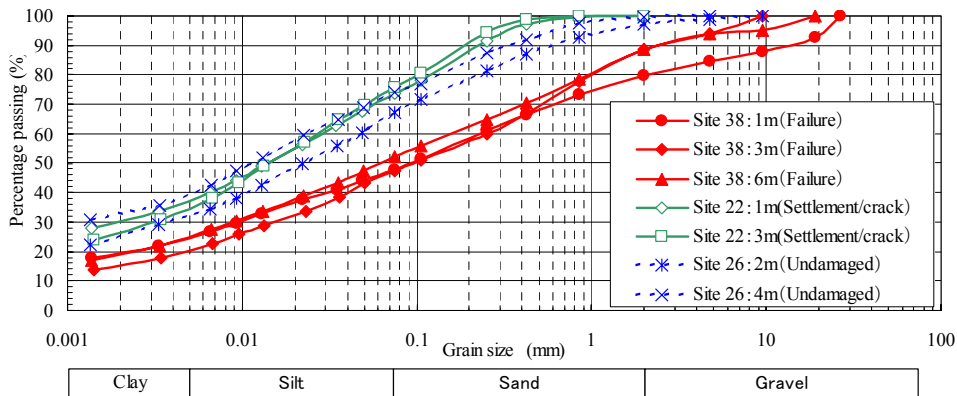
Figure 7 and 8 shows the grain size distributions and the relationship between damage levels and typical physical properties of the embankment materials, which were obtained by thin wall sampling method. The embankment materials, on the whole, contained many fine contents, and most materials were classified into silt and clay with a high liquid limit. The mean grain size D_{50} tend to be high and the fine contents FC tend to be low in the failed embankment. However, no great variation in plasticity index I_p could be observed according to the damage level.

Figure 7 Grain size distributions of embankment materials obtained by shin wall sampling method

- 5) As for embankment material, the mean grain size D_{50} tend to be high and the fine contents FC tend to be low in the failed embankment.

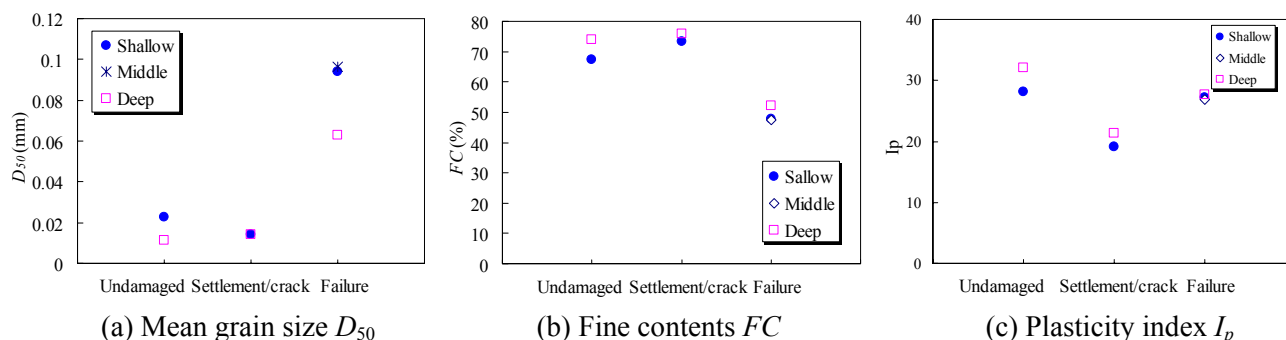
Figure 8 Physical properties of embankment materials obtained by shin wall sampling method
