## BEHAVIOUR OF EARTHEN STRUCTURES DURING THE PISCO EARTHQUAKE OF AUGUST 15, 2007

M. Blondet<sup>1</sup>, J. Vargas<sup>2</sup> and N. Tarque<sup>3</sup>

### ABSTRACT :

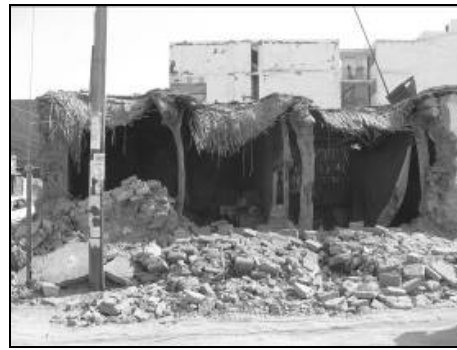
b) Eucalyptus trunks used as columns

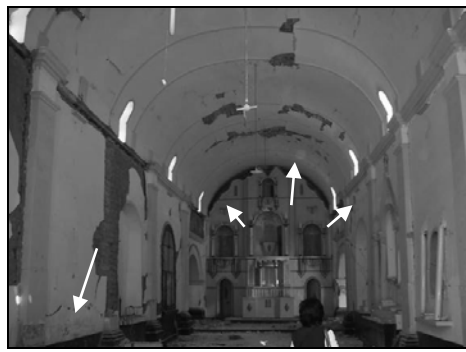
- Horizontal cracks on the lateral walls at about 1/3 of their total height (Figure 11a). These cracks can even break through the earthen pilasters (Figure 11b), causing the walls to collapse.
- Diagonal cracks on some of the lateral walls.
- Detachment of the choir (Figure 11c) and the altar's wall (parallel to the façade) from the church's lateral walls and cylindrical vault ceiling (Figure 11a).
- Detachment of the towers from the rest of the church (Figure 11d).
- Appearance of vertical cracks and fissures on the church towers (11d).
- Humidity related damage.

a) Detachment of the main

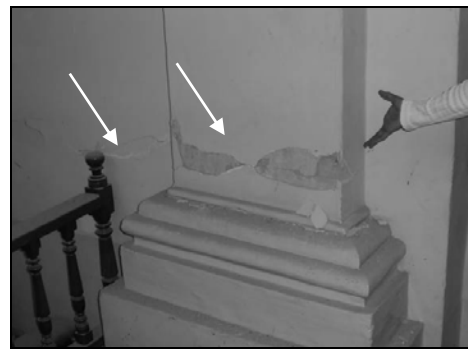
b) Horizontal crack in pilaster

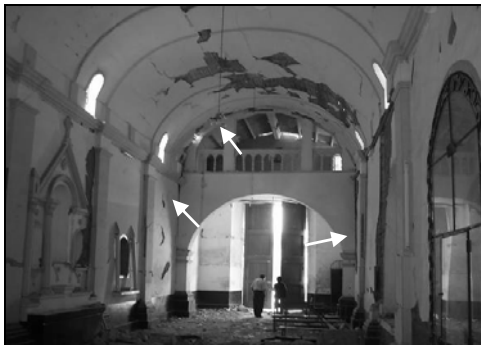
c) Detachment of the choir from the vault

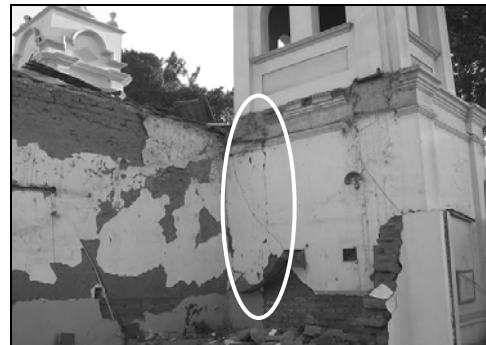
d) Vertical cracks on the intersection between the tower and walls

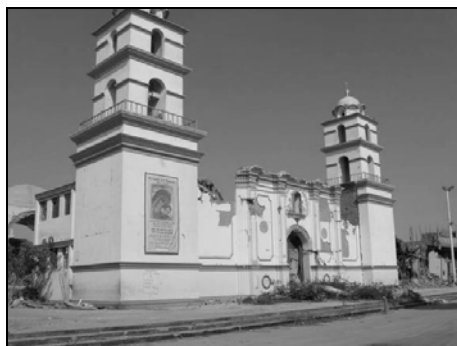
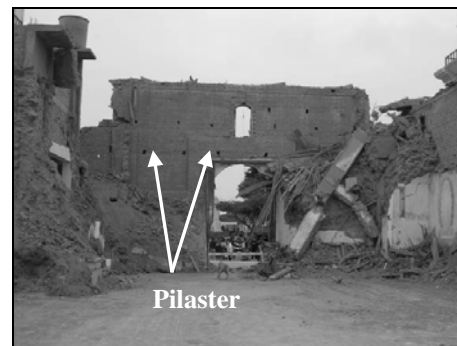
Figure 12 Church “San Clemente”.

This was the main church in Pisco and dates back to the XVIII century. Its façade was constructed using fired clay bricks masonry (Figure 12a) and its most outstanding feature were the two 4-storey high towers and 4 pilasters (that simulated columns) located equidistantly from the main entrance to the church (Figure 12b). The church’s lateral walls were built using adobe. The church had a cylindrical vaulted ceiling that was constructed using wooden arches and crushed cane covered by a mud and gypsum stucco. The roof rested on the lateral walls and the main altar’s wall had been reinforced using concrete frames. This reinforcement was probably a latter addition to the structure, most likely done during a more recent restoration of the church. There were 300 people attending a mass when the earthquake happened. About half of them died when the roof and walls collapsed. It is possible that the church’s collapse initiated with the cracking and overturning of the lateral walls, to which the roof followed.
