RECONNAISSANCE REPORT ON STRUCTURAL AND GEOTECHNICAL ASPECTS OF DAMAGES IN A RECENT EARTHQUAKE IN JAPAN

This paper outlines the geotechnical and structural hazards brought by the 2007 Niigataken Chuetsu-oki earthquake that occurred in the Niigata and Nagano prefecture, Japan on July 16th, 2007 (JST). The quake brought heavy damages to many wooden residential houses and traditional wooden buildings. This paper is a report of preliminary joint investigation on the structural and geotechnical aspects of the damages. Ground vibration and ground deformation were found to be the main cause that led to damages to low earthquake resistant buildings and other associated damages during the earthquake.

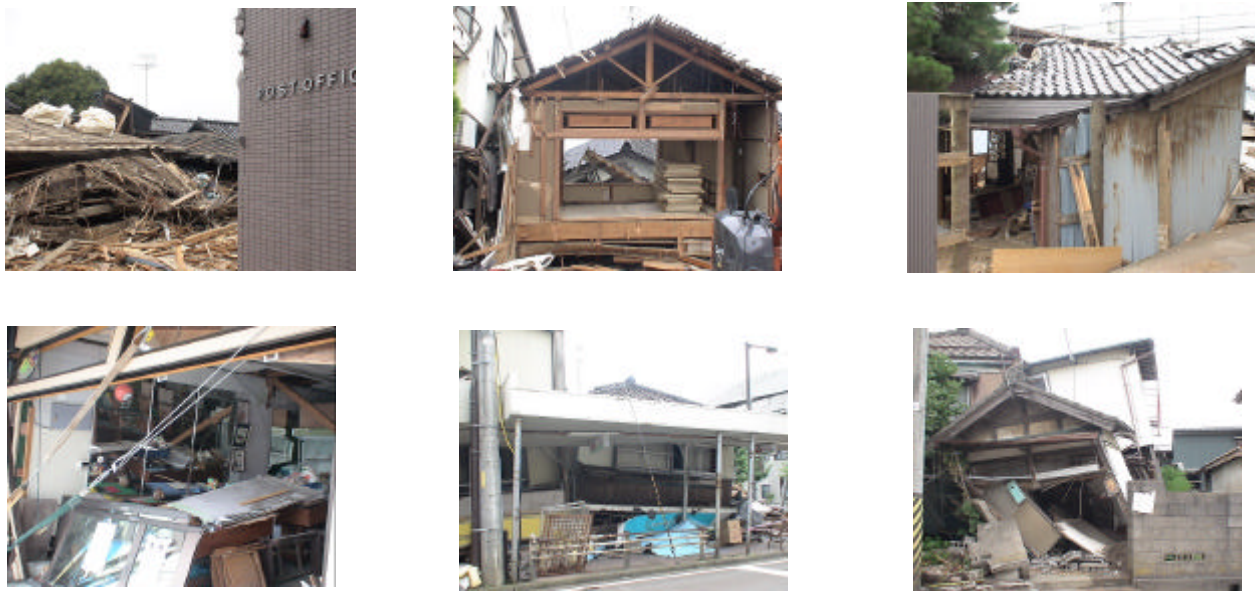
Figure 4 shows some of the damages to wooden residential and commercial houses. Damage was particularly observed in those structures that have exceptionally low earthquake-resistance combined with insufficient or poor structural conditions. These factors, added with their failure to conform to the requirements of the Building Standard Law of Japan, have led to such devastating damages. Many Shops and residential houses that lacked earthquake resistance in their store fronts/doorways collapsed towards their front. Buildings lacking of resistant walls along with poor joints and heavily decayed parts, were completely destroyed by the strong ground vibration.

Figure 4. Damages to wooden residential and commercial buildings

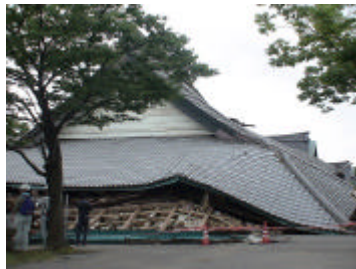
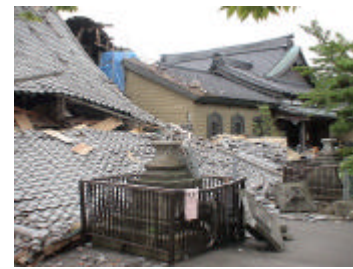
The worst affected amongst the traditional structures was the Monkoji Temple (Figure 5) recognized by the city government of Kashiwazaki as architectural heritage. The temple, located at Nishi-Honcho of Kashiwazaki City, was completed in 1930. In 1955 roof of the main temple was changed from copper plates to tiles. The 2004 Niigataken Chuetsu Earthquake ($M=6.8$) brought some moderate damages to the temple, and, therefore, the roof tiles of the temple were replaced 3 years ago (after the earthquake). The salient features of the temple are the western-style large-span roof frame and less no. of pillars used in the inner temple and prayer hall. The fired clay roof tiling contained no clay sheathing. The 2007 earthquake resulted in the complete collapse and destruction of the main temple (Figure 6).

Figure 6. Damages to wooden traditional structure (Monkoji temple)

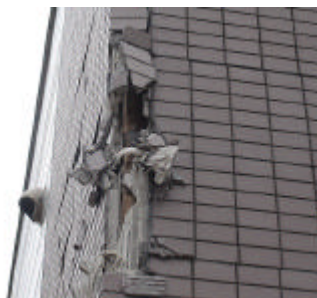
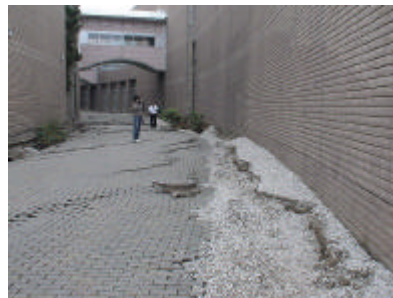
There were also many instances of low-rise buildings constructed prior to 1981 suffering large deformation, bending and failure of bracing, and heavy damage to the columns. In some old buildings, there were examples in which the exterior materials such as lath mortar fell off (Figure 7). The Aqua Park building of Kashiwazaki City suffered damages due to ground deformation, which will be discussed in section 4.

Figure 7. Damages to RC structures

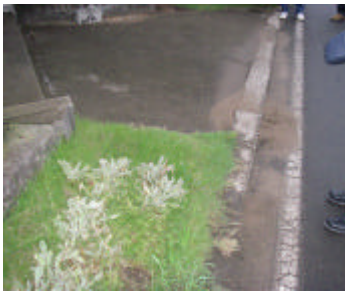
In the Arahama district of Kariwa Village (areas in the vicinity of JR Echigo Line's Arahama Station), many sand boilings indicating liquefaction and resulting ground subsidence were observed. Figure 9 shows such occurrence of sand boilings around Arahama Station. The fluvial deposits in that area were predominantly comprised of fine sand containing few fine-grain particles. The ground suffered large subsidence (approximately 2~5 cm) due to liquefaction, but did not cause damages to houses nearby. Cracking in the platform of Arahama Station and bending of the rail tracks were the results of the lateral flow due to liquefaction.

Figure 9. Sand boiling

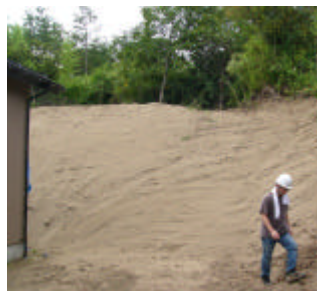
In the Inaba district of Kariwa village (adjacent to JR Echigo Line's Kariwa Station), a relatively large area of Arahama sand dunes were liquefied, leading to the collapse of several slopes. Figure 10 shows such collapse of slopes. About 20 m of slope failures were observed. The relatively low-density slope collapsed into an arc-shape, and the debris reached the neighboring houses and causing damage to the houses (Figure 11). According local eyewitness, a fountain of water reaching about 1 m in height occurred. This implies that the underground water level was higher than usual during the earthquake.

Figure 10. Liquefaction in slopes

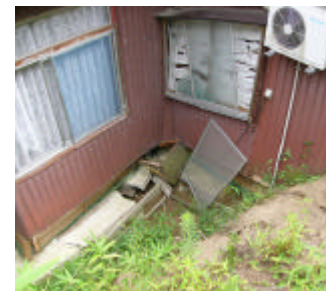
Figure 11. Lateral flow induced damage

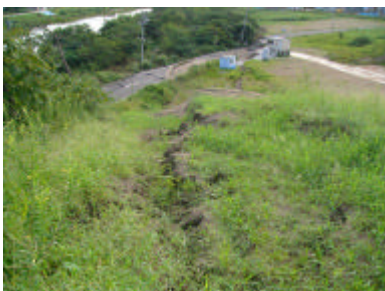
Figure 12 shows a slope collapse possibly caused by liquefaction that occurred between the river's embankment and the sand extraction center located on the bank of Sabaishi river (Yamamoto, Kashiwazaki City). As observed from Figure 13, the slope collapse resulted in the subsidence of the road, and the displacement of the embankment inwards. In the mid-section of the collapsed slope sand boilings could be seen, and therefore it could be deduced that the lower section recorded a sudden drop in strength due to liquefaction, thus leading to a large-scale collapse coupled with lateral displacement. Due to liquefaction and accompanying lateral flow of the ground (Figure 14), a neighboring house suffered displacement, thus affecting its basement and supporting walls.

Figure 12. Liquefaction

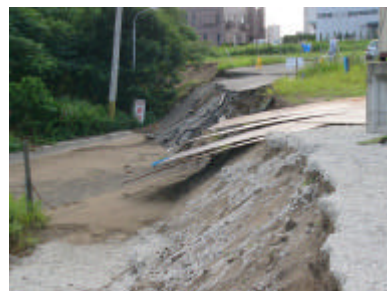
Figure 13. Lateral flow and subsidence

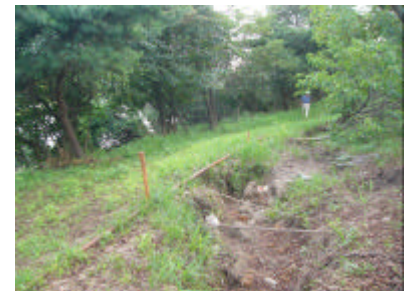
Figure 14. Lateral flow

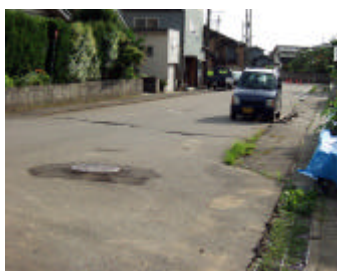
Due to liquefaction, differential settlement and uplifting of underground pipes and structures occurred in areas (Hashiba district, Kashiwazaki City) along the former river channel region of the Sabaishi River (Figure 15). The differential settlement affected the foundations of the houses, although damages were small (Figure 16).

Figure 15. Differential settlement

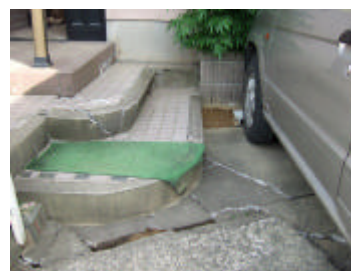
Figure 16. Damage to house

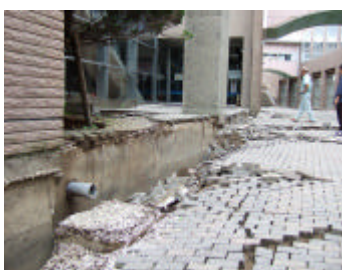
In the main building of Niigata Prefectural Aqua Park (Kashiwazaki City), large-scale subsidence caused by liquefaction of soils occurred. Figure 19 shows the state near the entrance area, where severe damage was inflicted on the foundation as a result of the ground subsidence with a maximum depth of 1m. Figure 20 shows the damages inflicted on the underground infrastructure in the surrounding areas, such as manholes and sewerage pipes. There were instances of manhole uplifted by about 70 cm above the ground. Even on the edge of a road little away from the Aqua Park building, sand boilings were observed, wherein the paved road settled, along with uplifting of the sewerage pipes.

Figure 19. Entrance of the building
