## AN OUTLINE OF DAMAGES TO SCHOOL BUILDINGS IN DUJIANGYAN BY THE WENCHUAN EARTHQUAKE ON MAY 12, 2008

Toshimi Kabeyasawa<sup>1</sup>, Toshikazu Kabeyasawa<sup>2</sup>, Koichi Kusunoki<sup>3</sup>, Kangning Li<sup>4</sup>

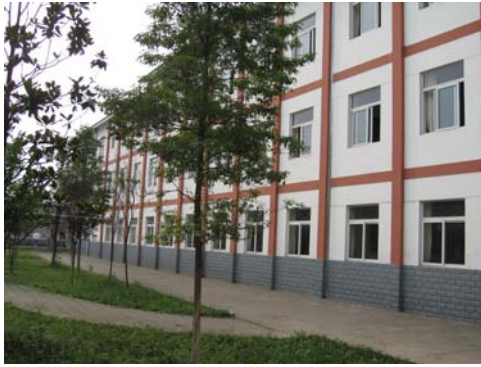
(Grade 0) No damage

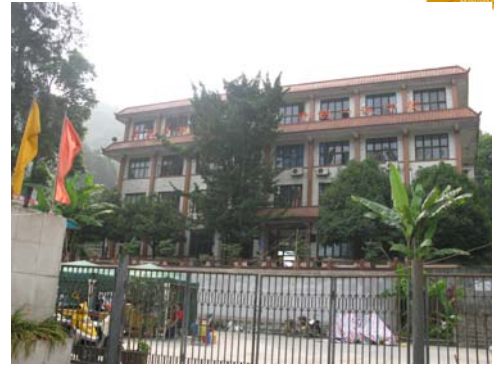
(Grade 1) Slight damage

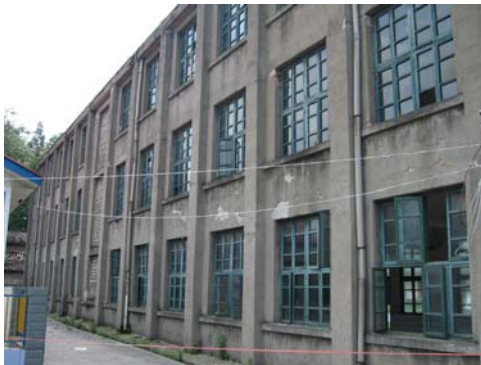
(Grade 2) Minor damage

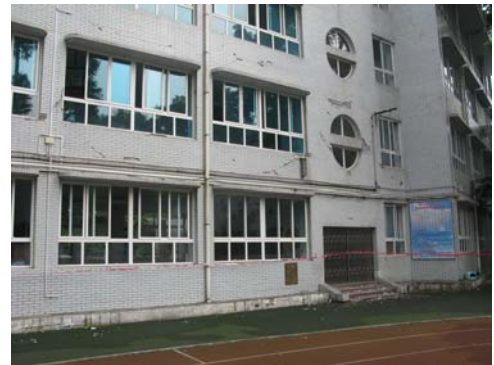
(Grade 3) Moderate damage

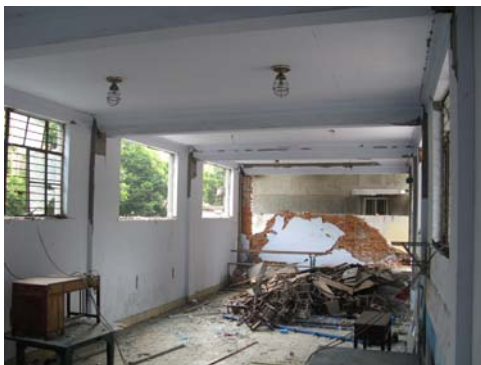
(Grade 4) Severe damage

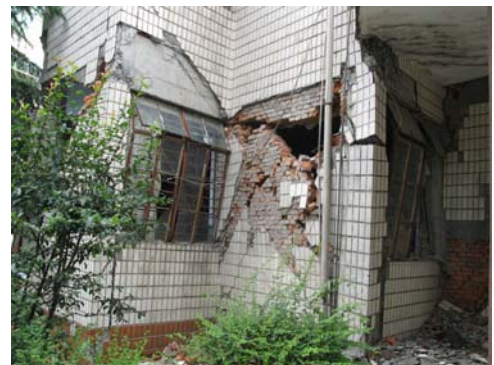
(Grade 5) Collapse or near collapse
