RECONNAISSANCE REPORT OF 0512 CHINA WENCHUAN EARTHQUAKE ON BRIDGES

Chu-Chieh Jay Lin¹, Hsiao-Hui Hung¹, Kuang-Yen Liu¹, Juin-Fu Chai²

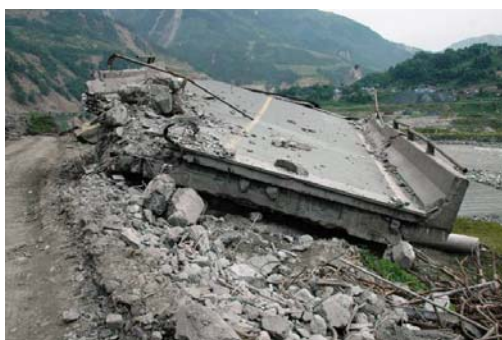
Fig.1 The falling slab of Baihwa Bridge

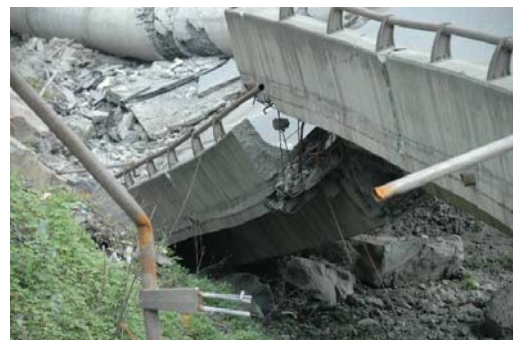
Fig.2 The broken slab and pier of Baihwa Bridge

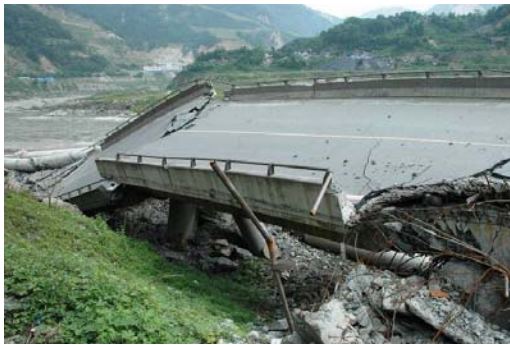
Fig.3 The falling slab of Baihwa Bridge

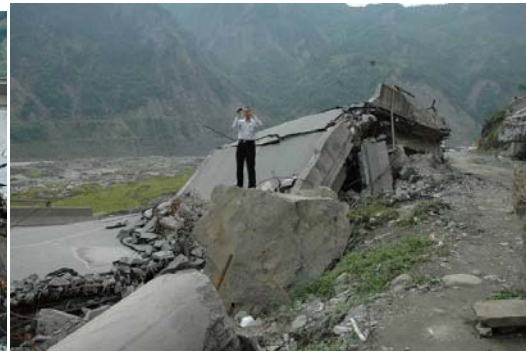
Fig.4 The falling slab of Baihwa Bridge

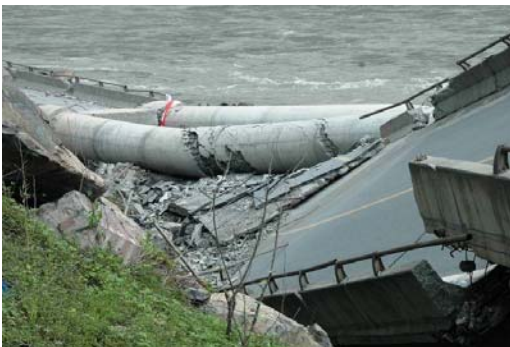
Fig. 5 The exploded pier of Baihwa Bridge

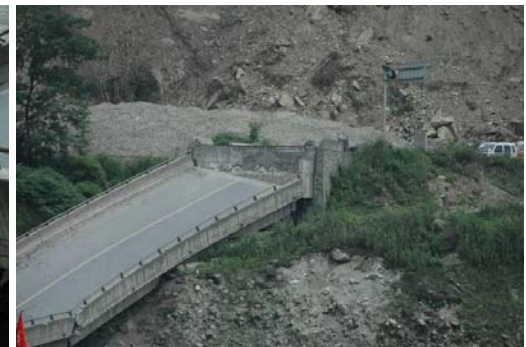
Fig.6 The abutment of Baihwa Bridge

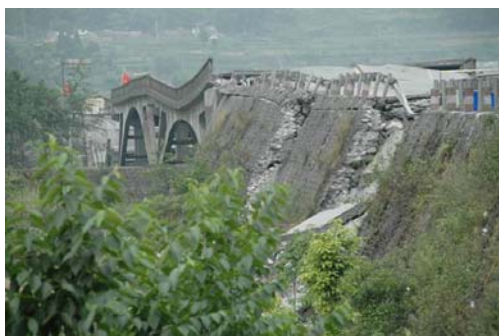
Fig.7 Damage of the Xiaoyudong bridge

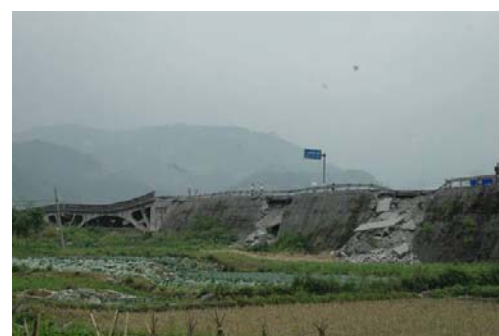
Fig.8 Fault rupture was observed

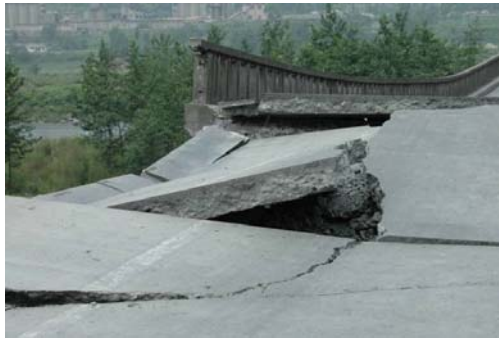
Fig. 9 Deck damage at approach

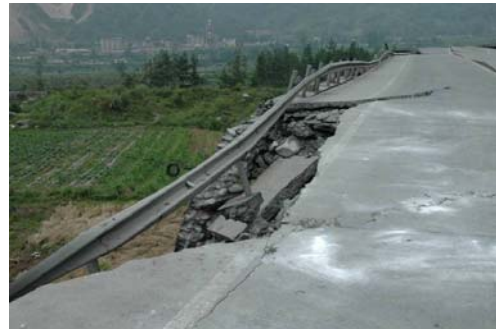
Fig. 10 Damage of the embankment

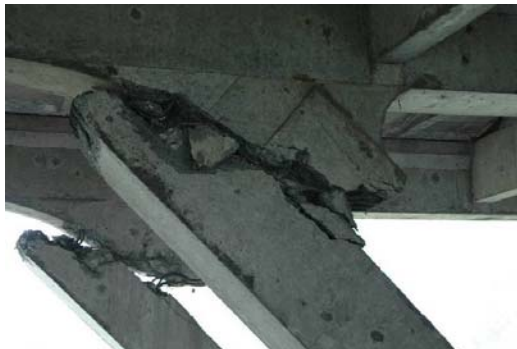
Fig. 11 Spandrel element fracture

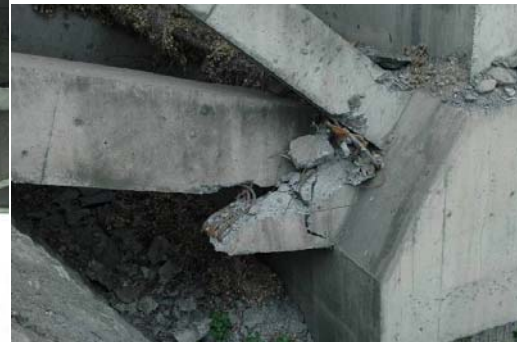
Fig. 12 Fracture at connection between arch and abutment

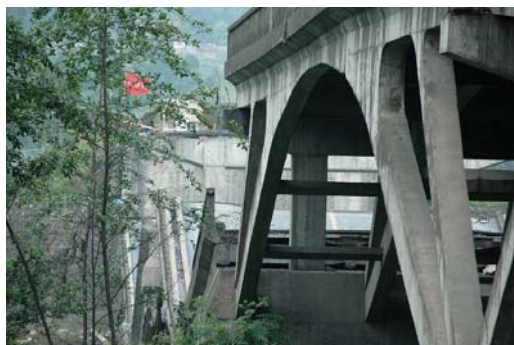
Fig. 13 The fallen spans of the Xiaoyudong Bridge

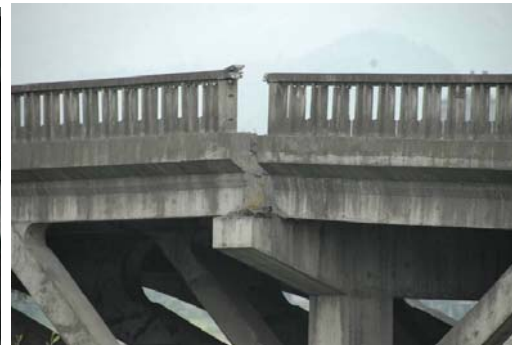
Fig. 14 Horizontal displacement of the spans

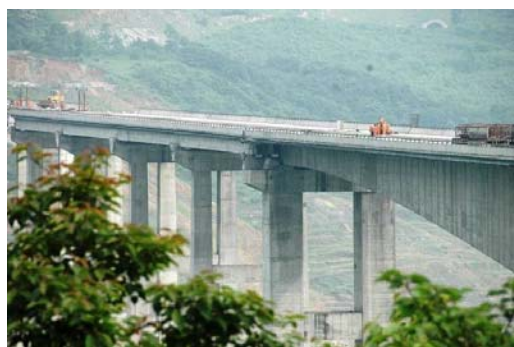
Fig.17 Horizontal shift of spans

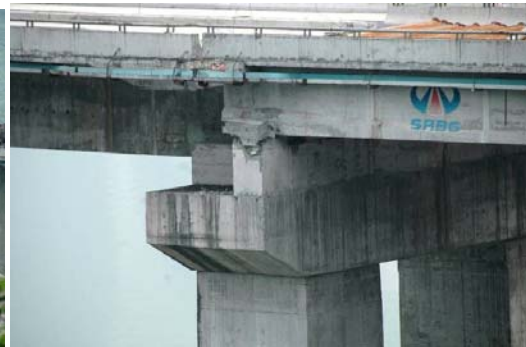
Fig.18 Damage of the side stopper

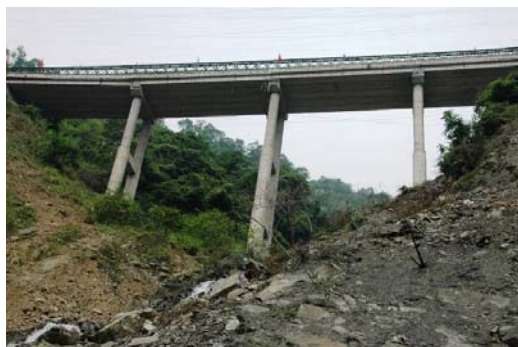
Fig.19 Horizontal shifts of the decks

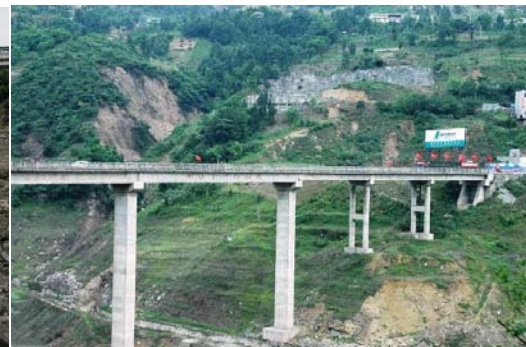
Fig.20 No damages observed on piers

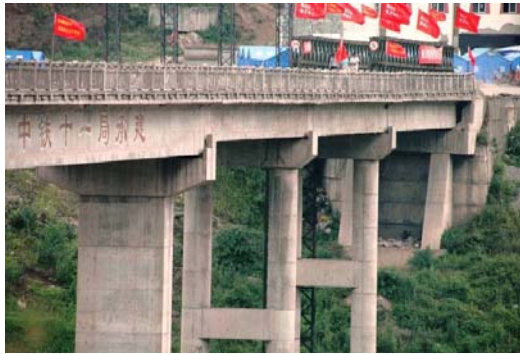
Fig.21 Damages on side stoppers

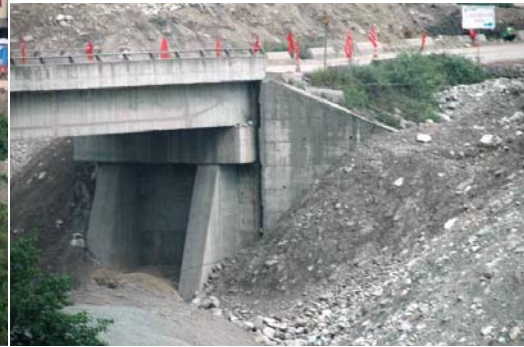
Fig.22 Damage on abutment

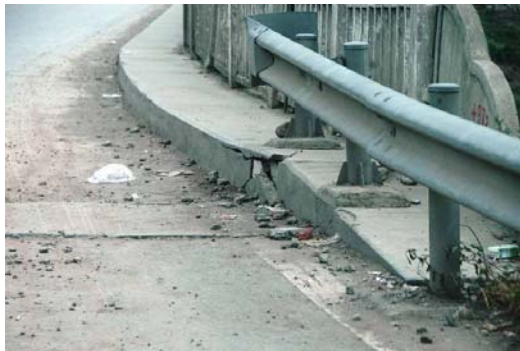
Fig.23 Damage on expansion joint

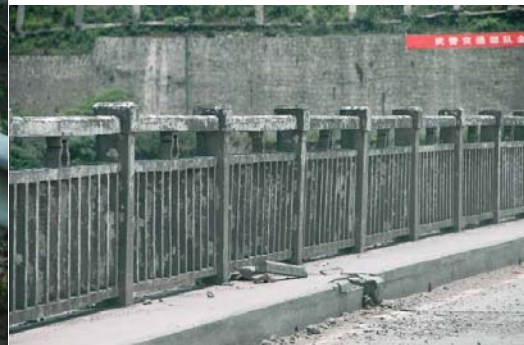
Fig.24 Damages on barrier and expansion joint

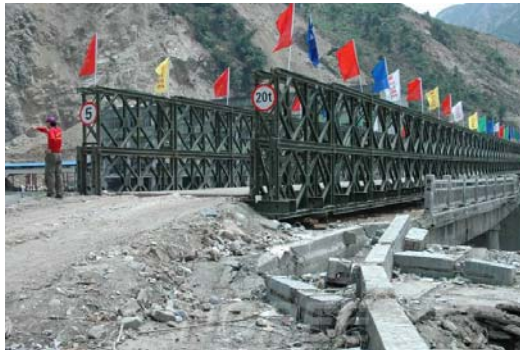
Fig.25 Bailey bridge with speed and weight limits

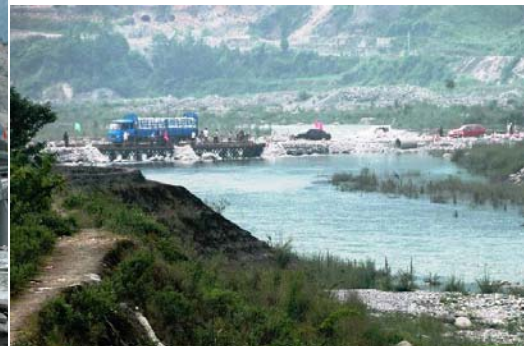
Fig.26 Emergency detour of Xiaoyudong bridge

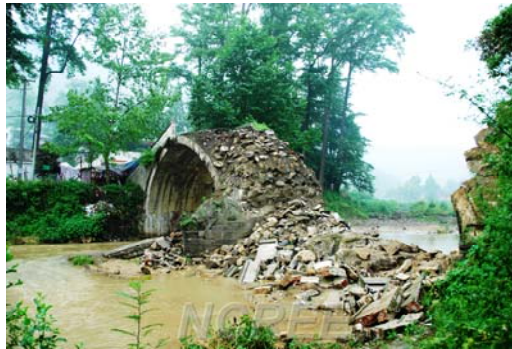
As shown in figures 27-28, the Bailu arch bridge was collapsed due to the strong earthquake motion. The emergency detour was constructed by military using the precast concrete planks immediately since the bridge is the only path to reach out side world for the community.

Fig.27 Collapsed arch of Bailu bridge

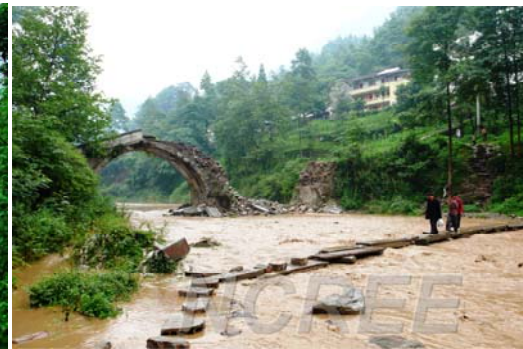
Fig.28 Damaged Bailu bridge and the emergency detour

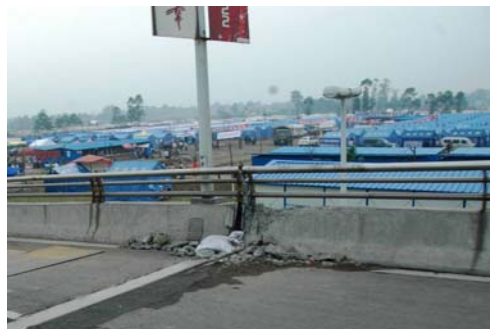
Most of the bridges at metropolitan cities remain intact, as shown in figures 29-30. However, the bridges at Mianzhu city suffered slight damages on expansion joints and remain in service with warning sign, as shown in figures 31-32.

Fig.31 Expansion joint damage at Mianzhu

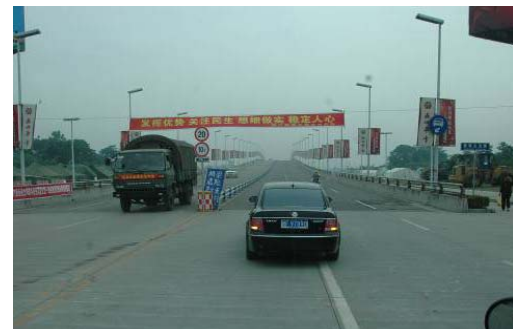
Fig.32 Warning Sign for bridge at Mianzhu
