## OUTLINE INTRODUCTION OF BUILDING DAMAGE IN HIGH INTENSITY AREAS OF WENCHUAN M8.0 EARTHQUAKE

**Sun Jingjiang Meng Qingli Ma Qiang Shi Hongbin Sun Zhongxian**

*Institute of Engineering Mechanics, China Earthquake Administration, Harbin 150080, China  
Email:jingjiangsun@sina.com*

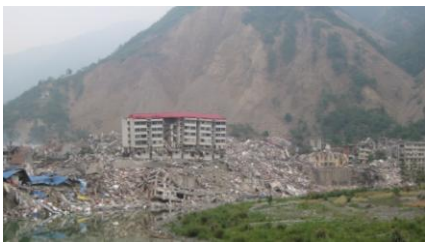
Fig. 1 Heavy damaged and collapsed buildings

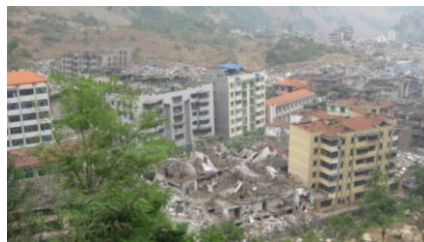
Fig. 2 Another scene of heavy damaged and collapsed buildings

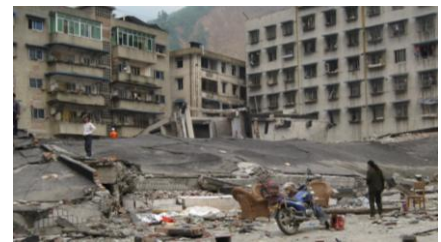
Fig. 3 Front building collapsed; behind-left building heavy damaged, behind-right building slight damaged

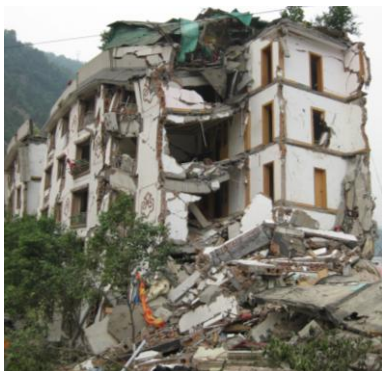
Fig. 4 Partly collapsed brick building

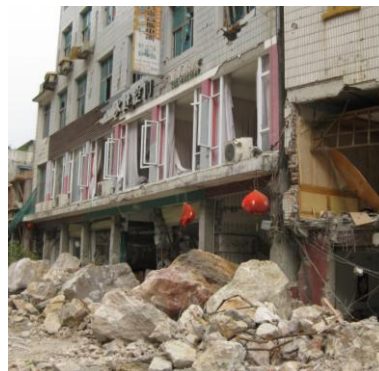
Fig. 5 Buildings damaged mainly by rolling stones, left-frame, right-BBF

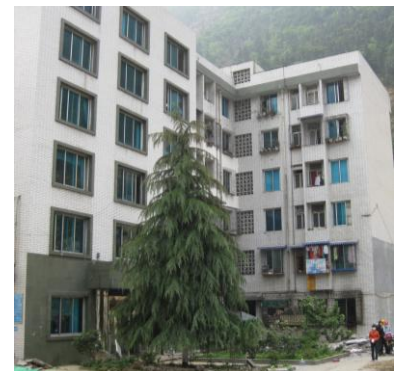
Fig. 6 Building keeps basic intact except one outwall hit by something

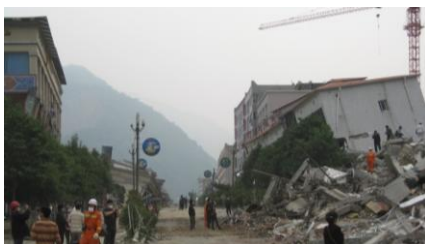
Fig. 7 All the buildings collapsed or heavy damaged along the street

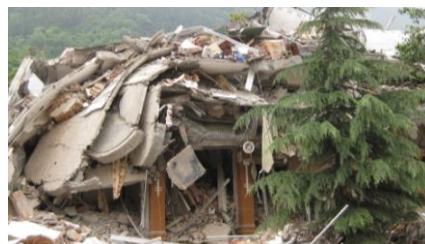
Fig. 8 Upper stories of BBF building collapsed

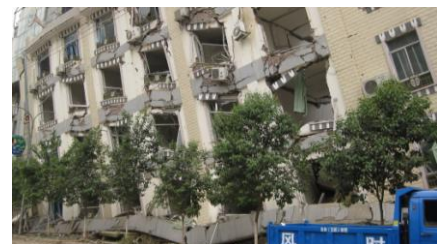
Fig. 9 First story of BBF building collapsed

According to past earthquake experience, the weak region of masonry building is the area between windows, therefore the building horizontal seismic loading capacity is determined by the cross sections of the total walls at windows level required by the seismic code. However, as the windows become larger and construction columns are built in between windows, the damage pattern has changed, this point can be seen from this earthquake that the most damage originally take place at the wall under the windows as shown in Fig.9, Fig.25

and Fig.29. The Figure 9 also shows that longitudinal external walls of this type of building act as a system of strong columns (walls and construction columns between windows) connected by weak thick beams (walls under windows) as shown in Fig.41. This damage pattern remind us that seismic force checking method of current code is not enough, the new design methods to improve the seismic performance of the walls under windows and to check building seismic forces should be developed.

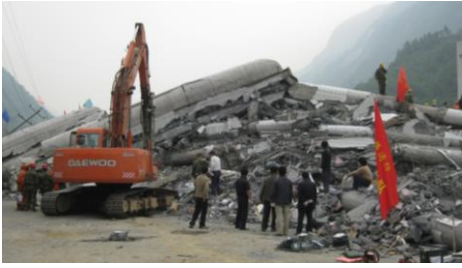
Fig. 10 Eight story frame building collapsed

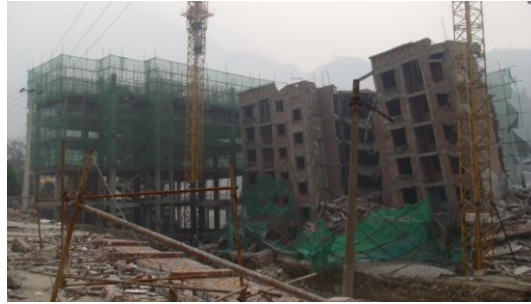
Fig. 12a Two constructing buildings, left, RC frame, some columns became hinge in 2<sup>nd</sup> and 1<sup>st</sup> stories, but still well stand there; right, BBF, 1<sup>st</sup> story and central part collapsed

Strong node, strong column and weak beam design principle is always stressed in seismic design. However, in this earthquake survey it was found that the damages of nodes and columns are far more than beams as shown in Fig.12, Fig.20, Fig.31, Fig.34 and Fig.35. It tells us that the current design method could not ensure the realization of the principle, therefore, more studies should be concentrated on this problem.

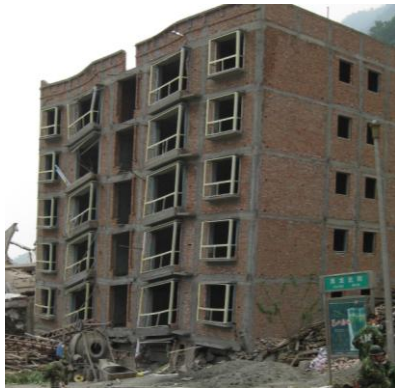
Fig. 11 First story of a constructing building collapsed

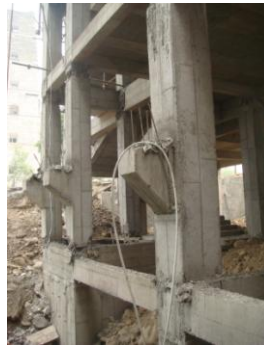
Fig.12b 2<sup>nd</sup> story local enlargement of frame building in Fig.12a

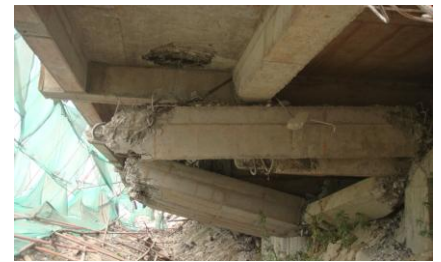
Fig. 12c 1<sup>st</sup> story local enlargement of BBF building in Fig.12a

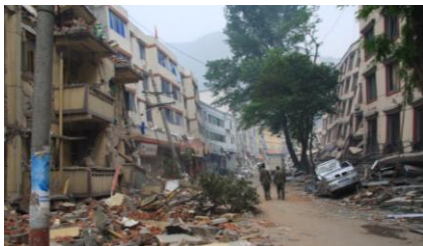
Fig. 13 All the buildings collapsed or heavy damaged along the street

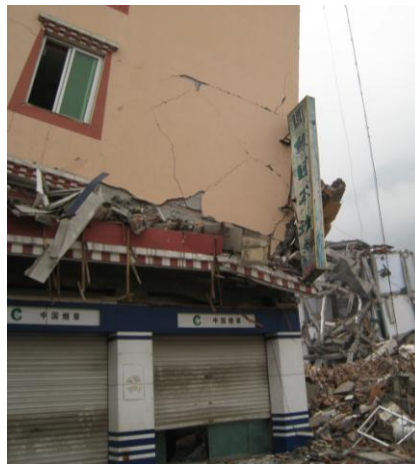
Fig. 14 2<sup>nd</sup> story of a five story BBF building collapsed

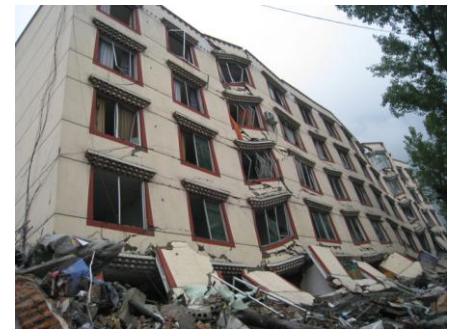
Fig. 15 A five story brick building collapsed

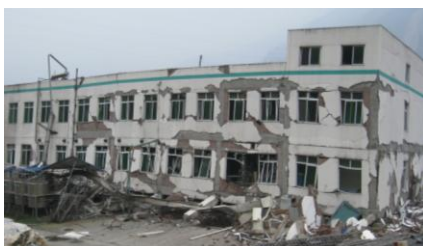
Fig. 16 First story of a three story frame workshop collapsed

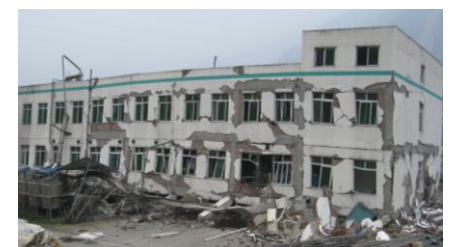
Fig. 17 Five story middle school frame building collapsed

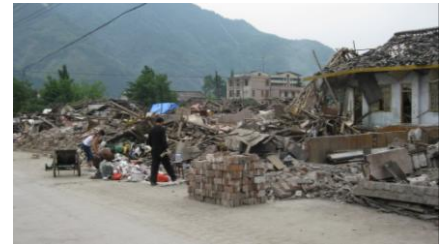
Fig. 18 Lots of old brick-wooden houses collapsed

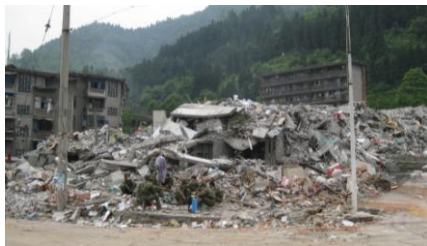
Fig. 19 Many old brick buildings collapsed

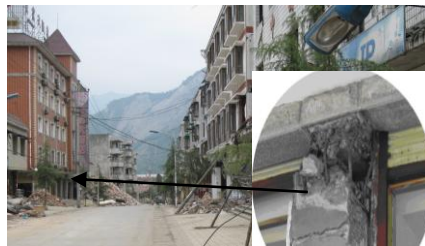
Fig. 20 A street scene at Hongbai Town

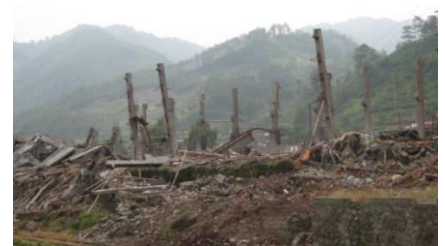
Fig.21 Workshop of a lecithoid factory collapsed

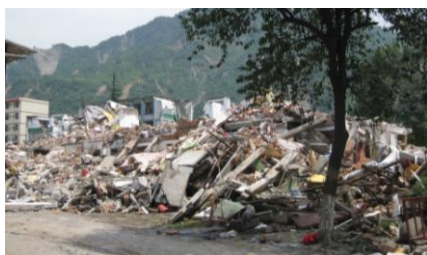
Fig. 22 Many brick buildings collapsed

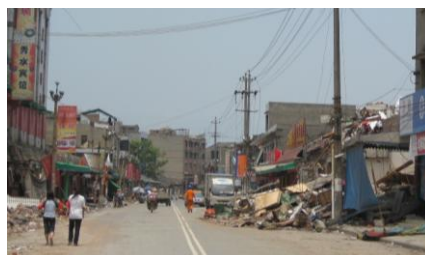
Fig. 23 A street scene in Hanwang Town

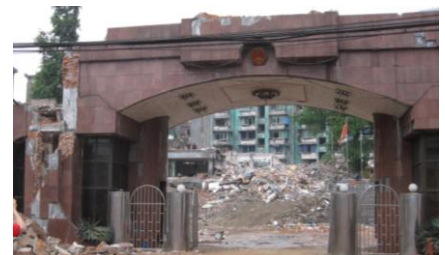
Fig. 24 All the town government buildings collapsed, only the gate left

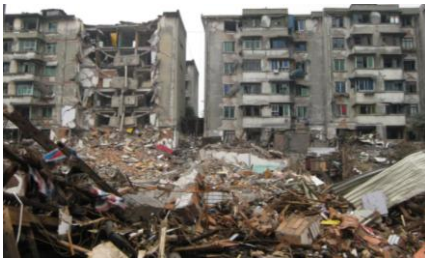
Fig. 25 Front brick-wooden houses collapsed, behind brick buildings heavy damaged

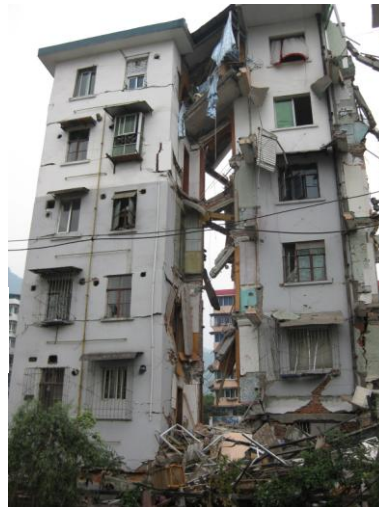
Fig.26 A damaged building, the same story is not on the same horizontal level ▶

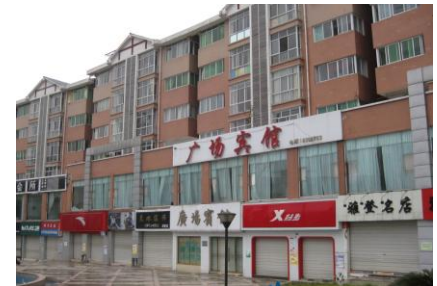
Fig. 27 A building keeps basic intact

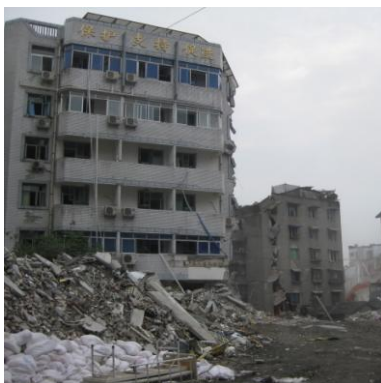
Fig.28 One side of a L-type building collapsed, now another behind damaged building can be seen

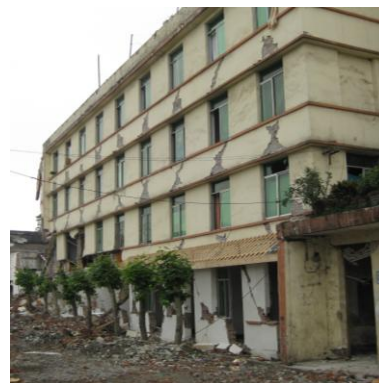
Fig.29 A brick building Heavy damaged at first story

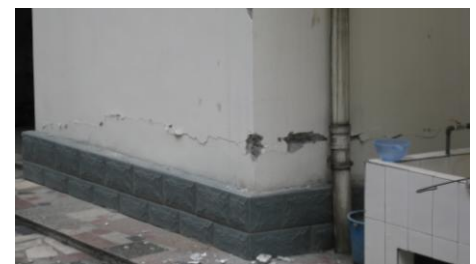
Fig.30 Horizontal crack of a brick building

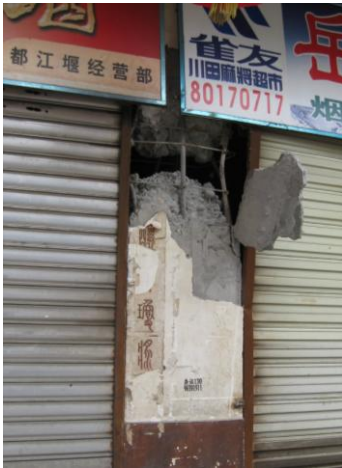
Fig. 31 Column damage of a BBF building

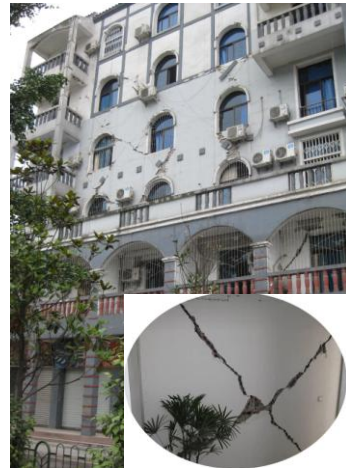
Fig. 32 Out and inner wall damages of a BBF building

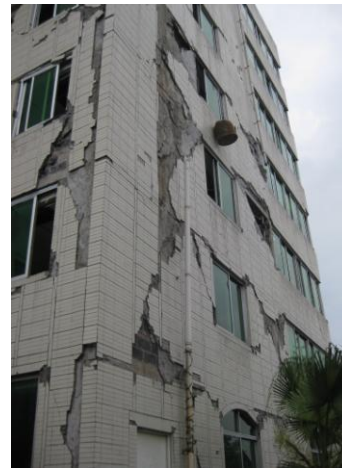
Fig. 33 Six story frame building damaged

The damage of a six story frame building is shown in Fig.33, except the stairs beam, all the supporting columns and beams keep intact. Another damage of frame building is shown in Fig.34, all the damages occurred at several nodes and column ends at first story.

(a) Infill wall damage

(b) Stairs almost break off

(c) Stairs beam end damage

Many damaged stairs have been found in this earthquake, one of them is shown in Fig.33b. Clearly, it is acted mainly by vertical ground motion. Therefore, it is necessary to consider vertical earthquake action in stairs design in higher intensity areas.

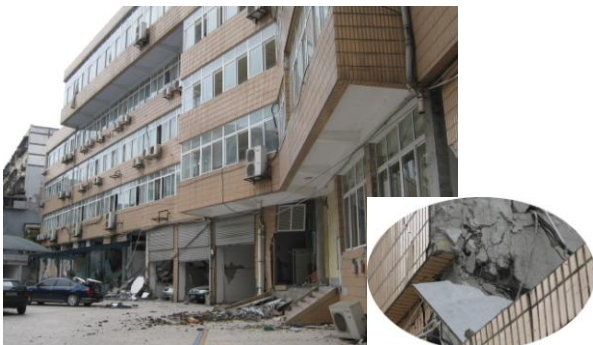
Fig.34 First story damage of a five story frame building with local enlargement of one node of column and beam

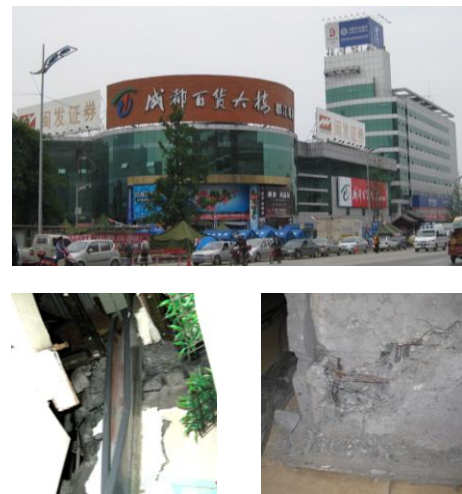
A frame and frame-shear wall united building can be seen in Fig.35, the enlargement pictures show the damages of a column top end of frame building and elevator shear wall of frame-shear wall building both at first story respectively.

Fig. 35 Damage of a frame and frame-shear wall united building

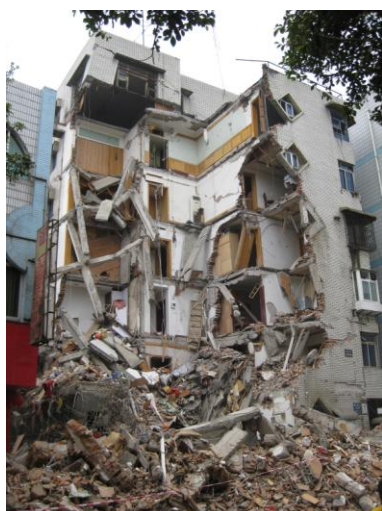
Fig. 36 Partly collapsed brick building

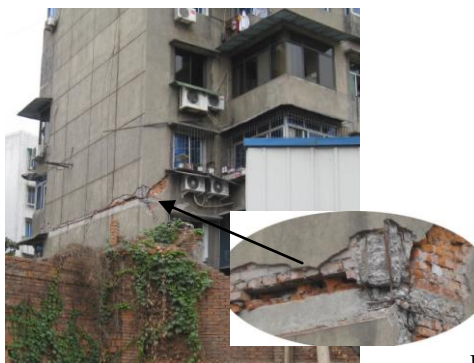
Fig. 37 Horizontal crack and dislocation at the bottom of 3<sup>rd</sup> story of a six story brick building

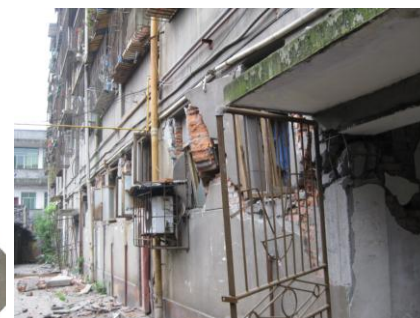
Fig. 38 first story of a six story BBF building heavy damaged
