SITE URGENT STRUCTURAL ASSESSMENT OF BUILDINGS IN EARTHQUAKE-HIT AREA OF SICHUAN AND PRIMARY ANALYSIS ON EARTHQUAKE DAMAGES

X.L. Lu¹ and X.S. Ren²

ABSTRACT:

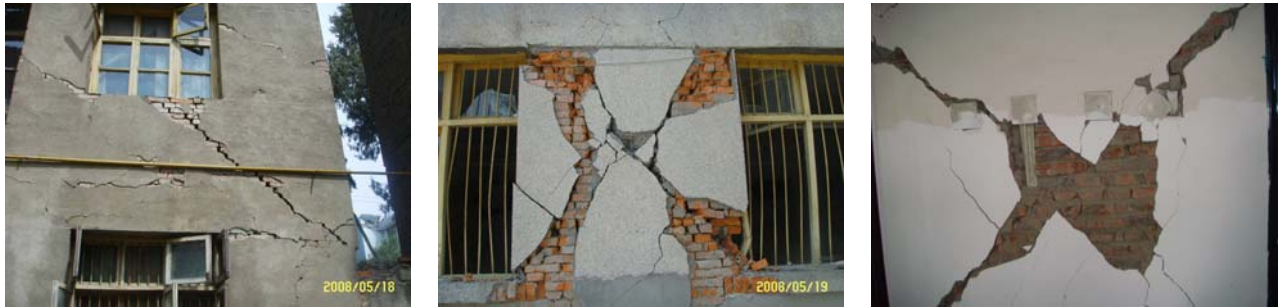
Through diagonal cracks or through X shape cracks on the wall are common phenomena of earthquake induced structural damage, which can be found in almost damaged buildings. This earthquake damage belongs to shear failure, which is caused by principal tensile stress exceeding shear strength of masonry. The through diagonal cracks usually appear mostly on the bearing transverse walls of the first to third floors, while X-shape cracks is very popular on the longitudinal walls, especially between the door or window openings of nearly every floor. When there are many pre-embedded pipelines, wire pipes and wire boxes in the wall, the width of this kind of crack will generally exceed 1mm because of the weakened section, which means more severe damage of building. Quite a number of walls lose their bearing capacity for the failure of the brick and mortar. Typical

phenomena of through diagonal cracks or through X-shape cracks on the wall are shown in Figure 1. The right picture of Figure 1 shows the influence of many wire pipes and wire boxes in the longitudinal wall.

Figure 1 Typical phenomenon of through diagonal or X-shape cracks on the wall

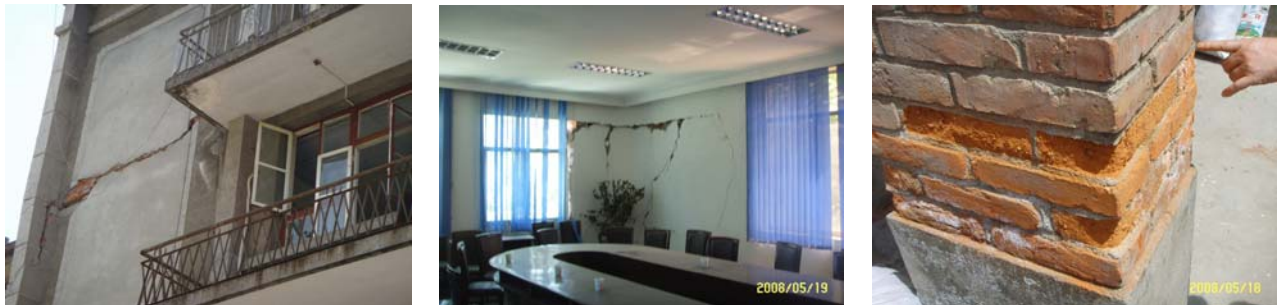
Horizontal cracks on the wall usually appear at the wall near the elevation of floor or roof. The through horizontal crack along mortar joint enlarges the damage and results in collapse of pre-cast hollow slab. Meanwhile, horizontal cracks also appear on the end of some bearing brick columns, which lead to decrease and even losing of the structural capacity. Although not many this kind of damage was found in the investigation of Qingchuan, partial collapse of buildings caused by this kind of cracks was not seldom seen in other disaster region, such as Wenchuan county, and Beichuan county. This kind of cracks means horizontal shear failure of walls. It can be deduced that the large vertical ground motion leads to this kind of earthquake damage. Typical phenomenon of horizontal cracks on the wall is shown in Figure 2.

Figure 2 Horizontal cracks on the wall or the bearing brick column

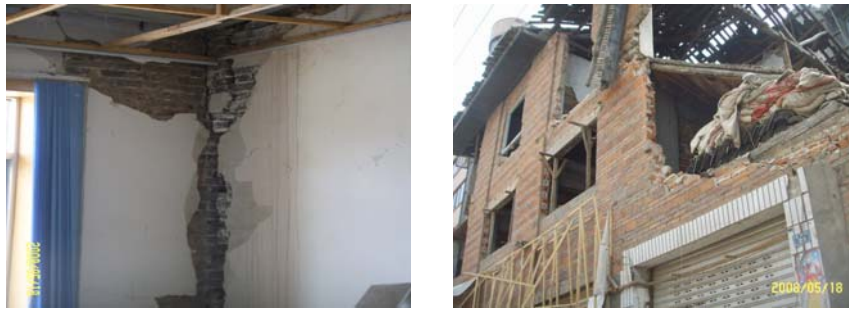
Due to the strong earthquake action, some longitudinal and transverse walls separate from each other. This kind of earthquake damage causes instability of walls and leads to out-of-plane collapse of walls. This phenomenon is common to appear on the rowlock wall and half width wall although it can occasionally be seen in solid wall, which is usually caused by bad or no indenting in the construction of wall. In the condition of wooden roof truss, this damage can be easily found in the top floor with partial collapse of the external wall. The left picture of Figure 3 shows the separation of inner walls, while the right picture of Figure 3 demonstrates the damage of wooden truss caused by the separation of the longitudinal and transverse wall.

Figure 3 Separation of walls at the intersection of walls

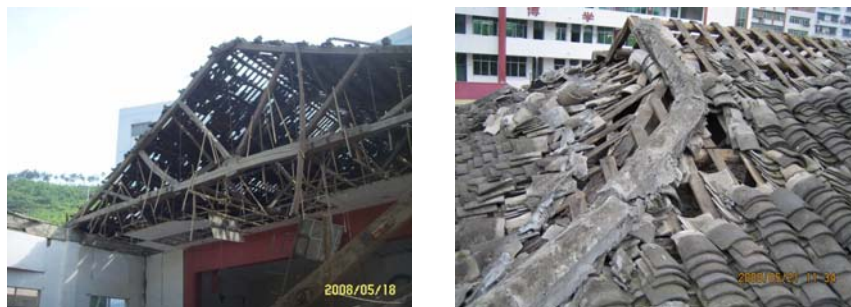
Wooden roof truss is frequently used in Sichuan province. The severe damage of wooden truss is shown as a large number of roofing tiles falling, failure of wooden roof truss and crack on the bearing. And in extreme condition, the damage of wooden truss will lead to the split of longitudinal and transverse walls and the partial destroy of the buildings. The typical damage of the wooden truss is shown in the left picture of Figure 4.

One more thing mentioned is that the severe damage of the little slop roof on the roof structure (as shown in the right picture of Figure 4), which is recently used as heat insulating layer of slab flat in addition to monitor the traditional wooden roof architecture in Sichuan.

Figure 4 Damage of the wooden truss

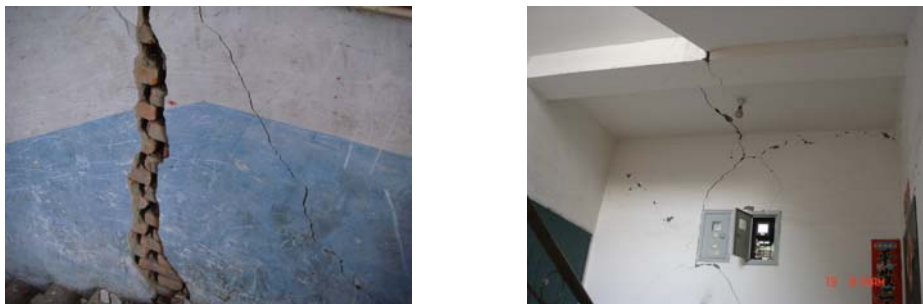
Comparing with the other part, the damage of stair is relatively severe. The earthquake damage focuses on the crack and even split of bearing transverse wall while not very severe damage were found on the reinforced concrete stair, as shown in Figure 5.

Figure 5 Typical damage of bearing wall and concrete slab in the stair part

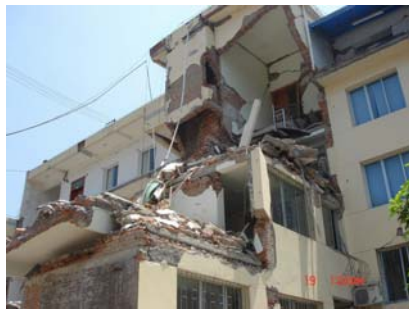
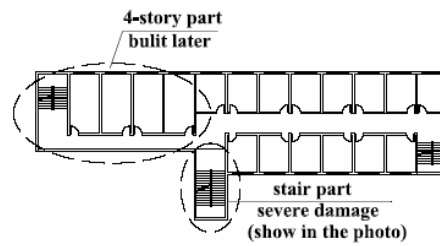
The left picture of Figure 6 shows the severe damage (partial collapse) of the stair part in the building with

irregular plane. From the layout of this building as shown in the right picture of Figure 6, the stair part is the convex part of the T-shaped plane.

Figure 6 Severe damage of stair part due to irregular plane (T-shaped)

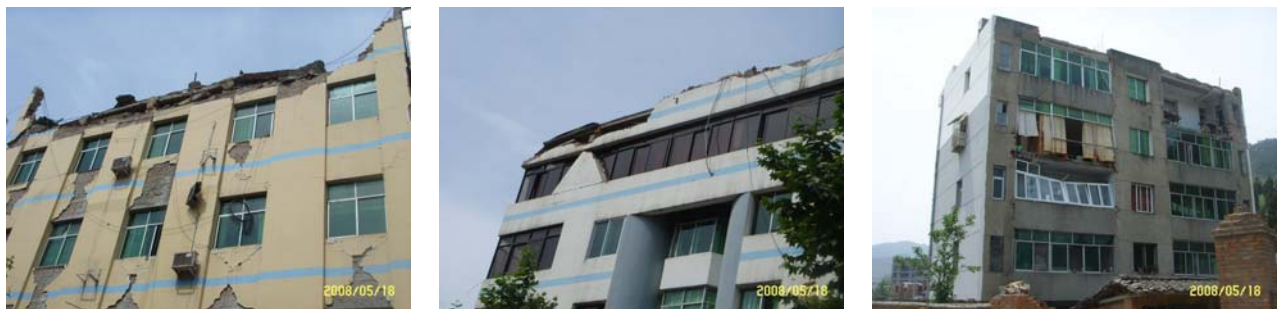
By comparison with the structural components, the nonstructural components are heavily damaged as no reliable ties between the nonstructural components and the structural components. The main damage patterns of the nonstructural components are horizontal crack, diagonal crack, even partial collapse. Figure 7 shows the partial collapse of the parapet, which even leads to the damage of the roof slab. Figure 8 shows the typical damage of nonstructural components, such as the collapse of the fence in the corridor, fracture of the cantilever canopy, falling of the outside ornament. Severe damages are also found on the protruding member in the roof, which will be discussed later.

Figure 7 Partial collapse and fall of the parapet wall

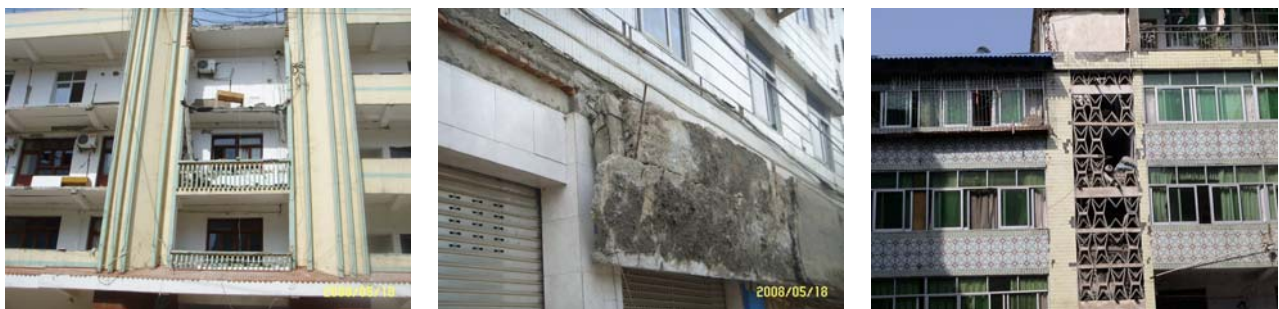
Figure 8 Typical damages of nonstructural components

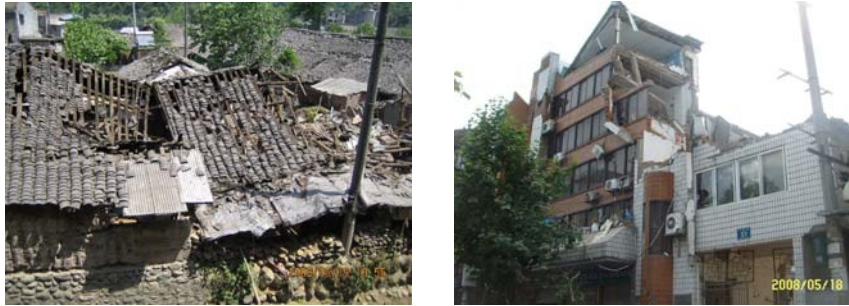
The structure of most countryside house is the mixture of adobe and masonry without seismic protection. And some buildings built earlier in the urban area did not take seismic protection into consideration. These buildings are severely damaged, as demonstrated in Figure 9.

Figure 9 Severe damages of countryside house and buildings without seismic protection

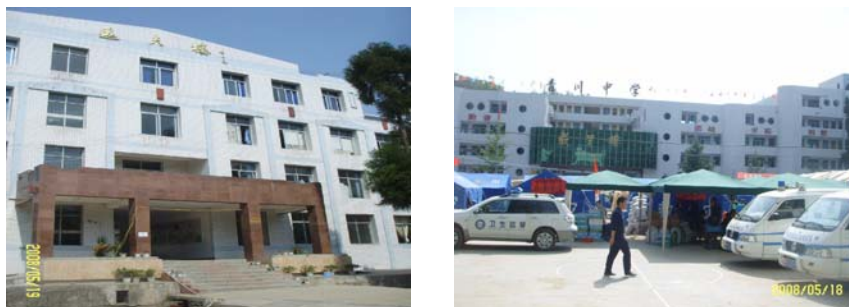
In the meanwhile, the buildings with seismic protection have good collapse resistant capacity under earthquake even if the design standard of that time is lower than the current standard. According to the magnitude of 5.12 Wenchuan Earthquake and its after-shock, the intensity of Qingchuan County is deduced to reach 9, which exceeds the current fortification intensity of 7. There was no school buildings collapsed in the urban area of Qingchuan County. Two teaching buildings of Qiaozhuang primary school and Qingchuan middle school have only slight damages, as shown in Figure 10.

Figure 10 Slight damages of teaching building of two schools

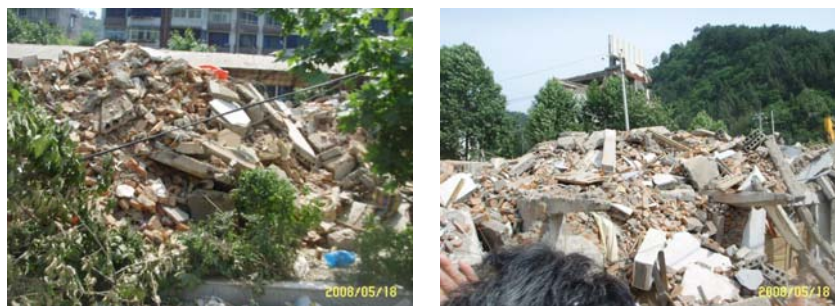
Unauthorized reconstructions caused severe earthquake damages. A typical example is a collapsed 5-floors building, which is used as the mountain delicacies market in the 1st floor and dwelling house in 2nd to 5th floor. It was designed as a 3 story building supported with bottom reinforced frame and finally constructed with 2 more stories added without reasonable design. Due to the weak structural capacity of bottom frame and the poor structural integrity, the building was totally collapsed. The wrecks of the collapsed building are shown in Figure 11.

Figure 11 The wrecks of a collapsed 5 storey masonry building supported by reinforced concrete frame in bottom

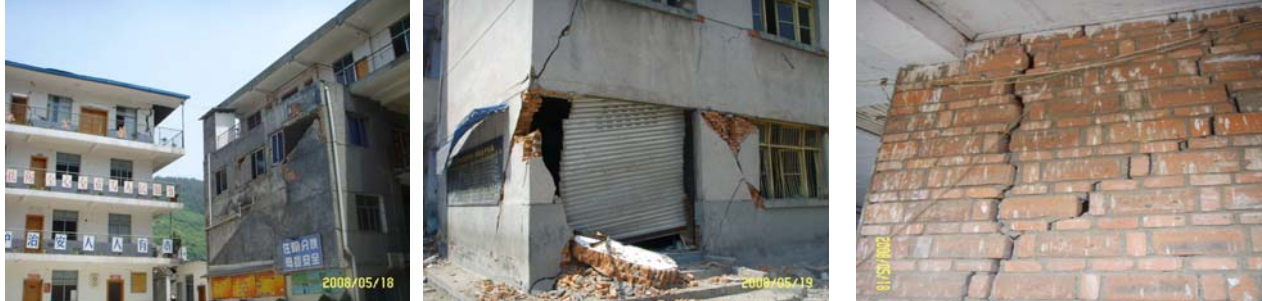
The typical unauthorized partial reconstruction includes removing or adding wall, punching a large whole, rebuilding and closing balcony after completion. Figure 12 shows the partial damages of unauthorized reconstruction with nearly no damage on the main structural components.

Figure 12 Partial damages caused by unauthorized reconstruction (closing balcony, demolishing and remodeling wall)

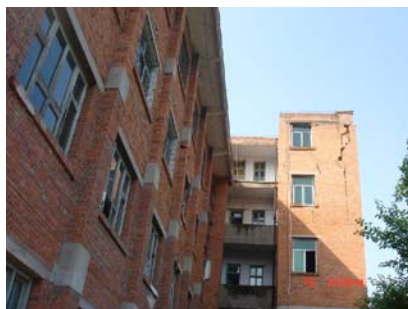
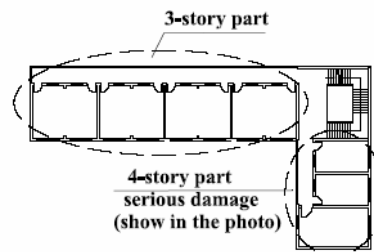
The buildings with irregularities of plane and elevation were damaged severe. Figure 13 shows the severe damages in the short part of a L-shape building. In Figure 6, the harmful influence of irregular plane (T-shaped) on seismic performance can obviously be seen from the severe damage of the stair part. And Figure 14 shows the severe damages in the position of staggered elevation.

Figure 13 Severe damage of buildings with plane irregularity

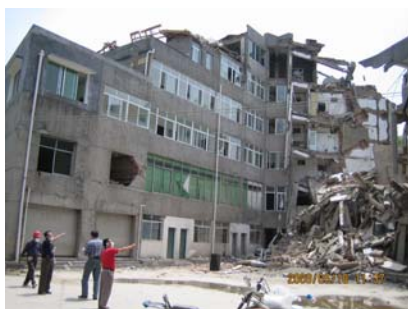
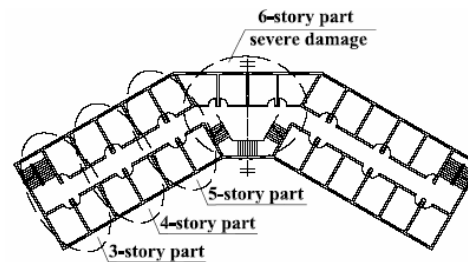
Figure 14 Severe damage of buildings with elevation irregularity

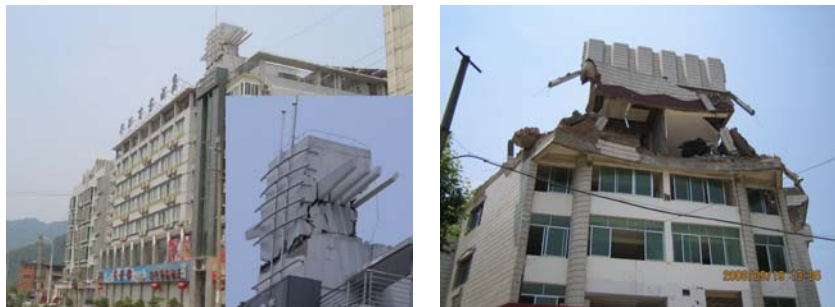
Protruding member on the roof belongs to the typical irregularity in elevation. Under earthquakes, the protruding part will have relative large deformation and result in severe damage because of the participation of

high vibration mode called as the whipping effect. Figure 15 gives two typical damaged examples of protruding members on the roof.

Figure 15 Severe damages of protruding members on the roof

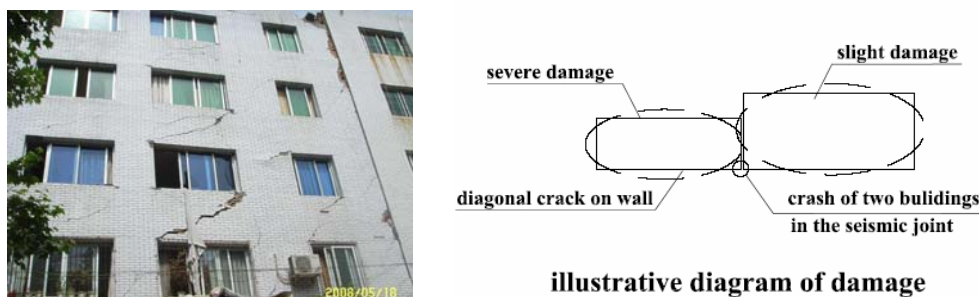
It is proved in the previous earthquake damages that seismic joint is an important seismic measure. Figure 16 shows the severe damage, such as wall crash of two buildings and the diagonal crack on the wall of the relative small building, which is caused by unreasonable setting of seismic joint, with too small dimension of the joint.

Figure 16 Damages caused by the unreasonable small dimension size of seismic joint
