Wenchuan Earthquake Field Reconnaissance on Reinforced Concrete Framed Buildings With and Without Masonry Infill Walls

ABSTRACT: This paper focuses on the seismic performance of multi-story reinforced concrete (RC) frames with and without masonry infill wall, which were affected by the 8.0 magnitude earthquake that struck northwestern Sichuan, China, on May 12, 2008. Field reconnaissance was carried out in Dujiangyan, Hanwang, and Yingxiu in order to investigate the types of damage observed in the infill walls and/or the bounding frames. Seismic code requirements are discussed and compared with observed details. Many structural deficiencies were highlighted by the earthquake damage, which include: soft and weak stories, strong-beams and weak-columns, short columns, interaction between the infill walls and the bounding RC frames.

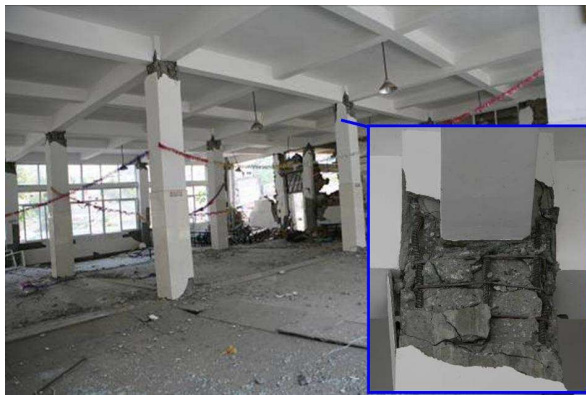
Figure 2 Plastic hinging in columns

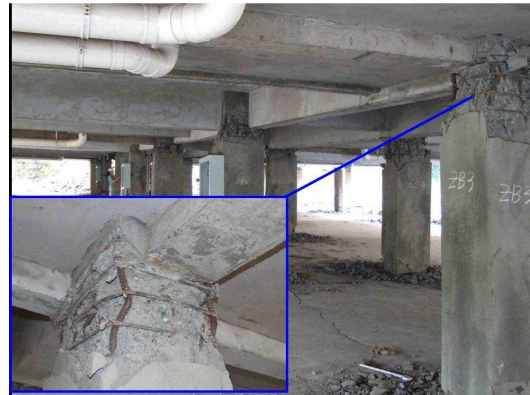
Little damage to moment-frame beams in the Wenchuan earthquake epicenter region was observed by the reconnaissance team because columns were generally weaker than beams. However, one of the requirements in designing ductile frames is strong-column and weak-beam, according to the current code for seismic design, that is, most structures are designed to have sufficient ductility to survive an earthquake. This means that elements will yield and deform, but they will be strong in shear and continue to support their load during and after the earthquake. The reconnaissance team toured a number of frame buildings and found that many frame buildings collapsed due to weak-column and strong-beam in the epicenter region. Figures 2 and 3 show the plastic hinges occurring at the top and bottom of columns. From the pattern of damage, it was concluded that the RC slabs that were cast monolithically with the beams played an important role to contribute to the stiffness of the beams when the structure was shaken under the earthquake motion.

Figure 3 Weak-column and strong-beam

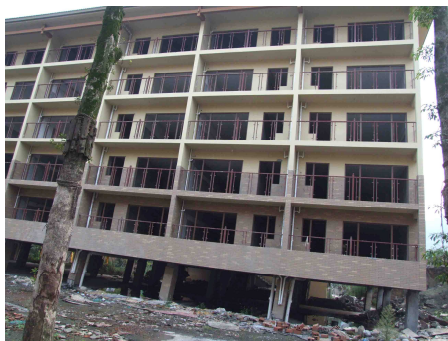
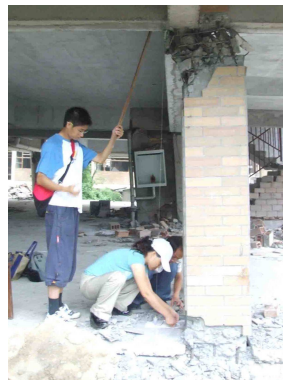
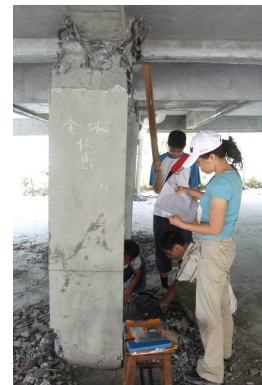
Figure 4 Formation of a soft and weak story

widely used in the epicenter region of Wenchuan earthquake. In Dujiangyan area, some of these buildings had less, even no infill walls (or other strong and stiff lateral load resisting elements, e.g. shear walls or strong columns) in the first story to increase the parking or commercial spaces. However, such buildings had many infill walls in two orthogonal directions as partitions in the upper stories to define residential spaces. Such an arrangement of tiles infill walls created stiffness discontinuities in these buildings, which may have contributed to their collapse by concentrating the drift demands in the first story. The high in-plane stiffness of the masonry infill walls, which is developed by diagonal compression strut action, can significantly affect the response of the more flexible moment-resisting RC or steel bounding frames [7-12]. It was observed that damage to masonry infill walls was concentrated in the lower stories of buildings. Figure 4(a) shows a six-story building where the first story is parking and has less infill walls while the upper stories are residential and have many infill walls. The building leaned to the west after the Wenchuan earthquake with about 200 mm drift concentrated in first story columns, Figures 4(b) and (c).

(a) Leaned 6-story building in Dujiangyan

(b) Measuring column drift

(c) Typical column damage

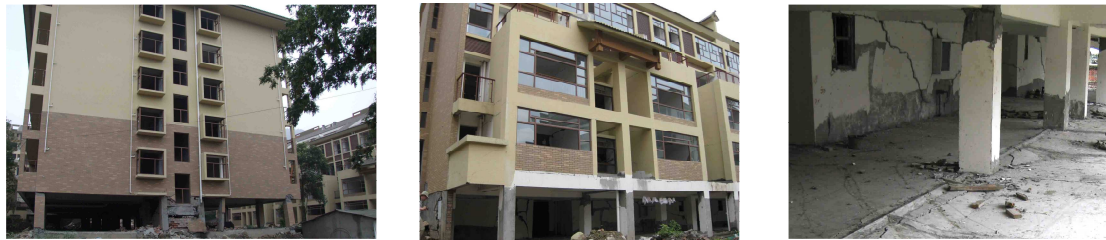
Figure 5(a) shows two RC frame buildings in Dujiangyan, the frontal one of the photograph is a six-story building, discussed in the previous paragraph, Figure 4, the back one is a five-story building with some infill walls in the ground floor, Figures 5(b) and (c). As mentioned before, the former building experienced about 200 mm drift in the first story, whereas the latter building exhibited shear cracks in the first story infill walls and minor damage in columns where infill walls likely played an important role in this better performance.

(a) Major damage (b) Moderate damage (c) Infill and column damages
Figure 5 Variability of building response after Wenchuan earthquake

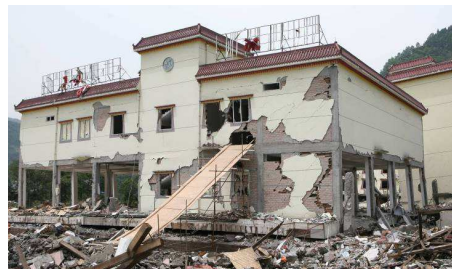
The first story of the building located in Yingxiu, Figure 6, collapsed during the Wenchuan earthquake, but damage of RC frame in the upper two stories with collapsed to damaged infill walls was limited. The infill walls that were made of hollow shale tiles had significant stiffness but low strength. The reconnaissance team observed that the first story had less infill walls than the upper stories. The brittle fracture of the first story

masonry infill walls, prior to flexural yielding of the columns, significantly reduced the stiffness of the first story and suddenly overloaded the first story columns in shear, resulting in the observed non-ductile failure.

Figure 6 Partial collapse of 3-story RC frame building with masonry infill walls in Yingxiu

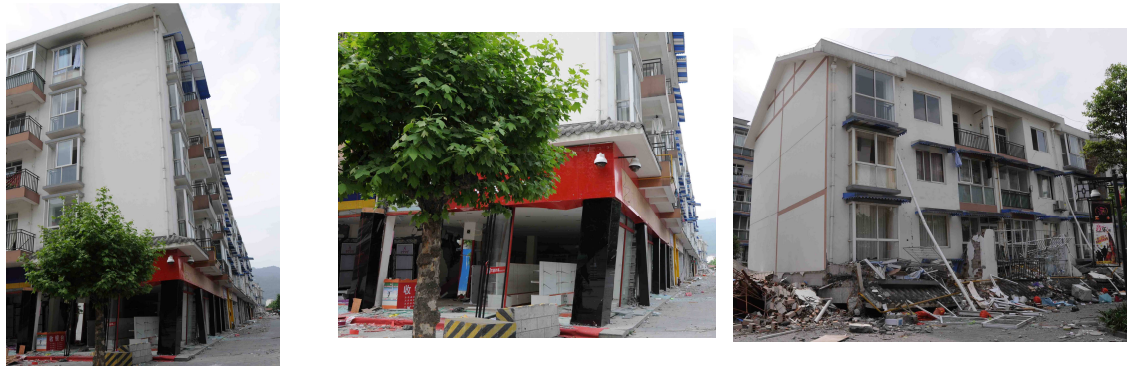
Figures 7(a) and (b) show views of a five-story RC frame building in Dujiangyan where large lateral deformation in the transversal direction occurred during the Wenchuan earthquake. The first story was a commercial space and the upper stories were residential. The building was constructed with hollow shale tiles infill wall in the frames perpendicular and parallel to the sidewalk in the stories above the first story. In the first story of this building, masonry infill walls were only present in the back of the building with open front and sides. The lateral stiffness of the building was considerably larger in the direction parallel to the sidewalk compared with that perpendicular to the sidewalk, due to the different number of column. Deformation was concentrated in the first story perpendicular to the sidewalk. The first story columns in this building were severely damaged and likely close to loss of gravity load capacity. Figure 7(c) shows a collapsed apartment building adjacent to the one discussed before. The first two stories of this building collapsed, whereas damage in the upper three stories was limited.

(a) Damaged 5-story building (b) Close-up of 1st story damage (c) Collapsed 5-story building
 Figure 7 Views from two 5-story RC frame apartment buildings in Dujiangyan

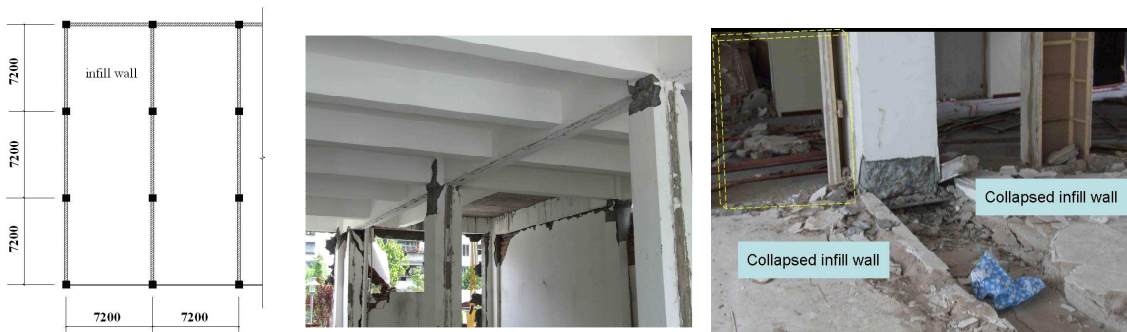
Some commercial buildings on the side of streets were constructed with light walls in the frames perpendicular to the sidewalk to separate the space. On the other hand, masonry infill walls were present in the back face of the building with the front kept open in the first story for commercial use. Figure 8(a) shows a plan of part of the first floor where dimensions are given in mm. A typical view from the interior of a two-story commercial building is shown in Figure 8(b) where plastic hinges formed in the top and bottom of the columns in the direction parallel to the sidewalk and the collapsed infill walls are shown in Figure 8(c). The lateral stiffness of the building in the direction parallel to the sidewalk was considerably less than that perpendicular to the sidewalk. Thus, building lateral deformations were concentrated in the direction parallel to the sidewalk. The infill walls perpendicular to the sidewalk were almost always unreinforced and were not tied to frame members, so they could not deform with the frame during shaking losing the confinement from the frame and collapsing.

(a) Partial plan view (b) Column plastic hinging (c) Collapsed infill walls
 Figure 8 Views from a commercial RC frame building in Dujiangyan

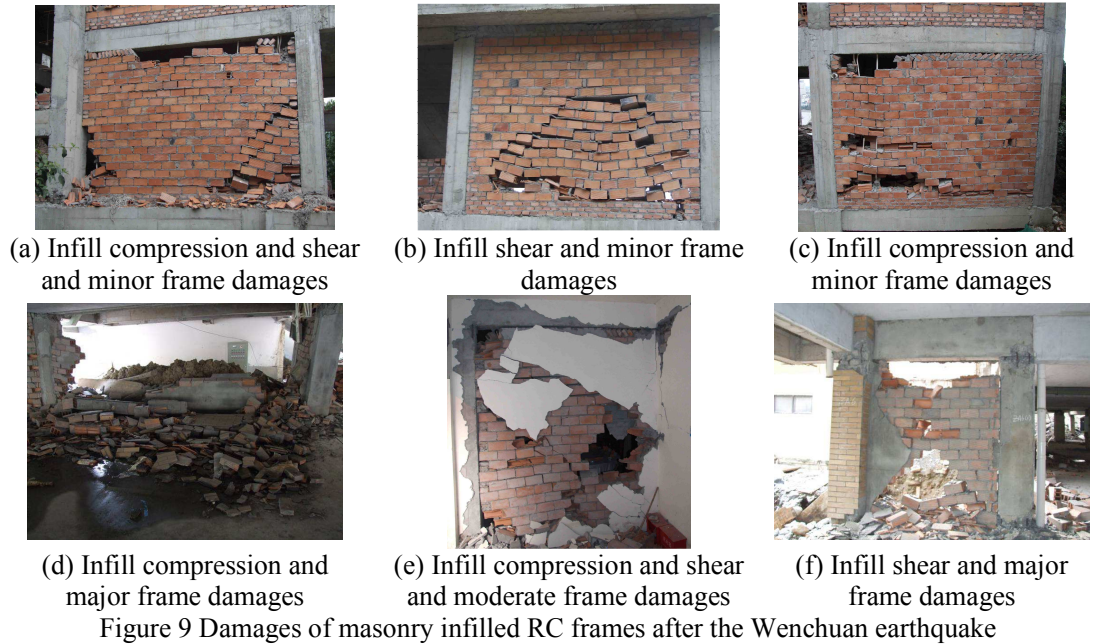
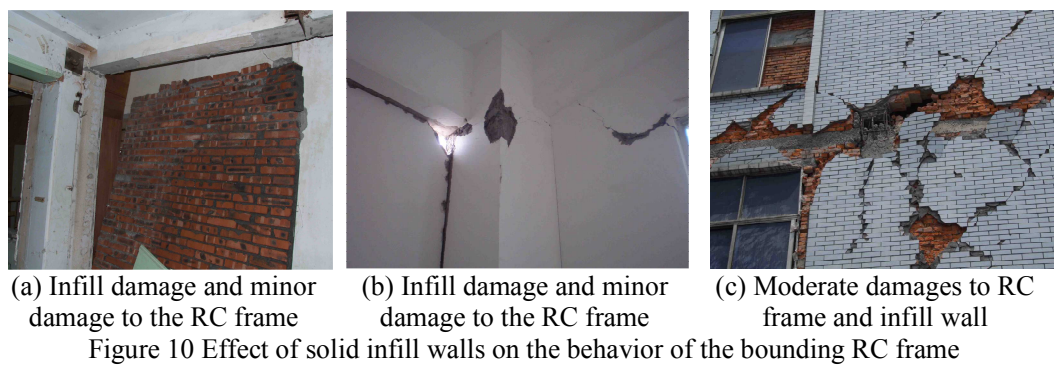
Figure 9(a) to (f) show a group of photographs of infill walls in several three-story moment resisting frame buildings that were under construction during the time of the Wenchuan earthquake. All of these infill walls were constructed with hollow shale tiles, some of them had facing material or decorative surfacing. Some of the weakest hollow shale tiles suffered compression damage, and then parts of the infill wall collapsed at the time of the earthquake. However, the beams and the columns suffered minor damage in the cases shown in Figures 9(a), (b) and (c). The lower strength and greater stiffness of the hollow shale tiles infill walls compared with the RC frames caused damage to concentrate in the former, which dissipated part of the earthquake energy and protected the RC frame. The beams and columns suffered moderate to major damage in the cases shown in Figures 9(d), (e) and (f). In all cases, infill walls suffered a combination of compression and shear damage.

Solid clay bricks were also used as infill walls in the old buildings in the epicenter region of the Wenchuan earthquake. Solid bricks have much more significant strength and elastic stiffness than the hollow shale tiles. In some case, no connection between frame and infill wall could be found. Therefore, the different lateral deformation between RC frame and the infill wall resulted in infill wall damage during the Wenchuan

earthquake and damage in frame was minor, Figures 10(a) and (b). The levels of damage were similar in the bounding RC frame (particularly the columns) and the solid masonry infill wall, Figure 10(c). This was the case when the frame and infill worked in unison (due to proper connection between them) and interacted at the time of earthquake leading to simultaneous occurrence of column ductile flexural yielding and infill brittle cracking.

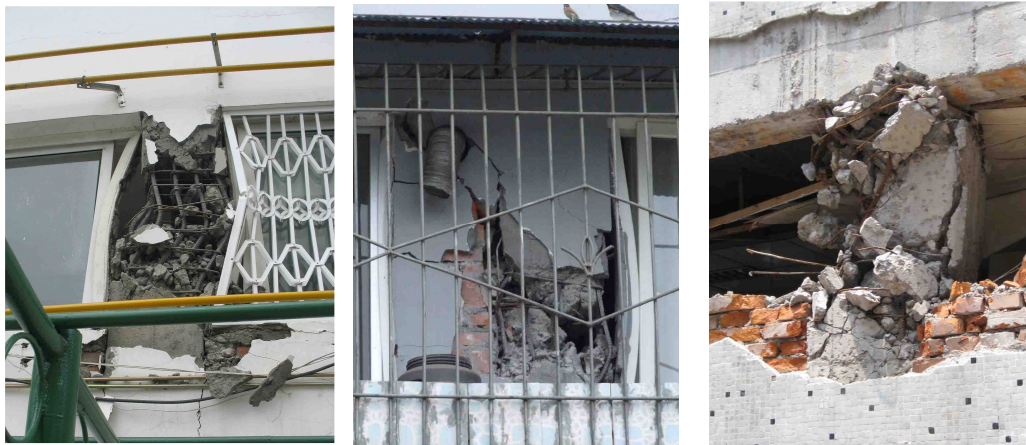
Columns located between windows likely performed as short columns with high shear deformations. In this case, the height-to-length of the column without lateral confinement was less than two. Often, flexural damage was accompanied by compression and shear damages, refer to Figures 11(a) to (c) for typical short column damages after the Wenchuan earthquake. It is worth mentioning that the majority of moment-frame column failures was due to one of the following four causes (or a combination of them): (1) low strength of concrete in column; (2) excessive beam strength; (3) transverse ties are smooth bars of only 6 to 10 mm diameter; and (4) interaction between the columns and the full or partial (due to windows) masonry infill walls.

(a) Windows in both sides (b) Infill in one side only (c) Partial infills in both sides
 Figure 11 Short columns observed after the Wenchuan earthquake

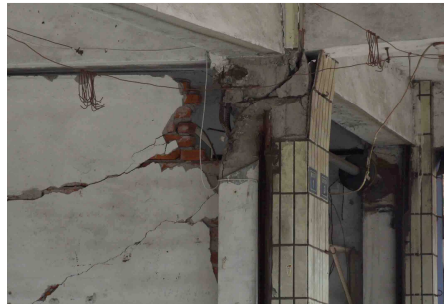
Tile infill walls contributed to the stiffness of the RC frame because of the high in-plane stiffness of the masonry infill walls, which were developed by diagonal compression strut action, indicated by *N* in Figure 12. Therefore, the column experienced a combination of shear and compression damage. The ductility of the

column in an infilled frame decreased compared with the frame without infill wall.

(a) Photograph of infill and column damages

Figure 12 Diagonal compression strut caused by masonry infill wall

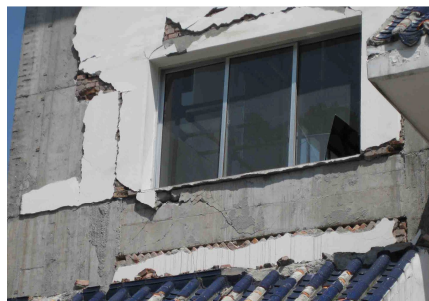
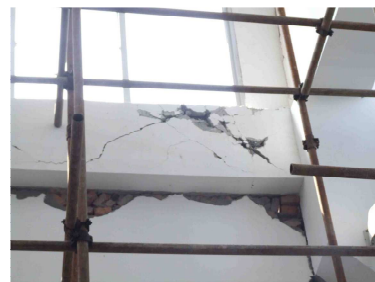
Figure 13 Beam damage in a building on Zipingpu dam after the Wenchuan earthquake

One type of damage in RC beams that was resulted from the interaction between RC frame and the infill wall is shown in Figure 13, which is different from the usual flexural and shear damage caused by pure gravity loading. The beam was subjected to upward pressure causing flexural and shear damages. This upward pressure resulted from the infill wall under the beam which was damaged by cracking and tended to expand vertically.

(a) View from outside

(b) View from inside
