## The performance of girder bridges in the Wenchuan Earthquake and a new method for seismic protection

Y. Huang

### ABSTRACT:

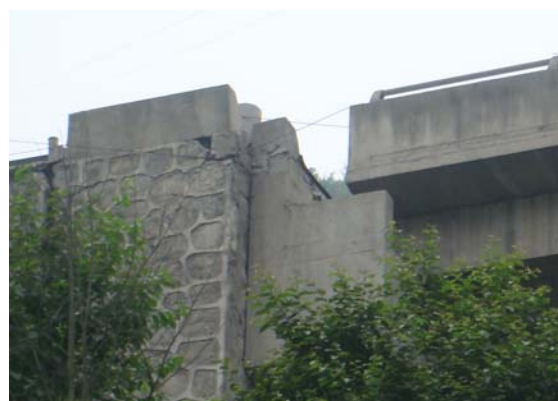
The bridge site is in the meizoseismal area. The landslide and collapse occurred in the mountain body beside the bridge, and the surface rupture near Abutment A1 which shifted towards the river side slightly can be found. There was a transverse crack on the wing wall of Abutment A1, and 1# girder shifted along the longitudinal axial of bridge (Fig.3). Plastic hinge appeared in the region of bottom of Pier P1, and the pier body inclined back (Fig.4). Pier P2 distorted. All of Pier P3 and P4 broke completely, and 2# cantilever span concrete curve slab fell down (Fig.5). As same as P8 and P9, one of the blocks on Pier P5 broke, and there were some cracks at

Fig.3 Crack on the wing wall of Abutment A1

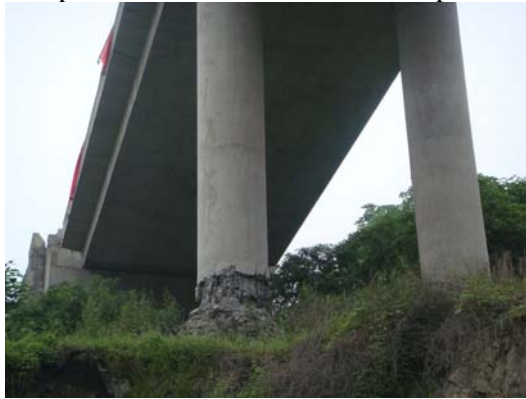
Several factors influenced this bridge's performance during the earthquake. From Fig.2, we can find that there is a fault which is less than 1 km away from the bridge, and the bridge site is only 4.2 km from the epicenter. The short distance from the epicenter meant that very large accelerations were arriving at the bridge. This is also reflected in the ground motions record near the site. Form Table 2.1, we can find that the peak acceleration on the ground of Wenchuan Wolong Station, which is on the west side of the bridge and is the nearest station from the site, is up to 0.96g on EW. The large displacement of the ground near Abutment A1 resulted abutment and piers moving and deflecting. Meanwhile, the inertia force of superstructure pushed the piers which support the

cantilever span curve slab, and resulted the piers broken, the decks of 2# girder fell down.

Fig.4 Rupture of concrete at Pier P1

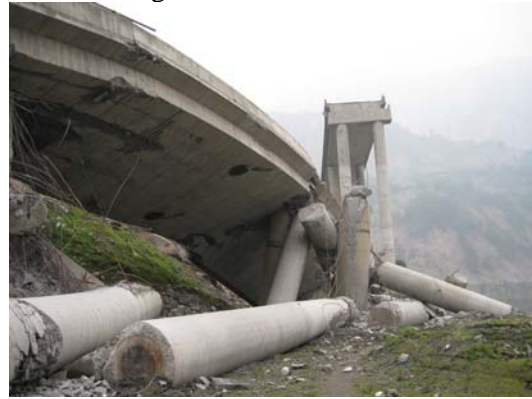
Fig.5 Fall of 2# girder

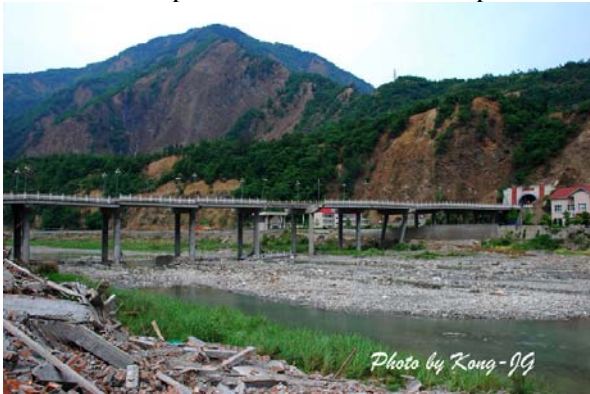
The bridge is located in the XI intensity area. The girders of Shisuoyi Bridge moved along longitudinal axial toward Beichuan Country nearly 2 meters, and the bridge deck moved along lateral axial also nearly 2 meters. Part of the deck on 5# girder transverse fell down. Pier P7 inclined severely, and the concrete of coping cracked (Fig.8). The Piers of Xiayu Bridge P3 and P4 broke completely. Girder 3#, 4# and 5# fell down (Fig.9). From Fig.7, we can find that there is a fault near the bridge. The motion of bridge during the earthquake was highly influenced by the fault. According to the Table 2.2, we can find that the peak acceleration on the ground of Jiangyou Hanzeng Station, which is on the east side of the bridge and is only 1.5km from the site, reached 0.52g on NS. As the strong ground motion, all of the girders moved severely. Excessive displacements and inertia forces of superstructure caused some piers deflected or broken, result some of girders fell down.

Fig.8 Shisuoyi Bridge deck moved severely

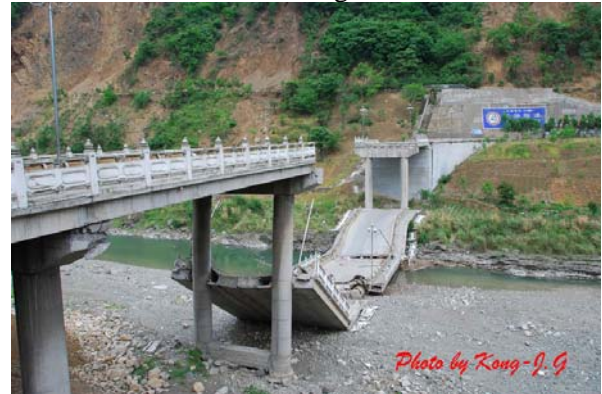
Fig.9 Fall of 3# -5#girder of Xiayu Bridge

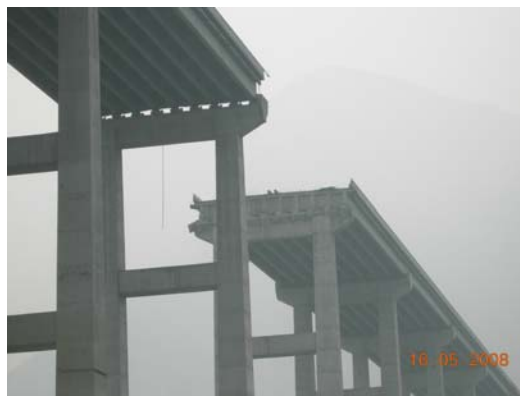
During this earthquake, the severest damage of this bridge is 4# girder falling down. The other damages including the movement of 3# and 5# girder, the deflection of guardrail on Pier P5, and the ruin of block on P9 and P10. Excessive earthquake action makes the excessive relative displacement between flexible pier and girder more than 1 meter that the bridge had originally been designed according to intensity VII (JTJ 004-89, 1990), which result in a span girder falling down.

Fig.12 Left is 3# girder, right is 5# girder, 4# girder fell

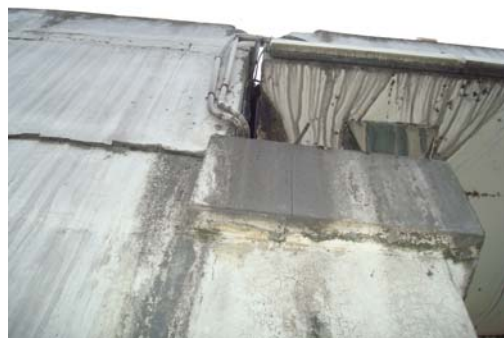
During the earthquake, the collision between girder and abutment at both ends of the bridge result in the wing wall of abutment cracked (Fig.13), expansion joint pulled off (Fig.14).

Strong inertia force caused the collision at the ends of girder, meanwhile continuous girder and rubber bearing accumulated the displacement at both ends of bridge, result in these damages.

Fig.13 Crack on the wing wall of abutment

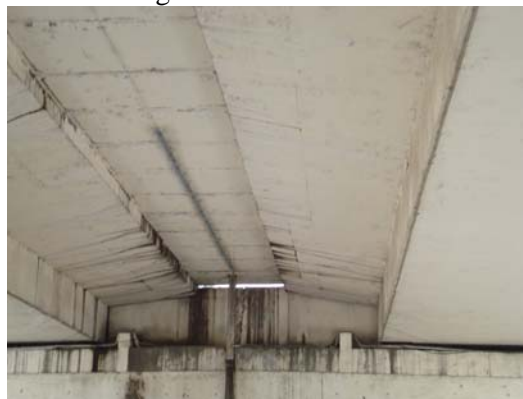
Fig.14 Damage of expansion joint
