## THE WENCHUAN EARTHQUAKE OF MAY 12, 2008: FIELD OBSERVATIONS AND RECOMMENDATIONS FOR RECONSTRUCTION

M. Free<sup>1</sup> T. Rossetto<sup>2</sup> N. Peiris<sup>3</sup>, F. Taucer<sup>4</sup>, B. Zhao<sup>5</sup>, R. Koo<sup>6</sup>, J. Wang<sup>7</sup>, X. Ma<sup>8</sup> and E. Verrucci<sup>9</sup>

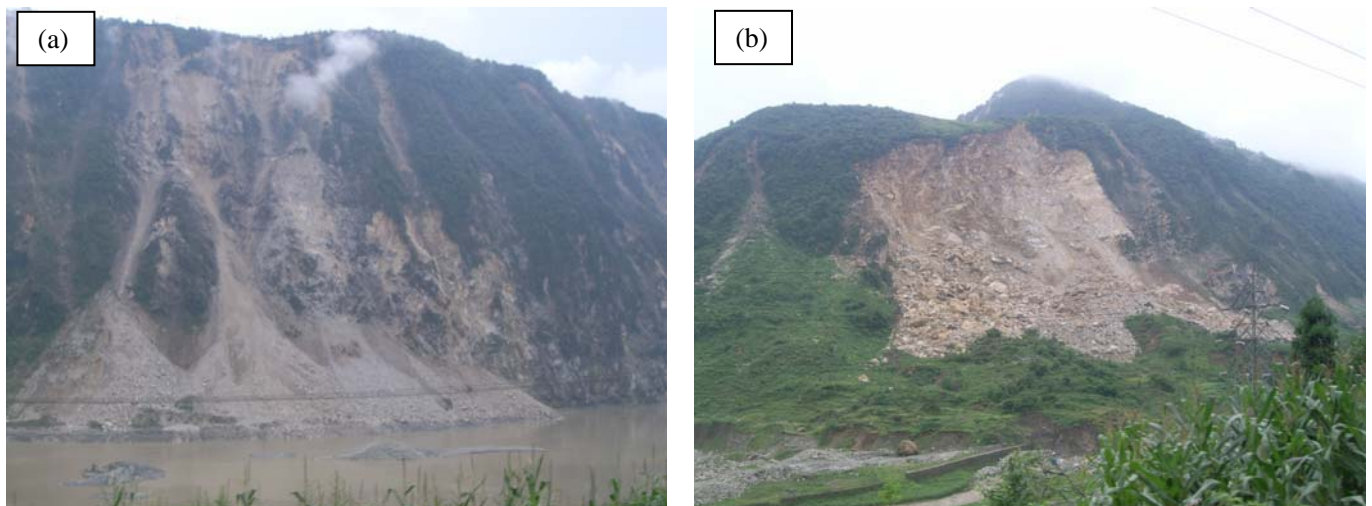
The observations en-route to many of the damaged towns revealed the abundance of landslides, slope failures and the performance of geotechnical structures such as retaining walls, anchored walls and other earth works. The landslides observed were largely rock falls, shallow rock and debris slides triggered by the strong ground shaking. Deep seated landslides involving failure through the rock mass also occurred but were less common. Secondary landslides were also triggered by the wet weather conditions following the mainshock event and by aftershocks. Figure 2a shows such a series of rock and debris slides on the very steep hillslopes near Ying Xiu. Figure 2b shows a deeper seated landslide. The rock types observed in the area varied from granite, sandstone to limestone (Densmore et al., 2007).

Figure 2: (a) shallow slip landslide involving the surficial soils (b) Deep slip landslide mobilizing the fractured rock basement  
Both hillsides were estimated to be 300m in height.

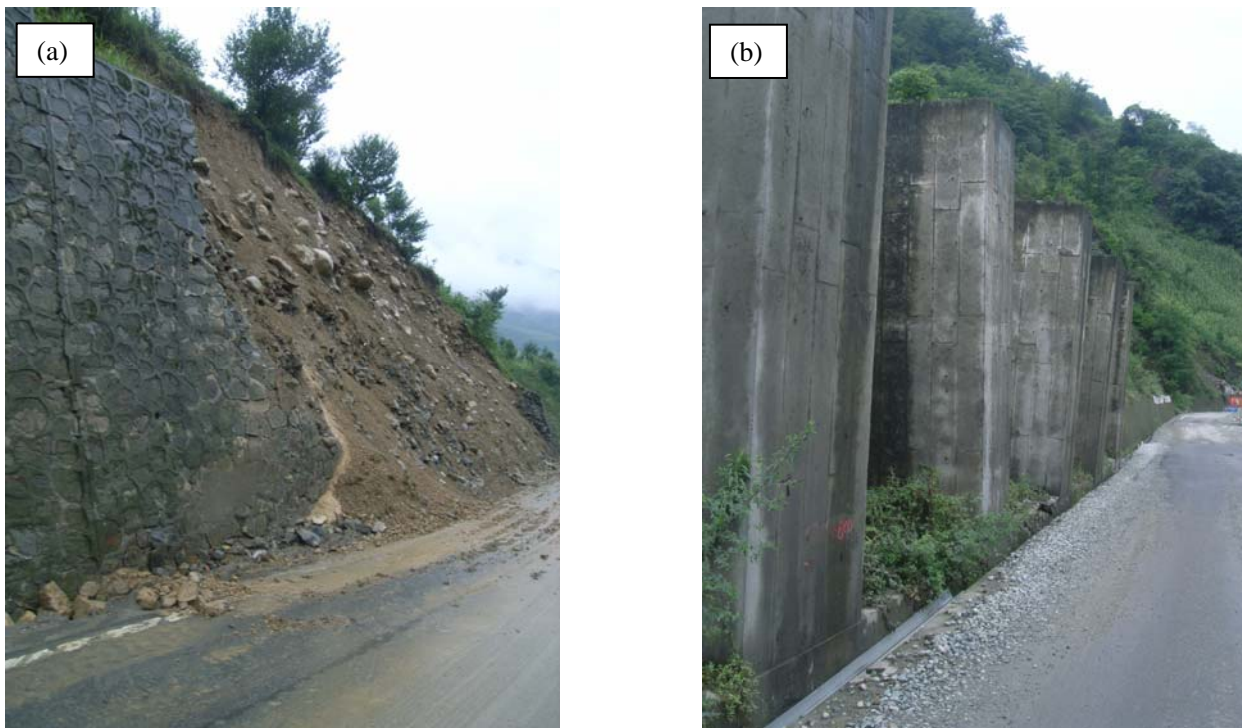
Figure 3: (a) Collapsed section of stone facing gravity retaining wall near Ying Xiu (b) Displaced section of RC bored pile retaining wall stabilizing a pre-existing landslide to protect the road, near Ying Xu

A variety of earthworks types were observed, which were used to stabilize the cuttings made for the mountain roads. The earthwork types observed were rock anchoring systems, soil nail walls, gravity retaining walls, reinforced concrete flexural retaining walls and face protection systems using cement sand mix with possible grout injection. The geotechnical structures have largely performed well during the earthquake. Gravity retaining walls made of cemented stone blocks did not perform well at certain sections. The walls were constructed with breaks at about 15m and these sections collapsed often resulting in a shallow landslide of the retained soil. Figure 3(a) shows such a slide on a major route near Ying Xiu. The gravity retaining walls are susceptible to failure due to prolonged exposure to wet weather if the drainage holes were blocked. A bulged section of a gravity retaining wall was found near Ying Xiu, where it is likely to fail due to further wet weather or due to an aftershock. Reinforced concrete retaining walls have performed well from those observed during the survey. Figure 3(b) shows an RC bored pile retaining wall stabilizing a pre-existing landslide and only experienced a stable head displacement of about 15cm, hence the road was unaffected.

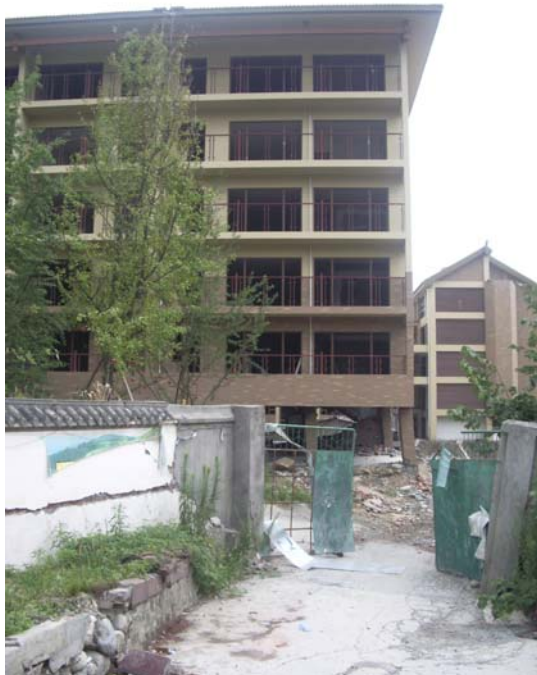
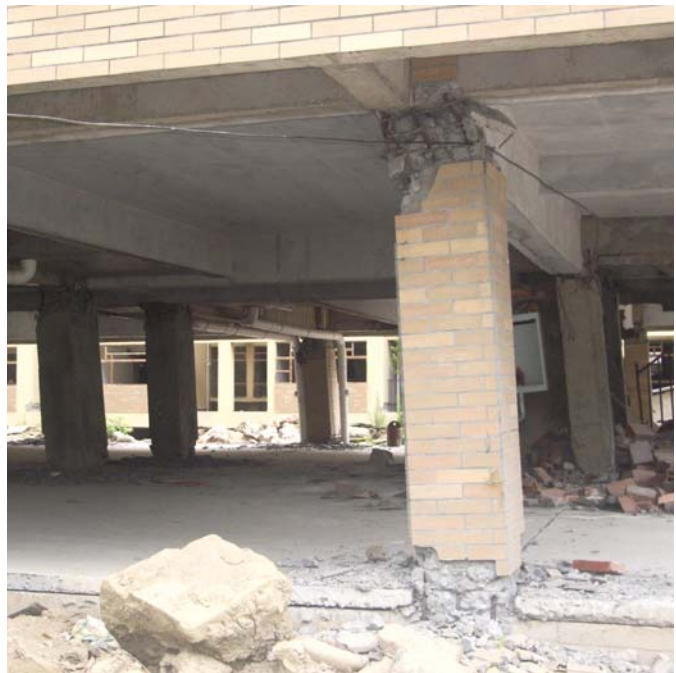
Reinforced concrete moment resisting frames (RC MRF) are the predominant type of construction in the cities of Sichuan Province. The majority of these were observed to have a height between 4 to 6 storeys, with the ground floor being used for commercial purposes and the upper stories as residential units. Upper floors have clay brick infill, whereas concrete block masonry is sometimes used for ground floor infill. Most of the buildings observed were built after the 1980's, thus had some level of seismic design. The typical ground floor column dimensions for these mid-rise buildings were 400mm square and beam dimensions 400mm (depth) by 150mm (width). Construction materials and workmanship are good. Reinforcement varied but often consisted of 3 deformed longitudinal bars per column side with 25mm diameter at ground floor. Column ties were of 8mm diameter hoops with 90° anchorage hooks, and placed at relatively wide spacing of 200mm, thus not providing appropriate confinement.

Figure 4: Six-storey RC MRF in Yazhouyan housing development, Dujiangyan that is exhibiting a soft-storey failure mechanism at ground storey (detail of ground floor columns, right)

The performance of the mid-rise RC MRF varied substantially according to location. However, in any single location, no difference was observed between the performances of buildings built to different codes, due to the predominance of soft-storey type failure. For example, the Yazhouyan housing development in Dujiangyan composed of 27 buildings between 4 and 6 stories in height. Construction of these buildings began in 2006 and some were still under construction at the time of the earthquake. These structures are founded on very stiff soil with driven pile foundations of 300-400mm diameter and 900kN maximum axial capacity. Although designed to the most recent Chinese seismic code, about 70% of the structures had suffered some degree of damage with many suffering soft-storey failure at either the ground or first floor, mainly due to non-consideration of the added stiffness due to the presence of infill. Figure 4 shows a typical example where this type of failure was also precipitated by the presence of reinforcement bar splices in plastic hinge zones and inadequate confinement reinforcement. Overall, RC MRF performed well outside the immediate fault zone, and achieved life-safety performance despite the fact that the reported felt PGA's are much larger than the design values for the area. In locations very near the fault zone, instead, they did not achieve life-safety performance.

From observation of the performance of reinforced concrete moment resisting frames it is clear that soft ground-storey modes of failure were a problem. These resulted from uneven distribution of infill walls between the ground and upper stories of structures. This has been seen as a major problem in many past earthquakes around the world, and provisions should be taken to guide the placement of infill in seismically designed structures to avoid occurrence of stiffness irregularities. Furthermore, more stringent detailing criteria for the curtailment of reinforcement bars in column ends needs to be enforced.

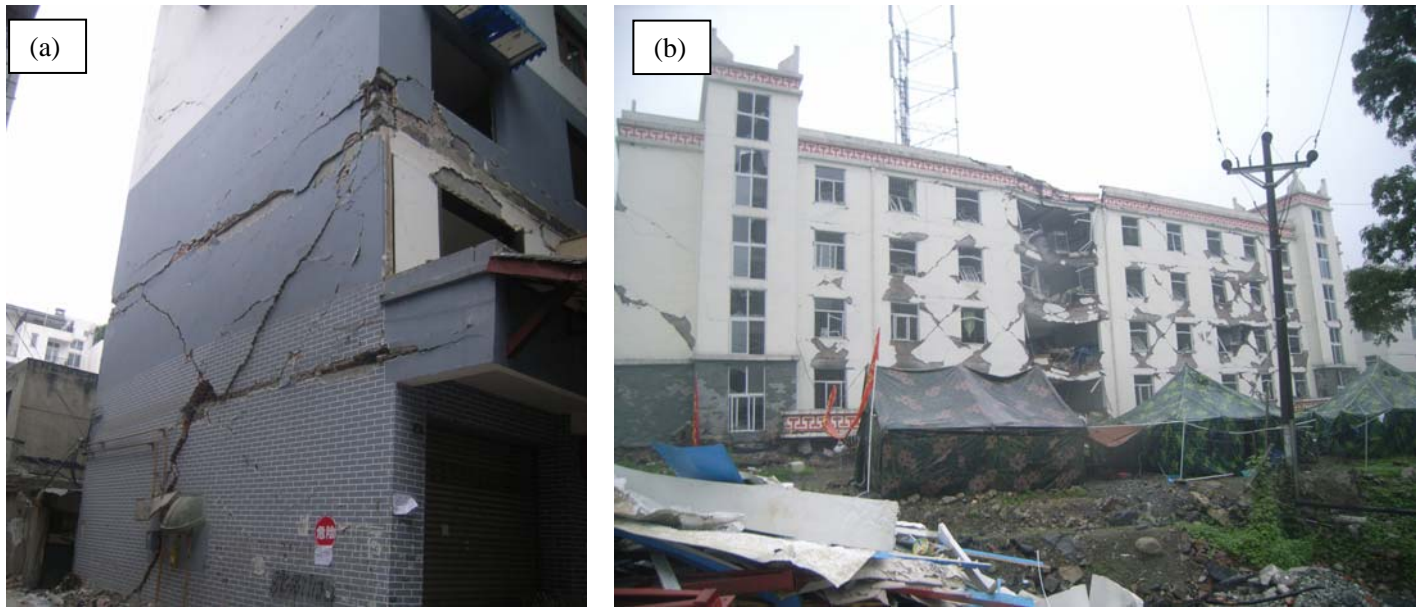
In Sichuan, unreinforced masonry construction is used for residential as well as commercial buildings. In towns these buildings are typically 1-2storey where the ground floor is used for commercial purposes and the upper floor for residential. There are some masonry structures built to 4-storeys or higher for commercial, residential and for schools. In the rural areas, masonry structures are largely residential and of single storey. The performance of masonry structures was seen to depend on their location with respect to the epicentre. The 1-2storey masonry structures in Dujiangyan generally performed well, probably because of terraced construction giving greater seismic resistance. Failures of this type of structures involved shear cracks running through the masonry bearing walls and damage to masonry columns. Figure 5(a) shows a 5-storey commercial structure appears to be using masonry bearing walls through confined masonry construction in Dujiangyan. The end bearing walls have experienced large diagonal shear cracks running through the RC beam and exposing a column section. Figure 5(b) shows a 5-storey masonry school building in Ying Xiu that has a collapsed ground floor and collapsed section of the building through all the floors. The masonry houses in rural areas performed badly, most houses having collapsed or suffered damage beyond repair.

Figure 5: (a) 5-storey confined masonry building in Dujiangyan with shear cracks on bearing walls, (b) 5-storey masonry school building in Ying Xiu partially collapsed

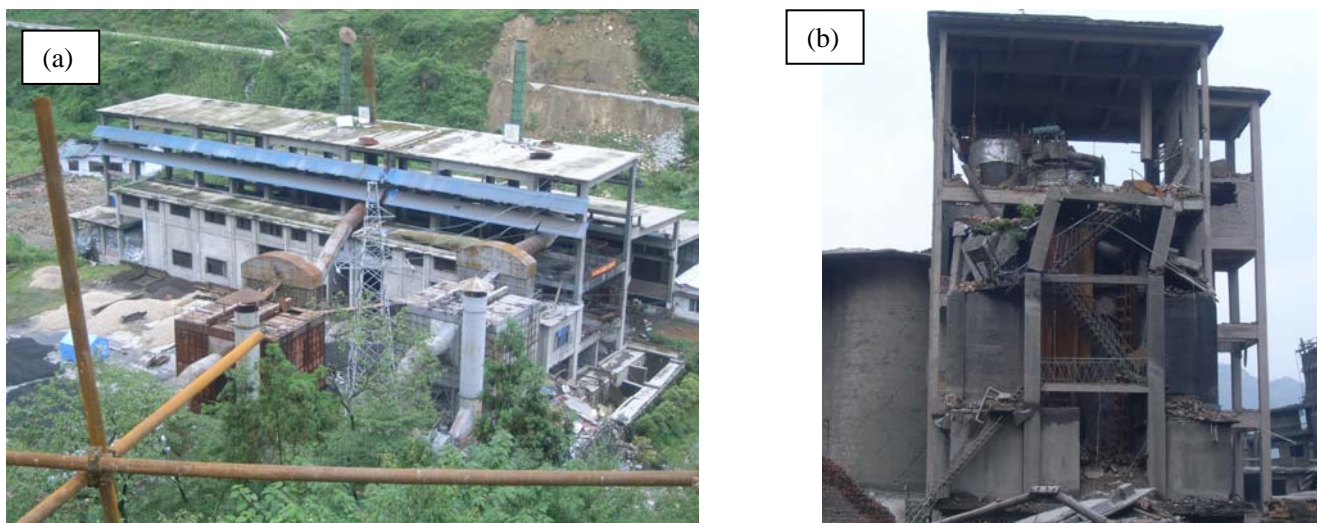
Figure 6: Damaged cement factories in (a) Ying Xiu and (b) Xiao Yu Dong

A few industrial facilities were visited in rural areas closer to the epicenter. These are of older construction than those observed in Chengdu and suffered substantial damage. Figure 6(a) shows a cement processing factory that was out of action following the earthquake. The building structure appears to be intact but there may have been damage to the equipment since the factory was not operational at the time of the survey. Figure 6(b) shows a cement manufacturing plant with damaged structures at several locations at the site. There were damages to masonry silos ranging from shear cracks to collapsed section of one silo. Factories such as these, sited in rural towns, were the main source of employment for local people, and also provided them with accommodation. Hence, the closure of these factories has a huge impact on the recovery of the local communities.

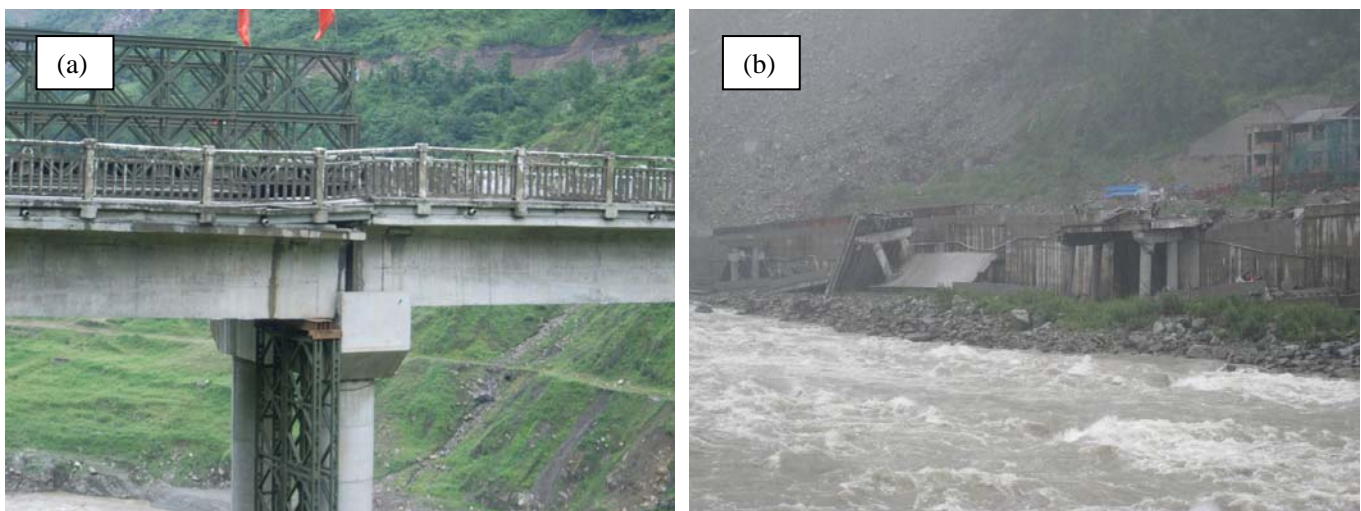
Figure 7: Damaged Bridges (a) Longitudinal displacement of simply supported beam at Shoujiang Bridge (b) Collapsed bridge along Mingjiang River in Ying Xiu Town

The EEFIT team inspected about 10 bridges along the road between Dujiangyan City to Ying Xiu town. Most of the bridges are damaged due to horizontal accelerations during the earthquake and were associated to one of the following patterns (see Figure 7):

- Loss of support in the superstore in the longitudinal direction
- Damage of parapets in the transverse direction, resulting from pounding of the superstructure after sliding with respect to the pier in transverse direction
- Damage due to rotation of the deck on the horizontal plane, due to differential ground settlements or to differences in the stiffness of piers and abutment
- Damage due to rock fall, landslides and loss of support of the bridge piers on the foundation
