The Characteristic and earthquake Damage of single-storey industry workshop of Mianzhu city in WenChuan Earthquake

HU Shaoqing¹ and SUN Baitao²

KEYWORDS: earthquake damage, single-storey industry workshop, Wenchuan earthquake,

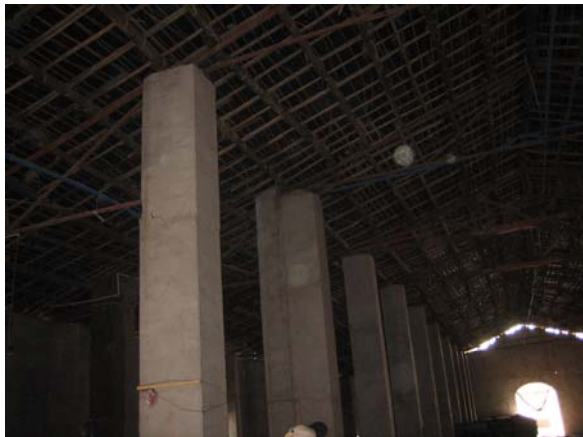
Figure 2 the whole building of Jufeng Edible Fungi workshop

It is three-span industry workshop. The column core is concrete and outer column is brick. The section of side

column is 380 mm × 380mm and the section of interior column is 500mm × 600mm; the span is 4m, the heights of columns are 4m and 6m respectively. With 14 frames, the distance of column is 4m. So the length of this workshop is 56m. The enclosure wall is brick wall. This workshop's roof is Light steel room-frame with tile roof and there is the diagonal brace between roof-frame. After the earthquake, the horizontal circular cracks occurred in the bottom of interior brick columns.

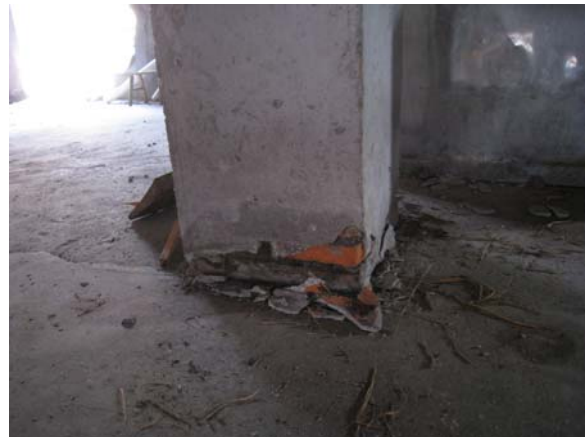
Figure 3 the local earthquake damage

The cause of damage: 1) Since the column is reinforced concrete interior and brick outer, outsourcing bricks are easily broken and scattered, then the slenderness ratio of member is increased and the bending capacity of column will be decreased. 2) The bending strength of brick column is weak and the deformation capacity is low, so the horizontal cracks occurred in the brick column likely when the building is subjected to a higher seismic intensity.

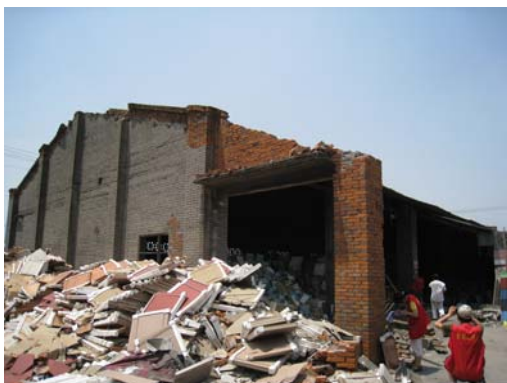
Figure 4 the whole building of Yuan sheng porcelain industry

Yuan sheng porcelain industry is single-span brick column workshop with the section of 740 mm × 600mm. The span is 15m and the height of column is 4.4m. With 5 frames, the distance of column is 6m, so the whole length is 30m. The enclosure wall is brick wall. This workshop's roof is wooden roof truss and there is diagonal brace between roof-frame. The purlin is on gable wall and there are ring beam and wind resistant pillars. After earthquake, the top of goalpost destroyed and individual roof slab fell. And the diagonal cracks appeared in the joint between purlin and gable wall.

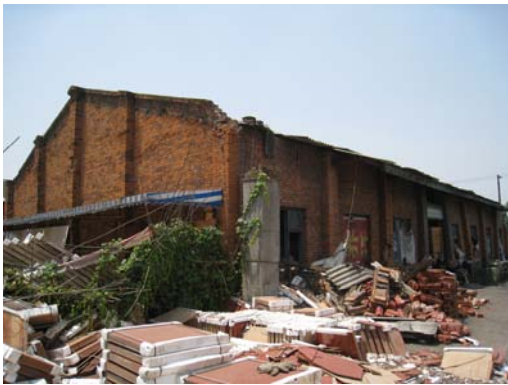
Figure 6 the whole building of Mianzhu marble factory

This building is single span brick column workshop with the section of 500mm × 500mm. The span is 14.8m and the height of column is 4.5m; With 8 frames, the distance of column is 3.7m, so the whole length is 29.6m.

The enclosure wall is brick wall. This workshop's roof is wooden frame with tile roof and there is diagonal brace between roof-frame. The purlin is on gable wall and there are no ring beam but with wind resistant pillar. After earthquake, the gable wall is out plane damage. And the top of side column destroyed and there is transparent vertical crack. The middle of column at the gate broke. The intercross crack appeared in the front longitudinal wall. Most of column broke at the height of window table-board and inclined inside.

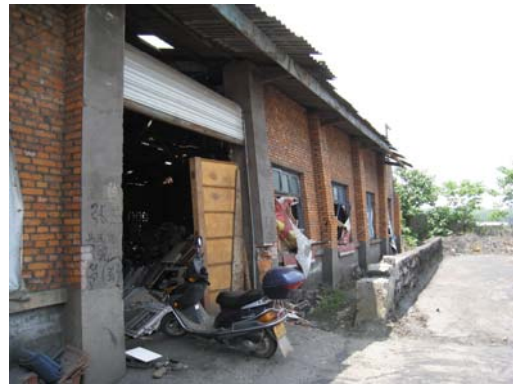
Figure 7 the local earthquake damage

The cause of damage: 1) Purlin is simply shelved in the gable wall, and there is lack of effective connection measures between the roof and the top of gable wall. The gable wall is the backward and forward swing like the cantilever beam when the building is subjected to earthquake, and then the damage outer plane occurred. 2) The thick of the surface mortar and cement of the column below the window is about 1 cm. Thus it leads to abrupt change in stiffness and uneven stiffness between the upper and the lower.

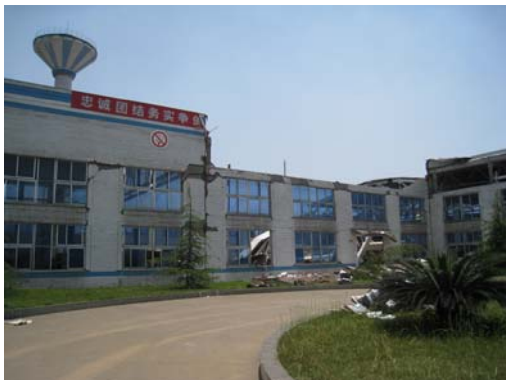
Figure 8 the whole building of Xiting Packing Co.

This building is single span reinforced concrete column workshop with the section of 700mm × 500mm. The span is 23m and the height of column is 7.5m; With 17 frames, the distance of column is 5.5m, so the whole length is 93.5m. The enclosure wall is brick wall. The building's roof is precast reinforced concrete roof frame with colored steel sheet roof. There are ring beam and wind resistant pillar. There is column bracings and braces between roof frames. After earthquake, local roof trusses fell. Most of the top of longitudinal walls fell outside. And the rain platform broke and fell. The space of expansion joint changed large.

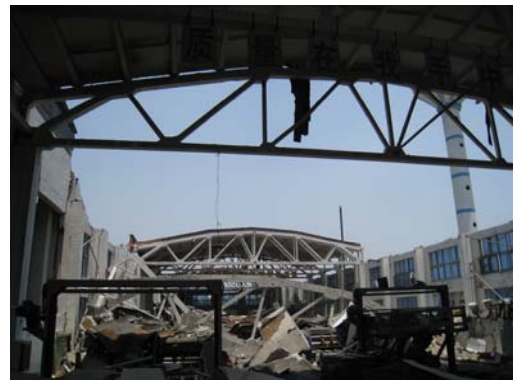
Figure 9 the local earthquake damage

The cause of damage: 1) there are weak connection between the reinforced concrete column and roof frame, the longitudinal wall and roof frame. 2) The precast reinforced concrete roof frame is heavy, so the earthquake force to which the building is subjected is large.

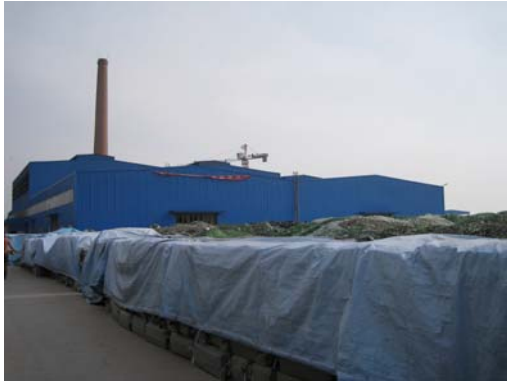
Figure 10 the whole building of Hung-sen Glass Co.

This building is two-storey steel workshop. The seismic design intensity is 7 degree. The column is I-section steel column and the cross-section is 900mm × 450mm. The span is 27.2m; the height of the first floor is 4.9m and that of the second floor is 12.5m. With 7 frames and the distance of the column is 6.3m, so the whole length is 44.1m for two-storey section. However, with 8 frames the whole length is 50.4m for one-storey section. This workshop's roof is Light steel room-frame and there is the diagonal brace between roof-frame. After the earthquake, the building is intactness.
