## Seismic Damage of R/C Frame Structures in Ms8.0 Wenchuan Earthquake

### ABSTRACT:

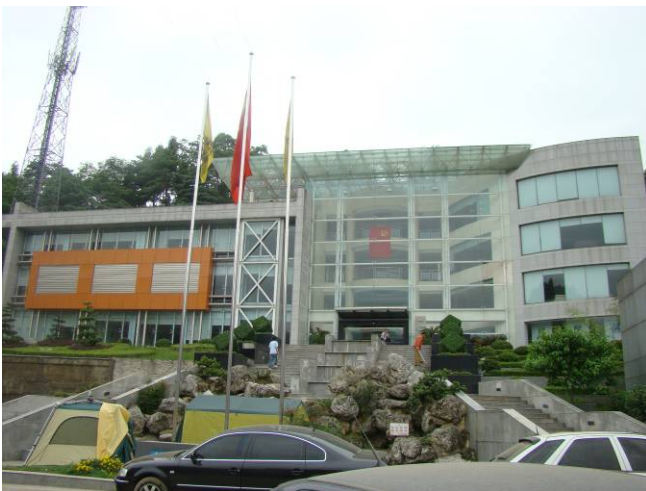
The damage degree and pattern of the masonry infill shows in fig.1~fig.6, it can be seen that even in the immediate neighborhood area of the fault rupture, there is intact R/C frame only with few lightly damaged masonry infill existing, for example, fig.1, the 4-story R/C office building (Baoshan Group Ltd.) who is located in Longmenshan town, with very stable rock base, where is only about 20 kilometers far away from the major Longmenshan fault rupture. Another rectangular 4-story R/C office building (Chuankuang Group Ltd.) who is located at the Jiangyou county town in the east of about 40 kilometers away from the major rupture, its’ masonry infill also shows similar performance, fig.2. This kind of slight damage is also found in most high-rise R/C buildings (15-story over) in Chengdu city, fig.3. The only difference is the damage usually happened in the mid-level stories in high-rise buildings instead of the bottom stories of multi-story buildings.

Fig.1 4-story office building of Baoshan Group Ltd.

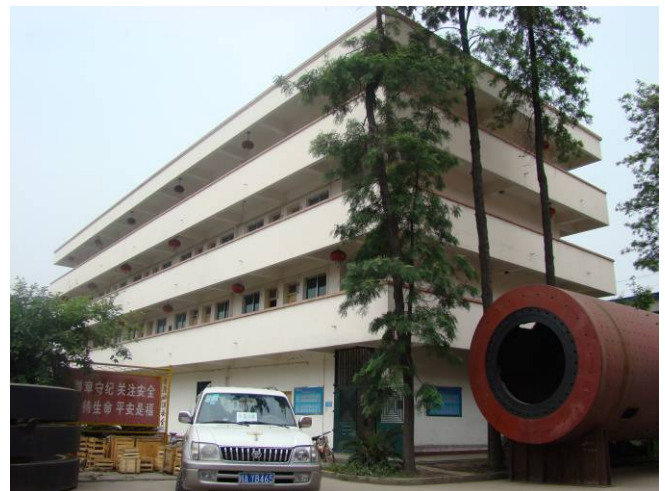
Fig.2 4-story office building of Chuankuang Group

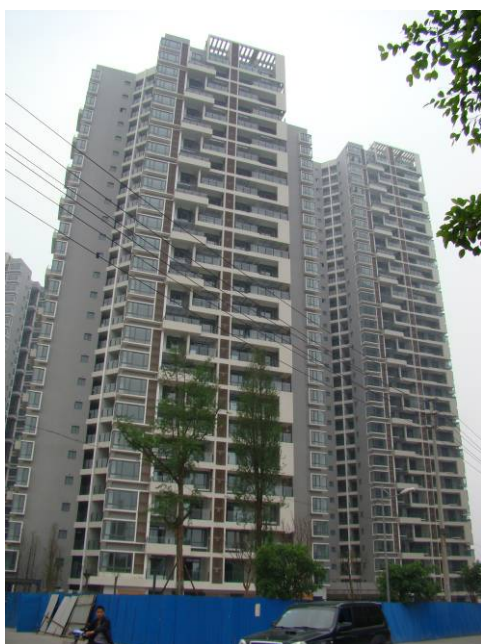
Fig.3 High rise building in downtown Chengdu

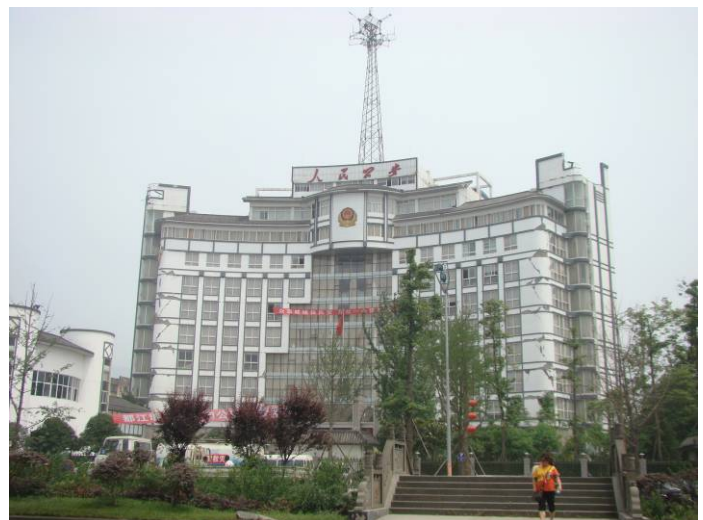
Fig.4 Building with serious damaged masonry infill

Serious damage to the masonry infill of the R/C frame structures is found in all over the affected area with damage intensity over the 7 degree (Chinese seismic intensity standards). Most serious damages of the masonry infill happened in the first floor of most R/C buildings, fig.4~fig.5. Generally, with the floor increasing the damage becomes lighter gradually except for the staircase tower. This phenomenon is coincided well with the knowledge that the seismic story drift of R/C buildings is usually larger than other upper stories, from numerical analysis. It's obvious, due to the controversy of the relative larger story drift of the frame in first floor and the limited deformability of the masonry infill, during the strong ground shaking, the lateral movement of the frame will inevitably cause obvious damage to the masonry infill.

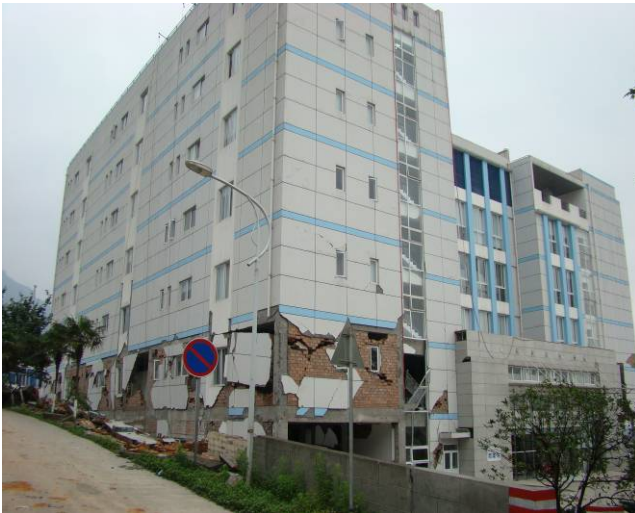
Fig.5 seriously damaged masonry infill

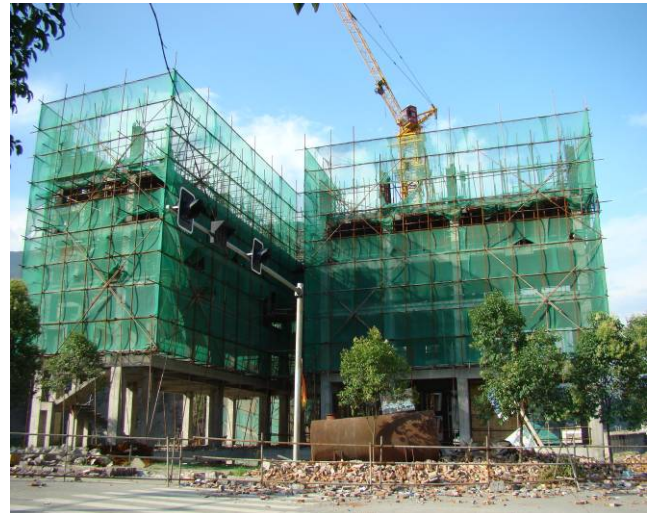
Fig.6a. beam-column damage of R/C frame

Well designed R/C frame shows very good performance even located very close to the fault rupture, for example, an almost finished new R/C frame building, fig.6a~c, the masonry infill still has not constructed, the damage of the beam-column demonstrates the stronger capacity of the R/C frame structure comparing with the next door masonry building, who is also in construction and also almost finished. In this case, the relatively severer and concentrated damage happened in the two corner staircases shows the weakness of the corner

staircase in earthquake. The column end damage of the peripheral columns shows the coupling effects of the bending, shearing and torturing deflection. The beam end damage shows the typical behavior of the moment frame under earthquake, it's a kind of expected seismic damage. Assuming, if the masonry infill is constructed in this frame, how it will be performed during the earthquake?

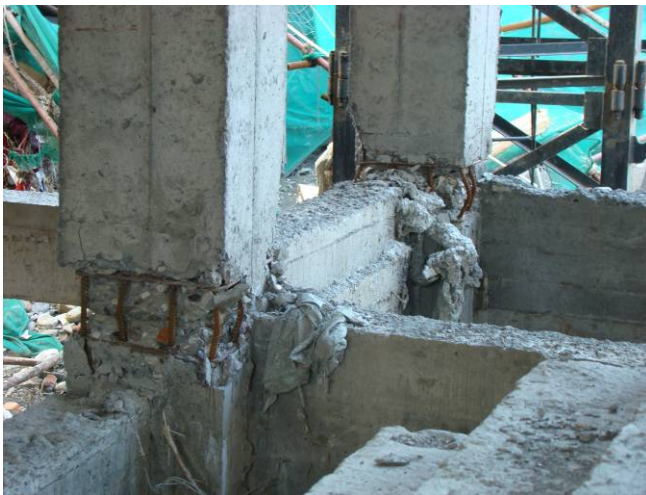
Fig.6b. beam-column damage of R/C frame

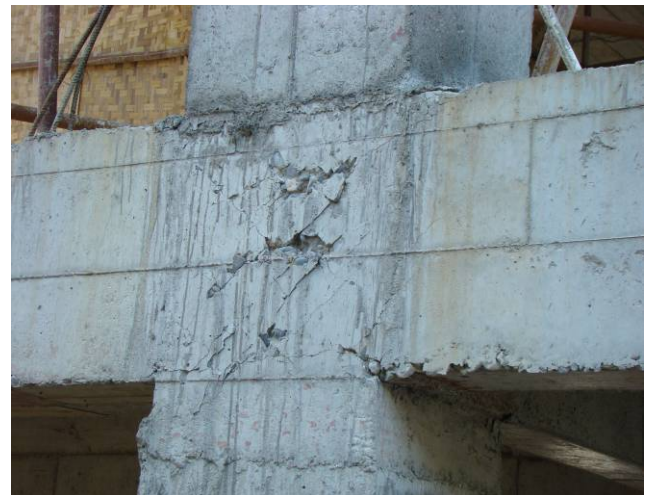
Fig.6c. beam-column damage of R/C frame

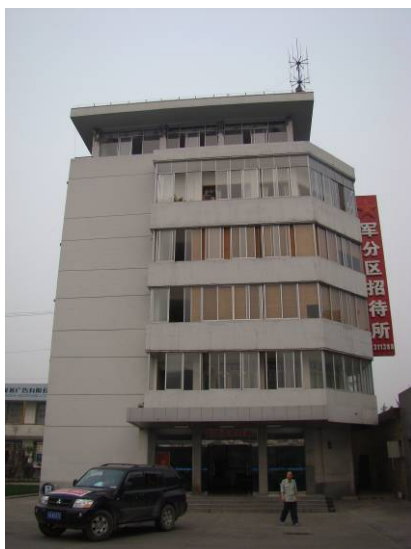
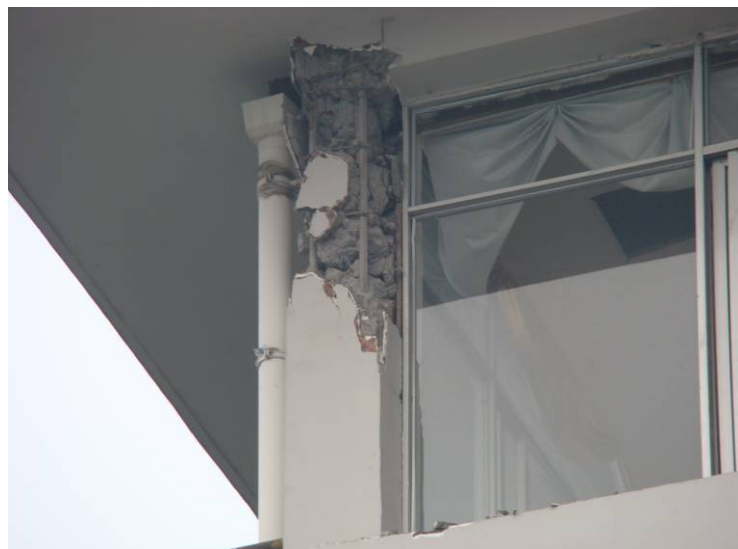
Investigation shows that the damage of the top-story or the staircase tower of the R/C buildings mostly happened in areas with mid-distance, say about 80km or so, to the fault rupture. One example is a hotel building located in downtown Deyang City, fig.7, there is no structural damage observed in its' lower stories, but the top end of the column in the top story is seriously damaged with obvious yielding of the longitudinal reinforcement. Another example is an office building located in downtown Jiange county, fig.8, there are only some obvious masonry infill damages but without any structural damage in it's lower stories, also, the top end of the column in the top story is seriously damaged. Form the front façade, the building looks like a symmetric structure, but in fact, the whole building is separated by a vertical segregate opening immediately close to the right damaged tower part. Similar case is also found in the field investigation in Muyu town of Qingchuan County, the office building of the local town hall, fig.9 It discloses the amplifier effect of the top tower of the R/C frame building to the ground motion on one hand and the negative effect of the vertical stiffness change in a building on the other hand.

Fig.7 Column damage in top story

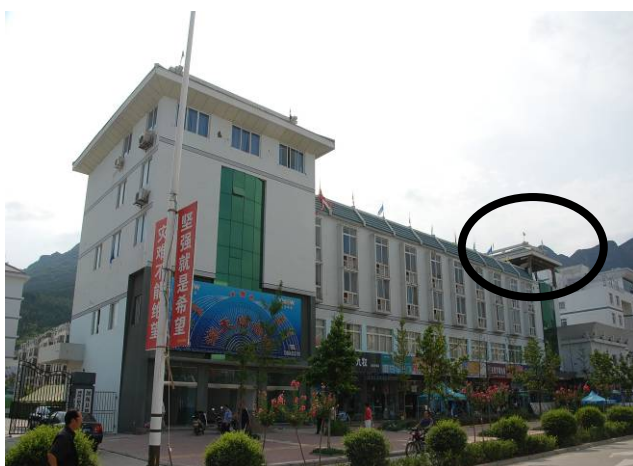
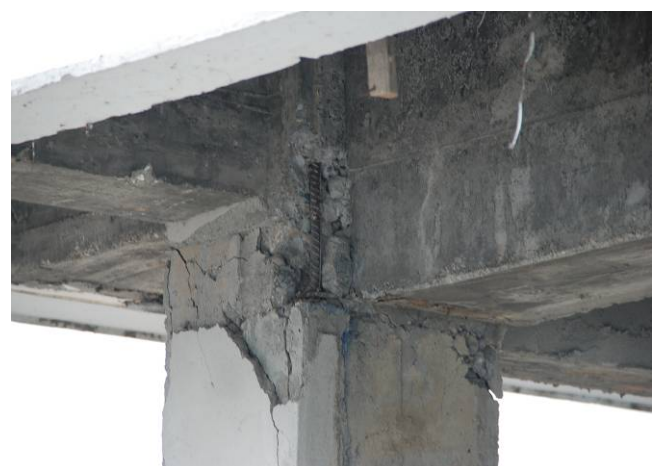
Fig.8 Top story damage

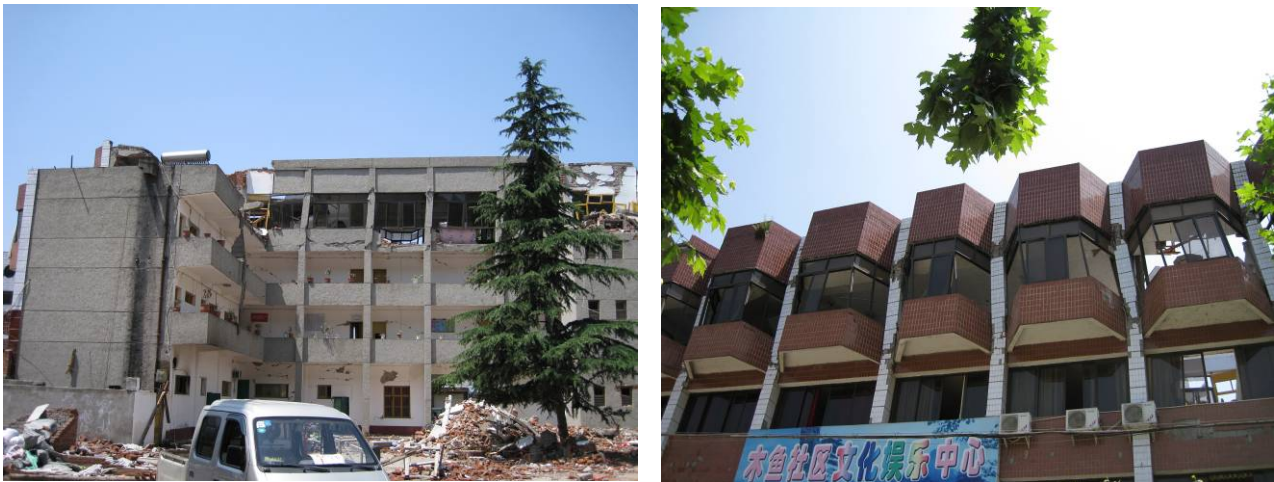
Fig.9 Top story damage

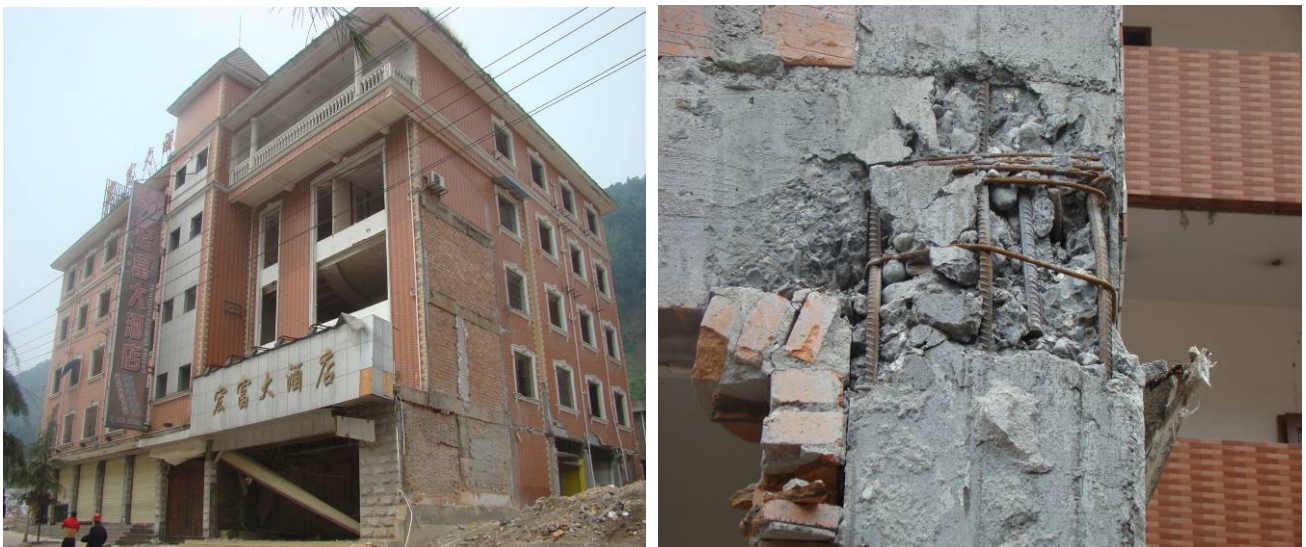
The damage of the bottom story of R/C frame buildings is also one of the major damage patterns in affected areas especially in areas very close to the fault rupture. One example is a hotel building located in Hongbai town of Shifang county, fig.10, where most buildings suffered serious damage and only 40% remain standing after the major shock. It's a typical R/C frame building with seriously damaged bottom story. Most top-end of the bottom columns performed as concrete failure and reinforcement yielding with obvious buckling while most masonry infill walls shows fatal shear damage with typical diagonal "X" cracks or collapse. Similar case is also found in Yingxiu town, very close to the epicenter. They are the canteen building and corridor building connecting the classroom and another collapsed R/C frame canteen hall, of the Xuankou middle school. The bottom columns especially those with infill walls and staircases suffered serious damage but remained standing fortunately, fig.11. The damage also can be attributed to the coupling effects of the sharpened story stiffness change between the bottom floor and the upper floors, and the relatively larger story drift of the bottom floor in typical R/C frame structures under earthquake.

Fig.10 bottom story damage

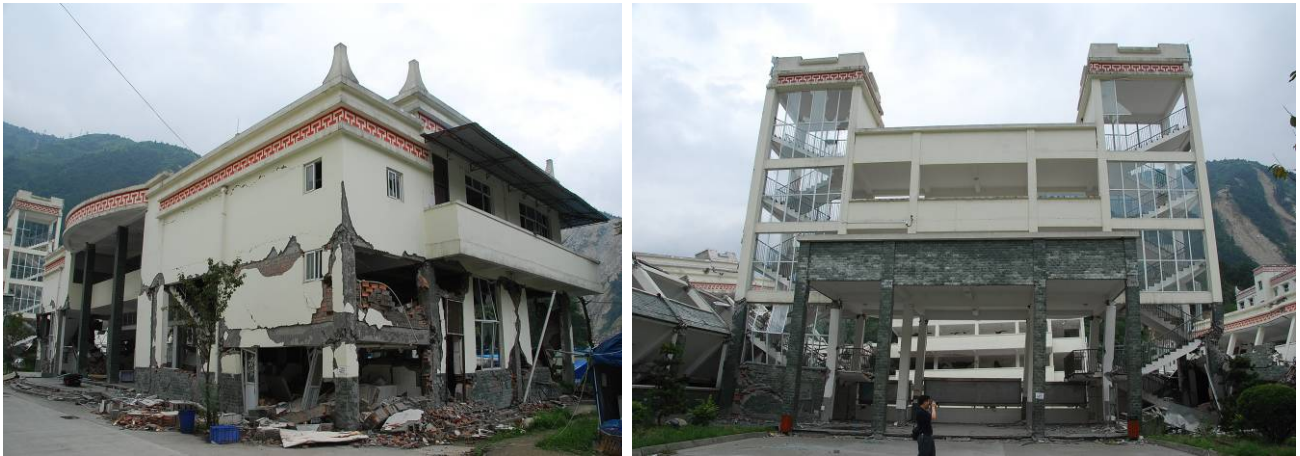
Fig.11 bottom story damage

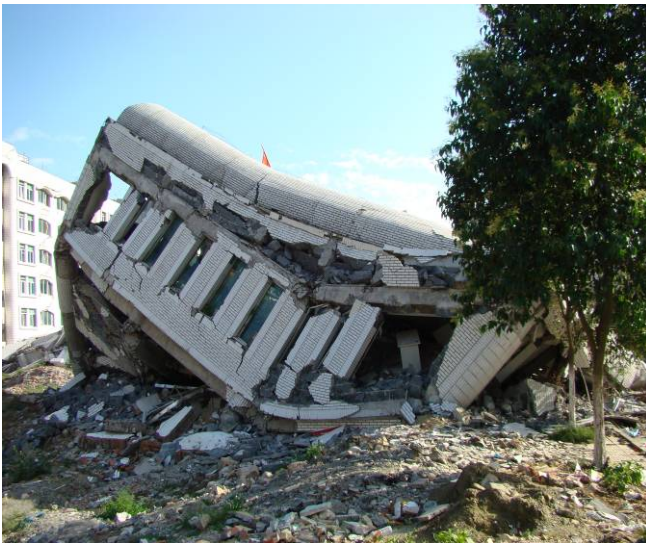
Collapse of the R/C frame structures are also observed in areas immediately adjacent to the fault rupture. One example is a 9 story bank building located in downtown Beichuan county, which is the highest building in downtown Beichuan and totally collapsed to the riverside direction, fig.12. Another example is the abovementioned canteen hall of Xuankou middle school located in Yingxiu town, fig.13. The causes of the collapse are still in profound studying.

Fig.12 collapse of a 9-story frame building

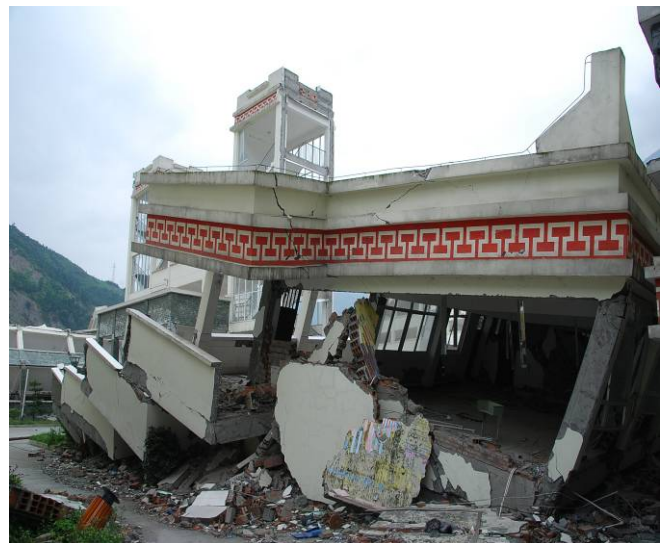
Fig.13 collapse of a 4-story frame building
