# Some case studies of construction accidents in India

Special emphasis on safety of temporary structures

**Dr. K.N.Jha**

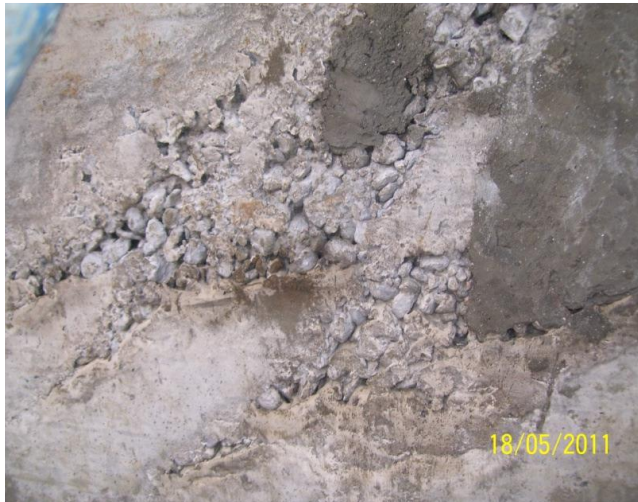
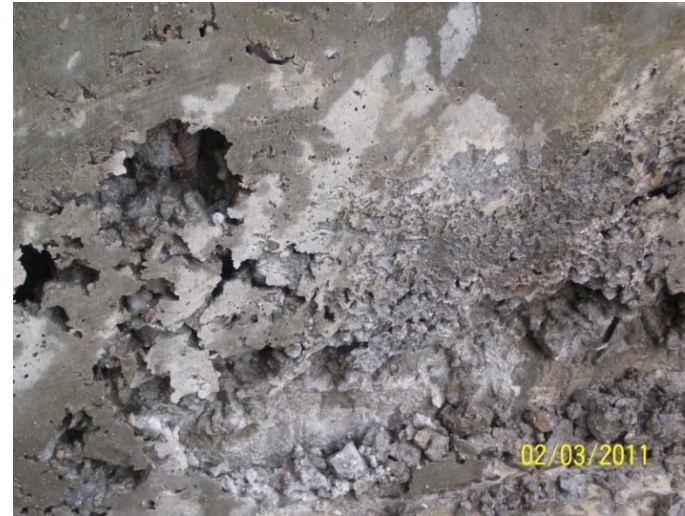
1. Honey comb

**Formwork needs to be designed & built accurately so that the desired size, shape position, correct location, quality and finish of acceptable quality of the cast concrete are attained.**

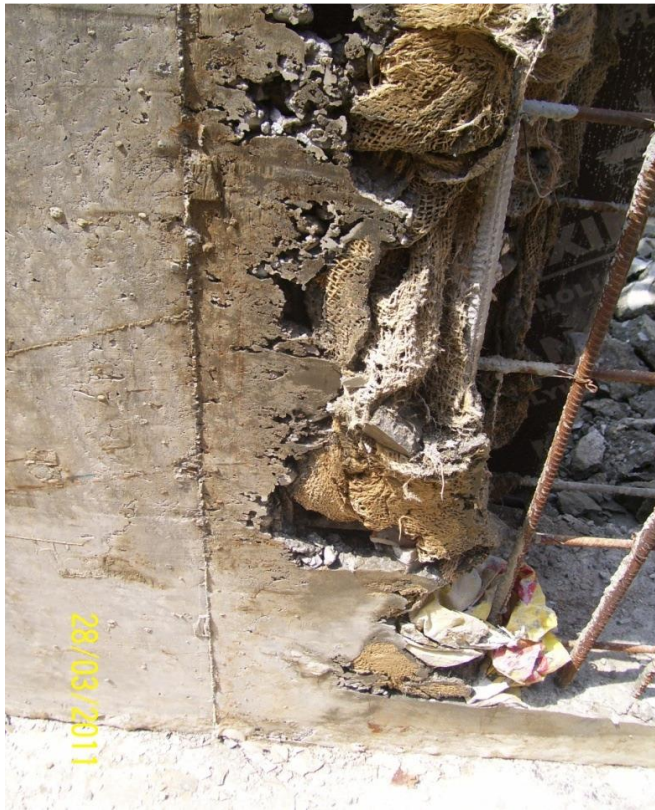
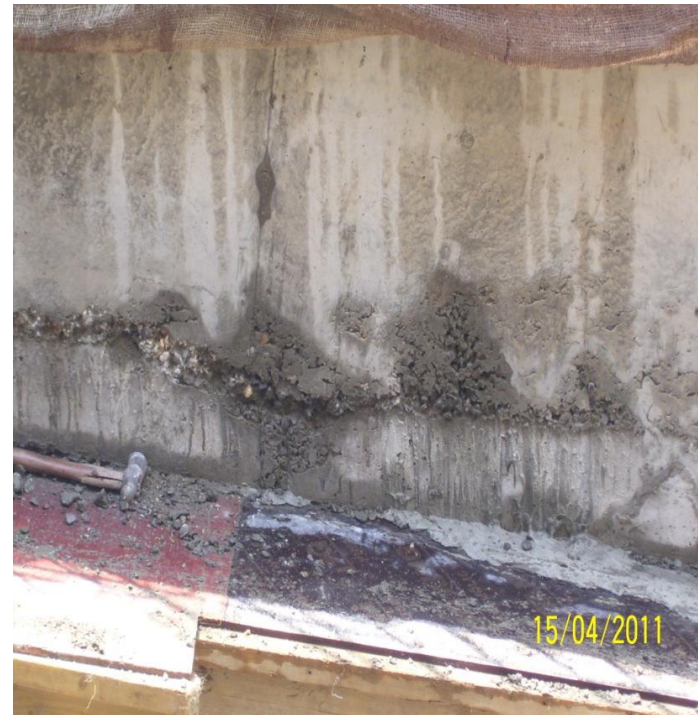
- Common defects due to poor formwork quality
  2. Poor Construction Joint /Offsets in Concrete Joint

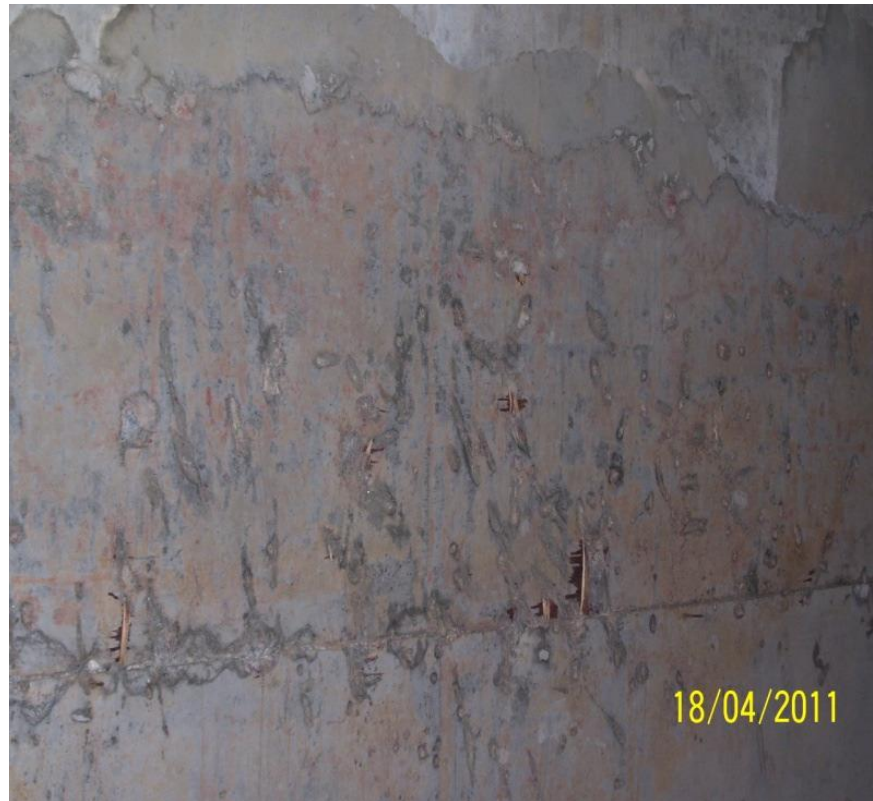
- Common defects due to poor formwork quality
  3. Plywood Grains Stuck on the Concrete Surface

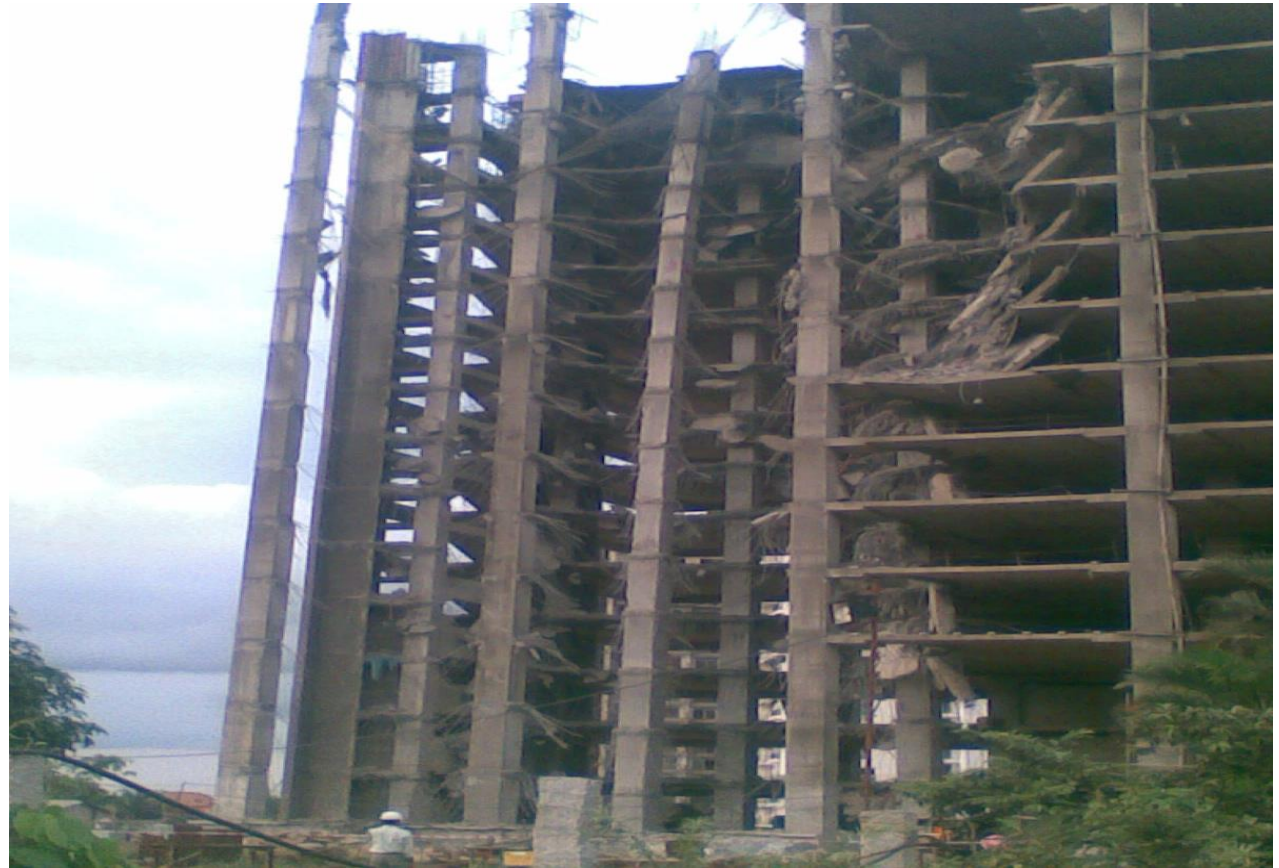
Collapse of one floor leading to another

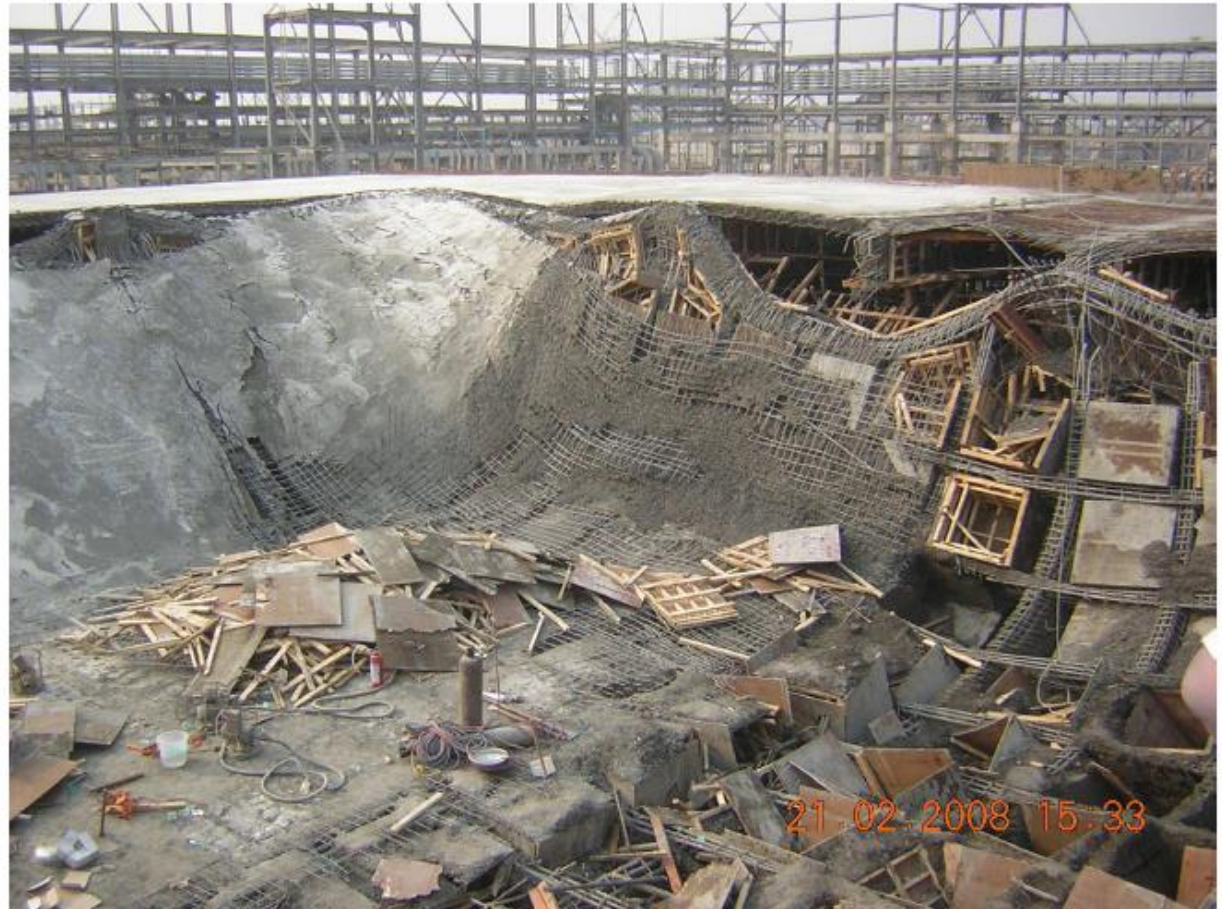
View of  
collapsed  
waffle slab  
segment

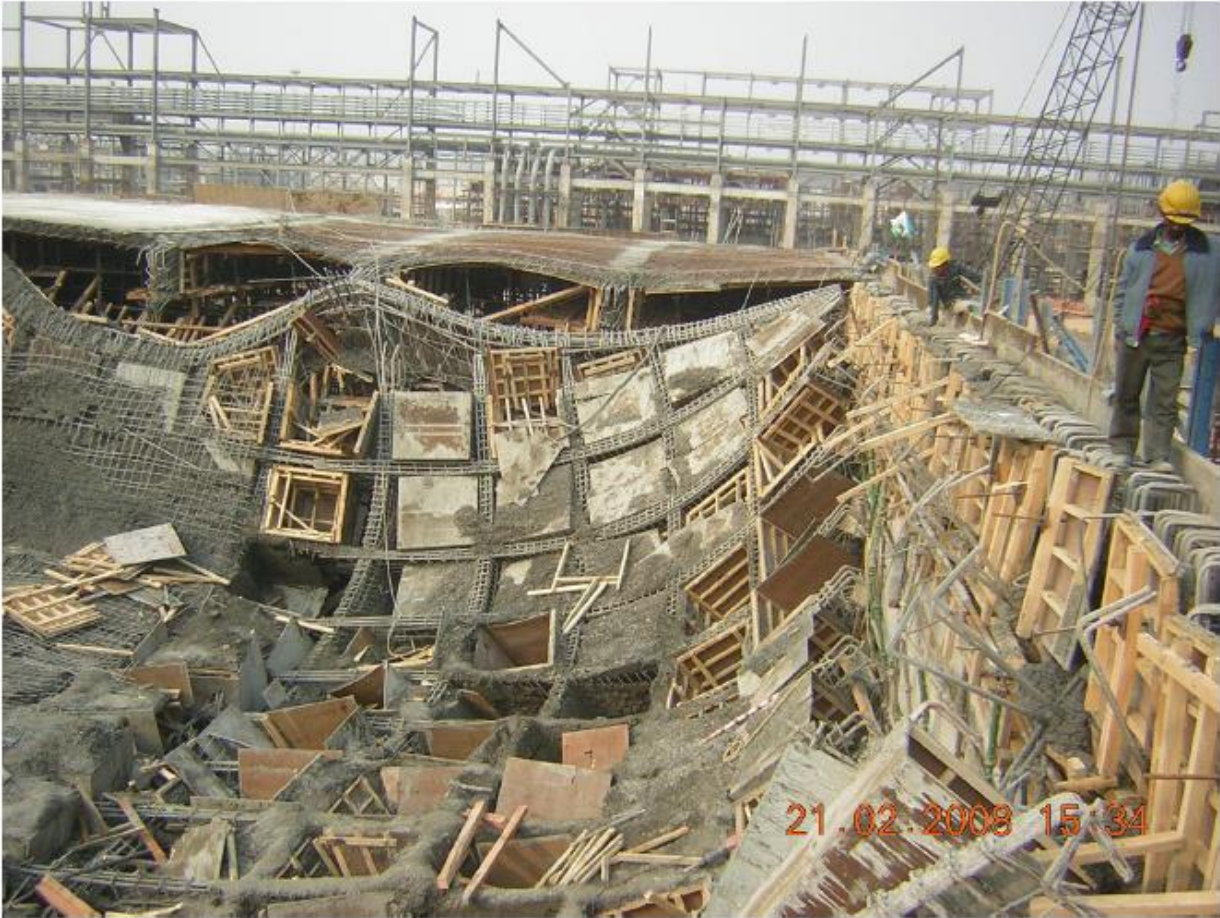
Another view  
of collapsed  
waffle slab  
segment

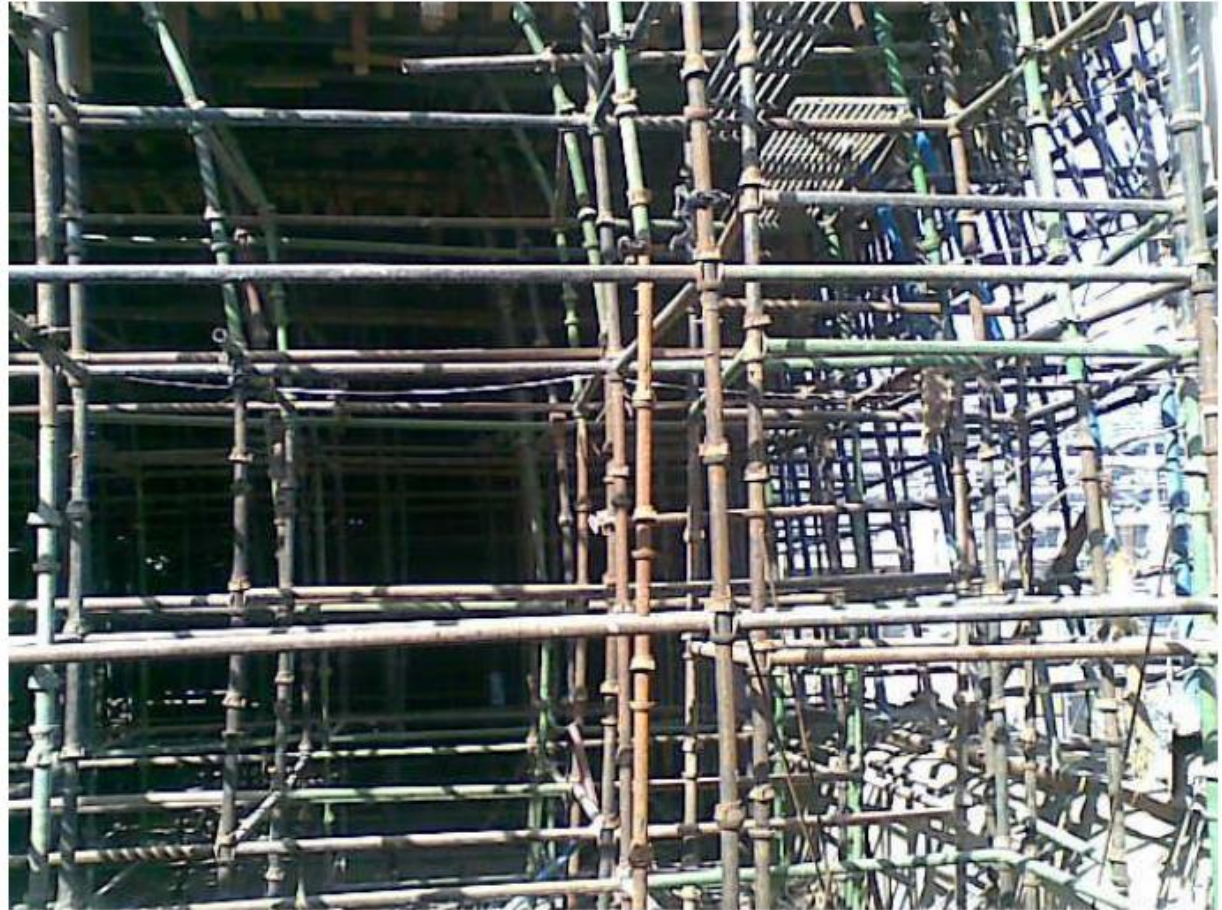
View of the  
bent shoring  
(due to excess  
load)

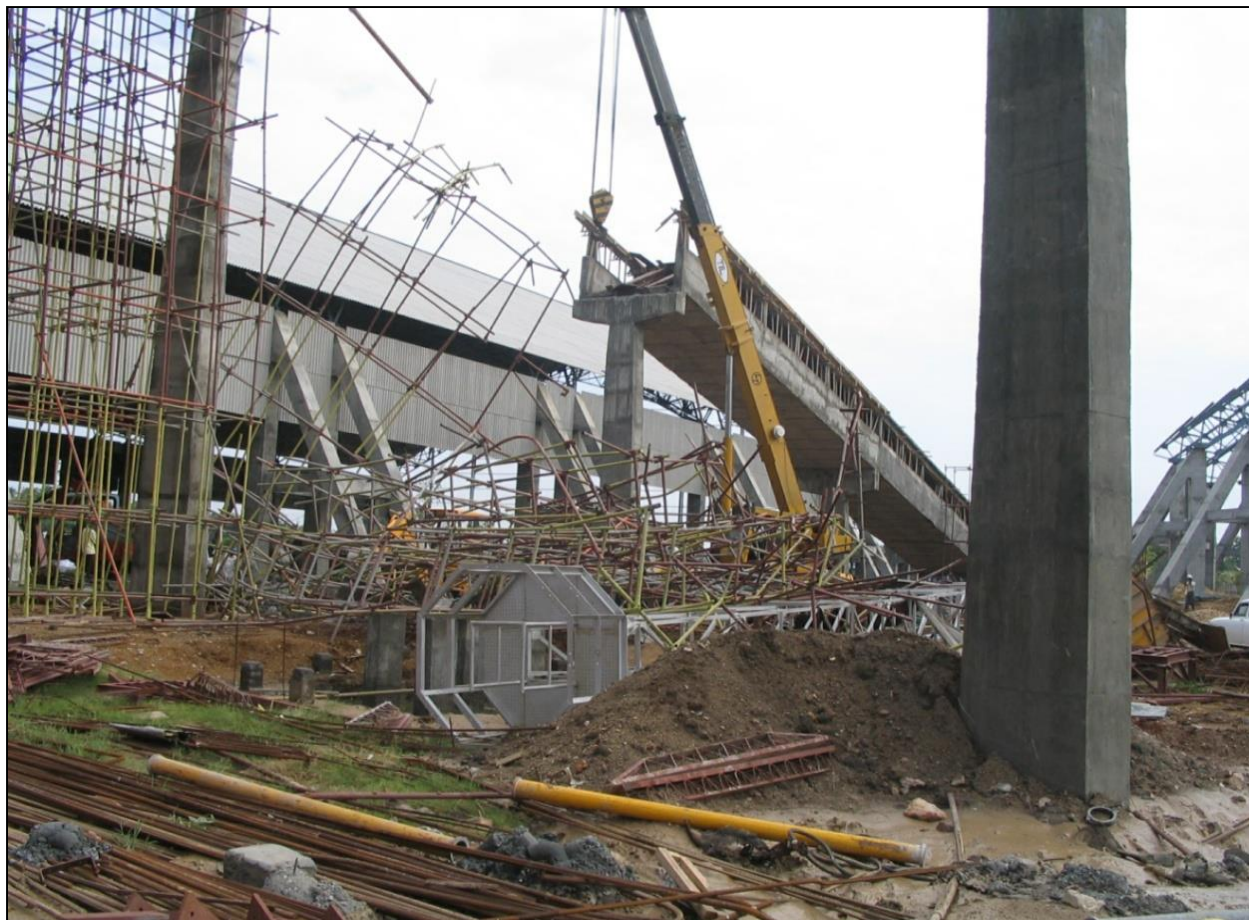
Another view  
of the  
accident site

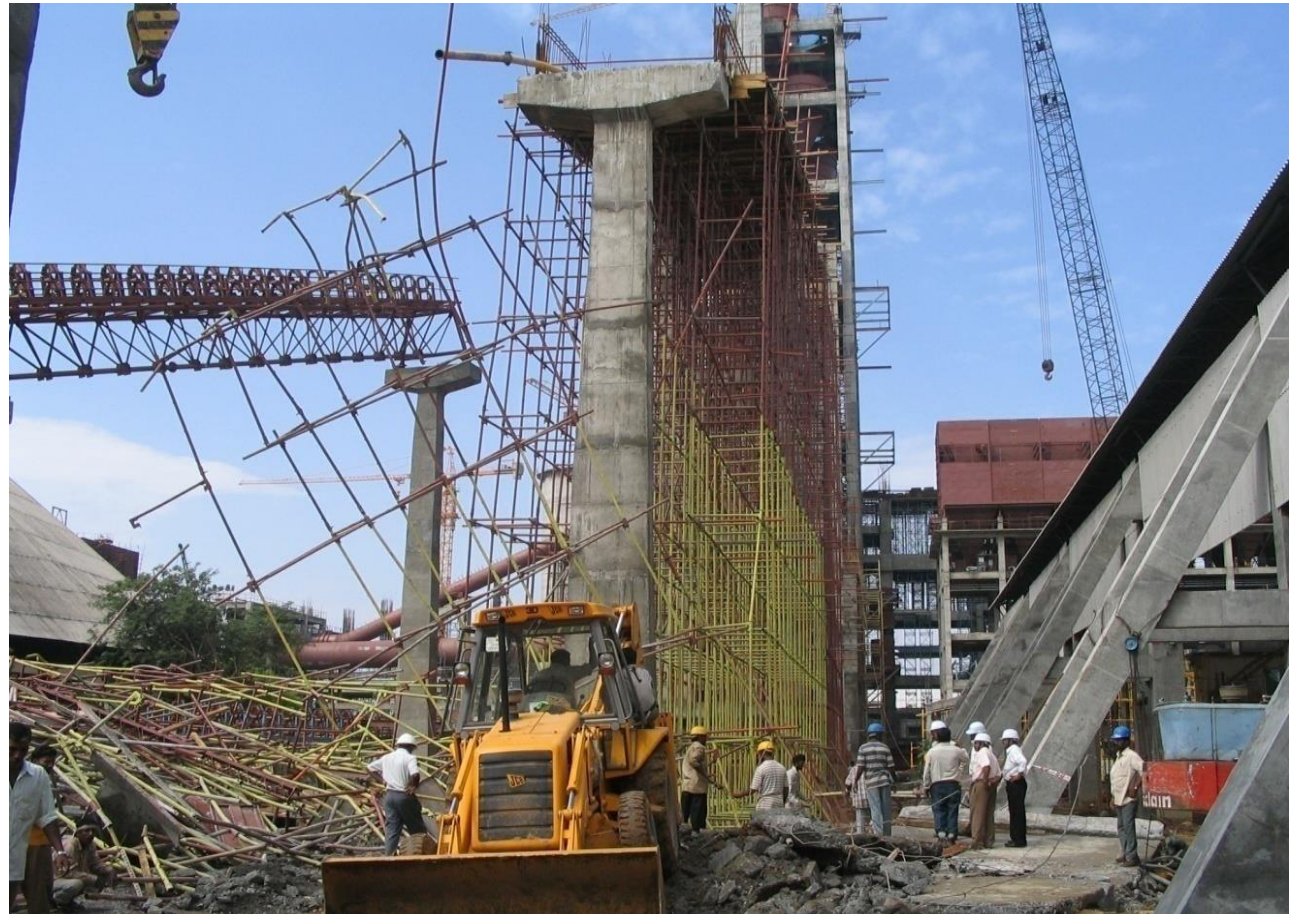
Shoring tower  
in position for  
the deck slab  
adjacent to  
the collapsed  
slab

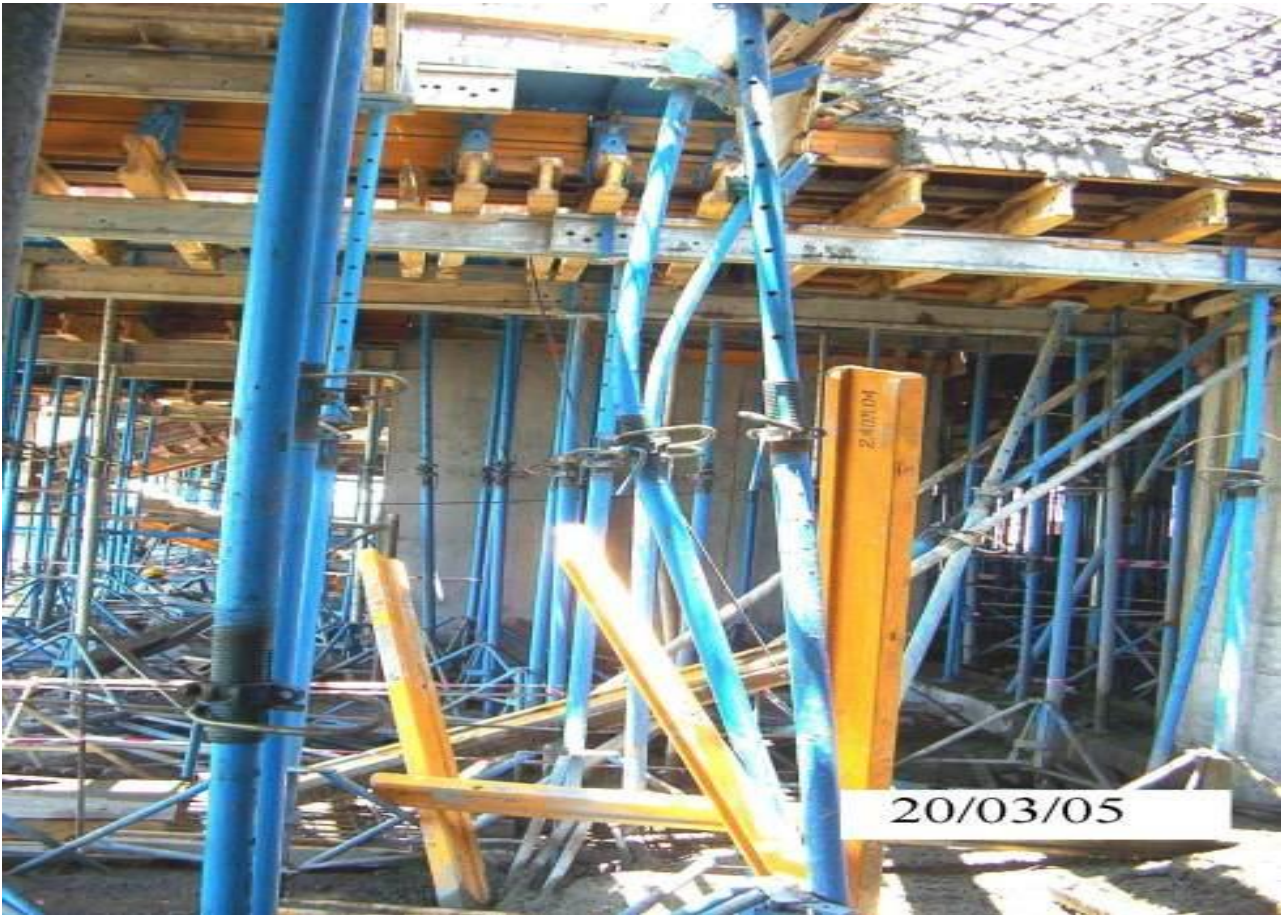
View of the portion of the slab which failed due to concrete overloading

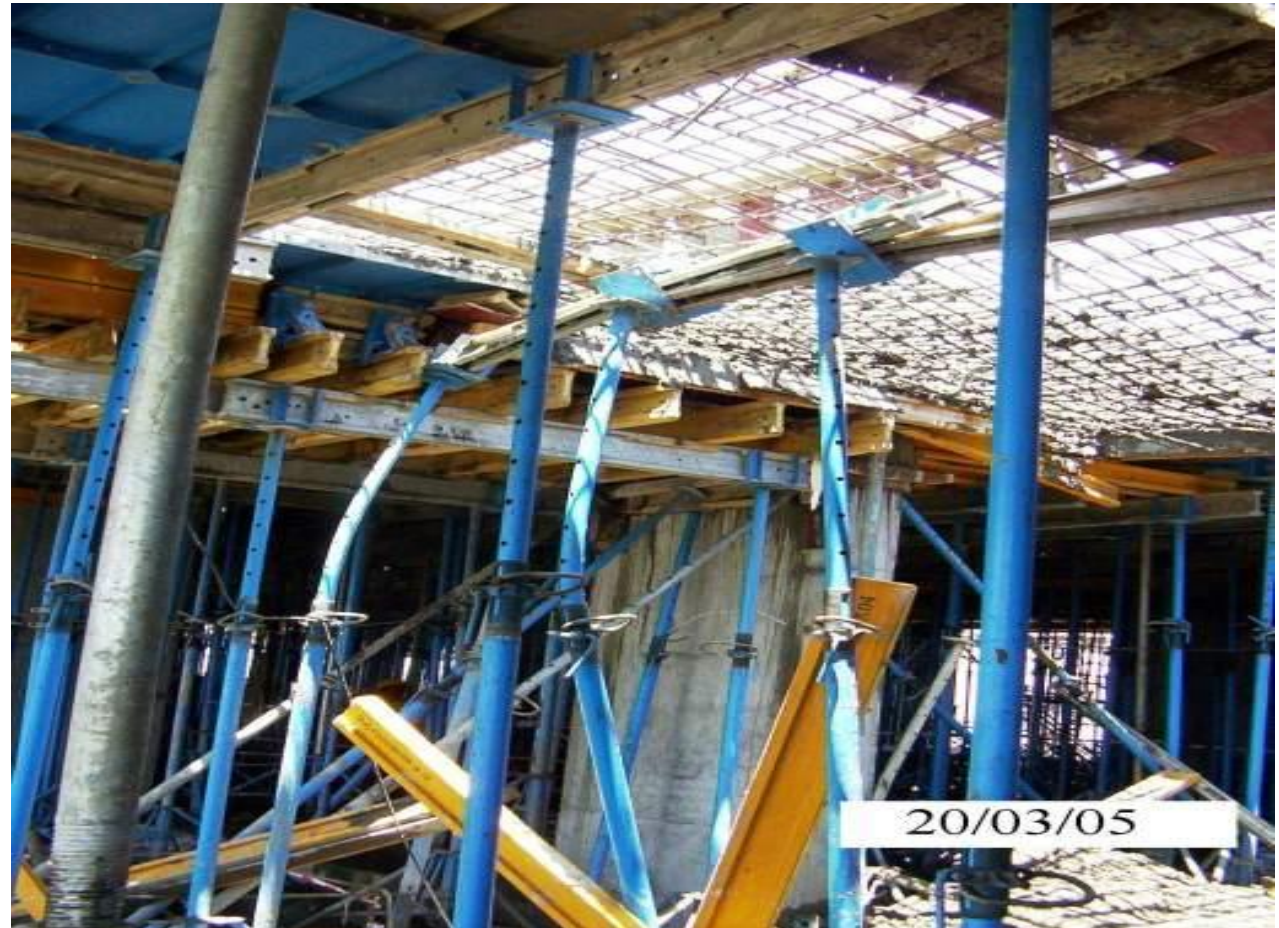
Another view of the portion of the slab which failed due to concrete overloading (note the buckled props)

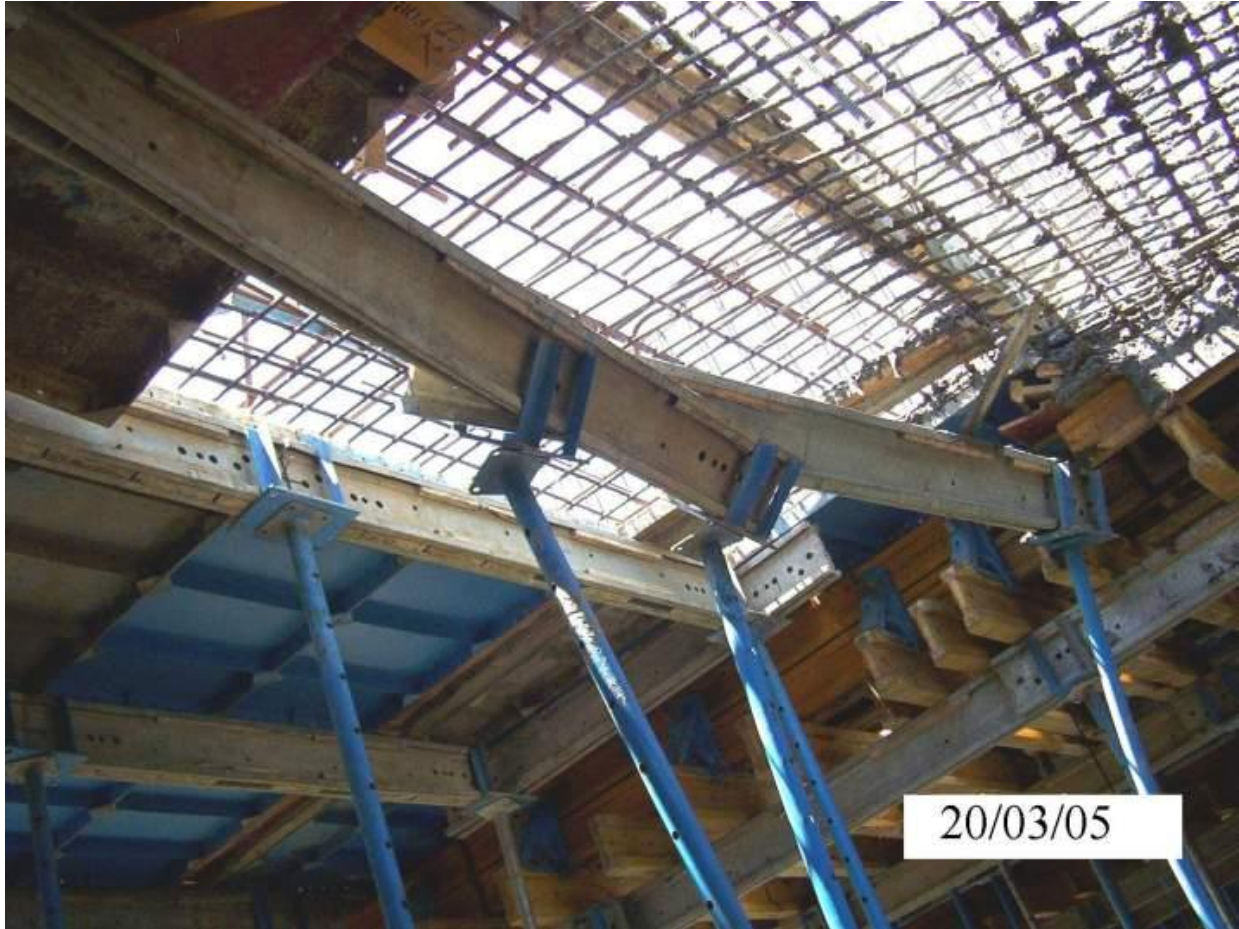
Another view of the portion of the slab which failed due to concrete overloading

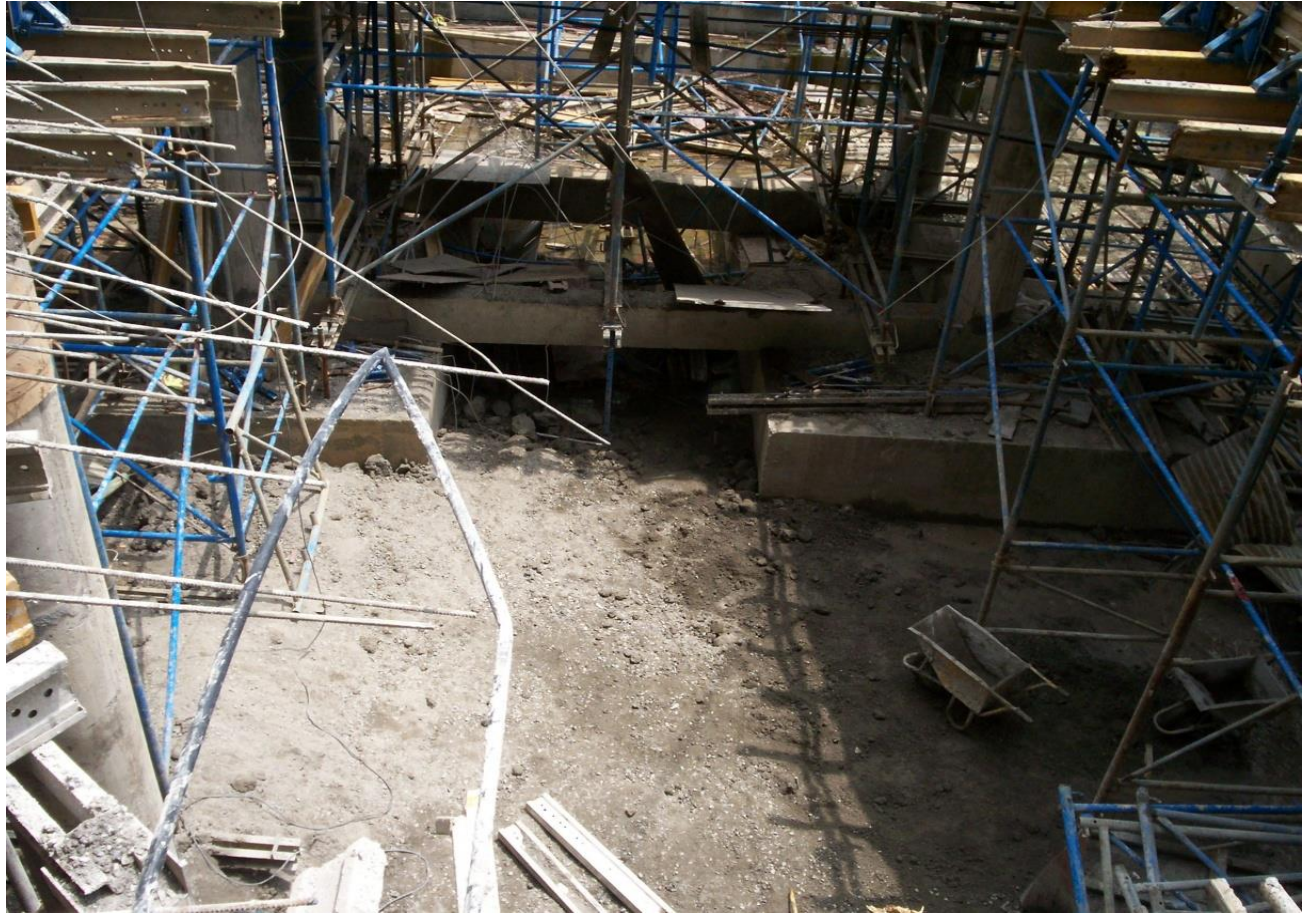
View of  
portion of  
slab and  
beam  
formwork  
which  
collapsed

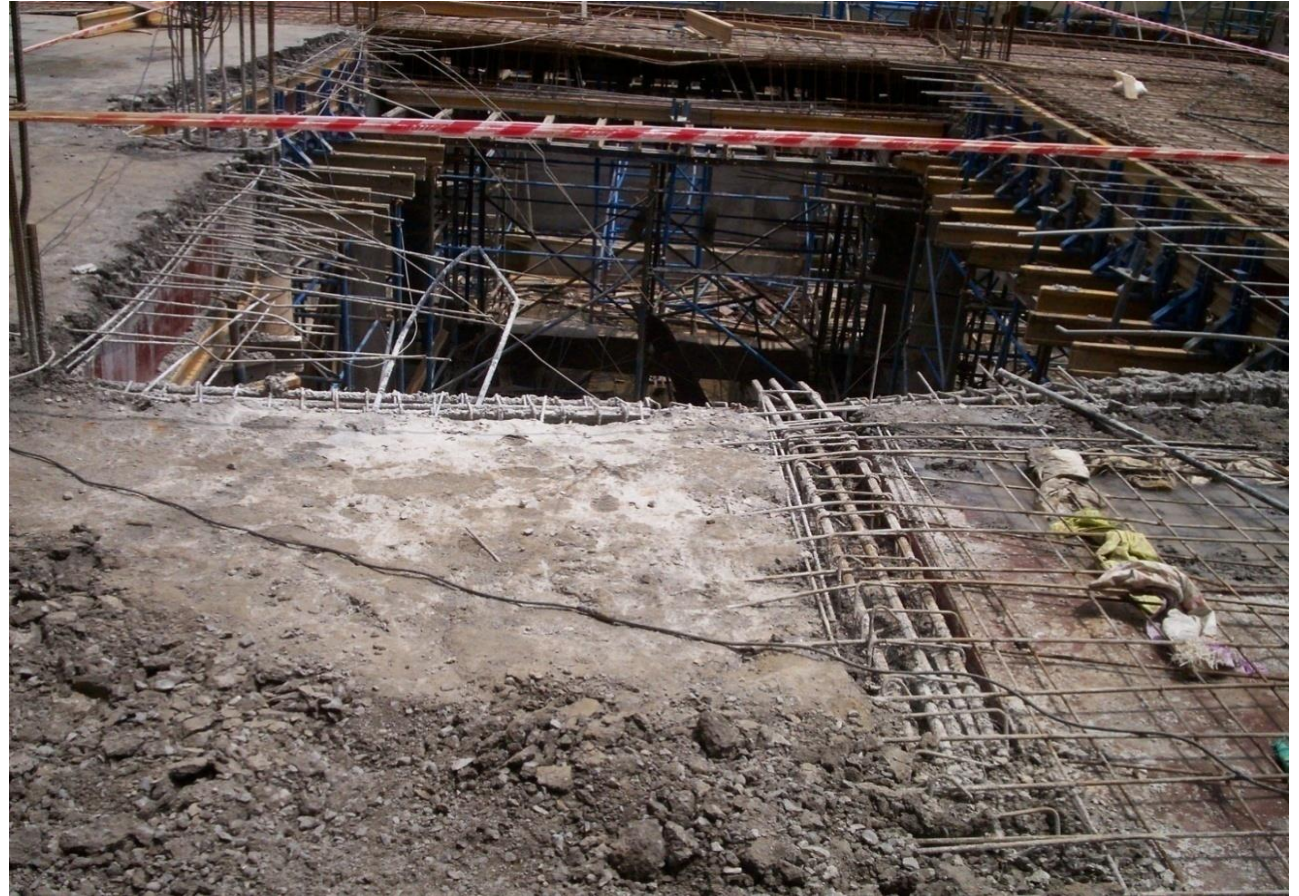
Another view  
of portion of  
slab and  
beam  
formwork  
which  
collapsed

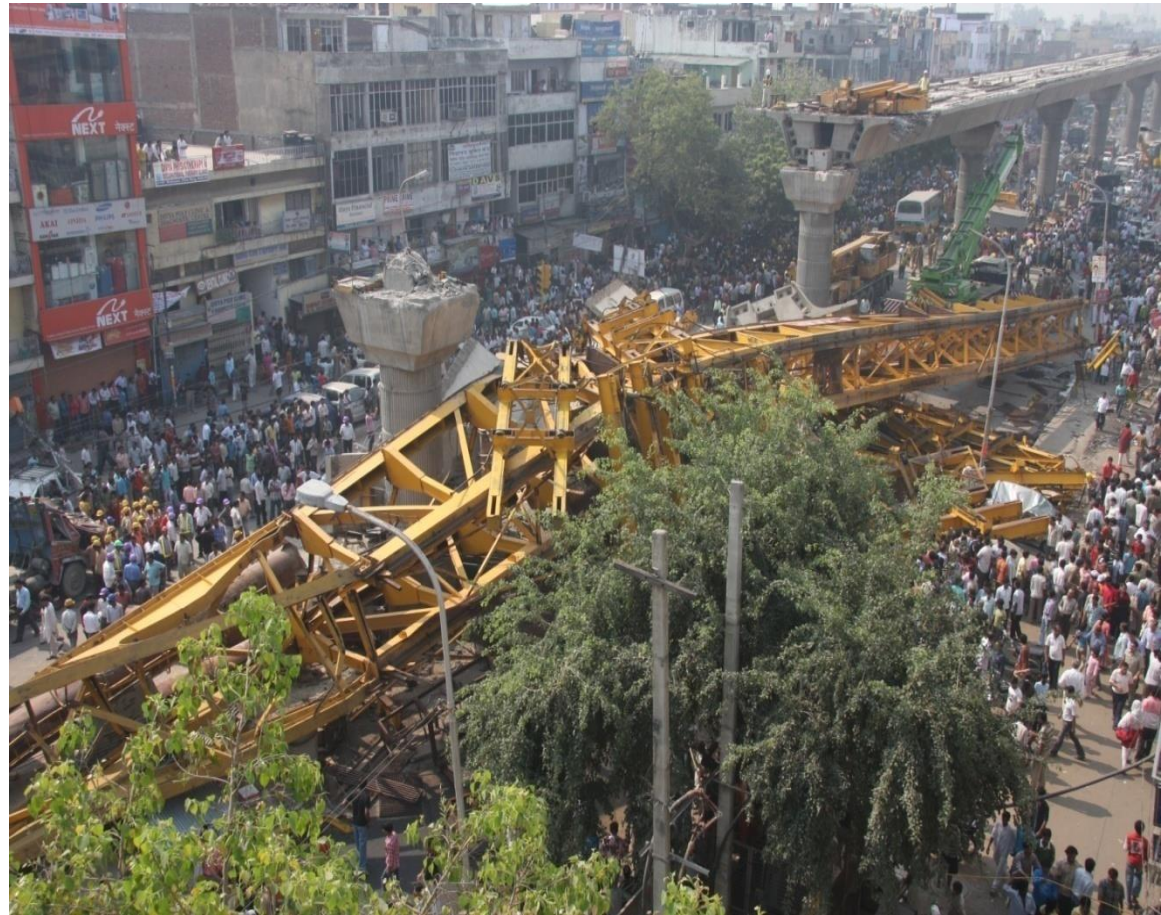
Collapse of  
launching  
girder in  
Laxmi Nagar

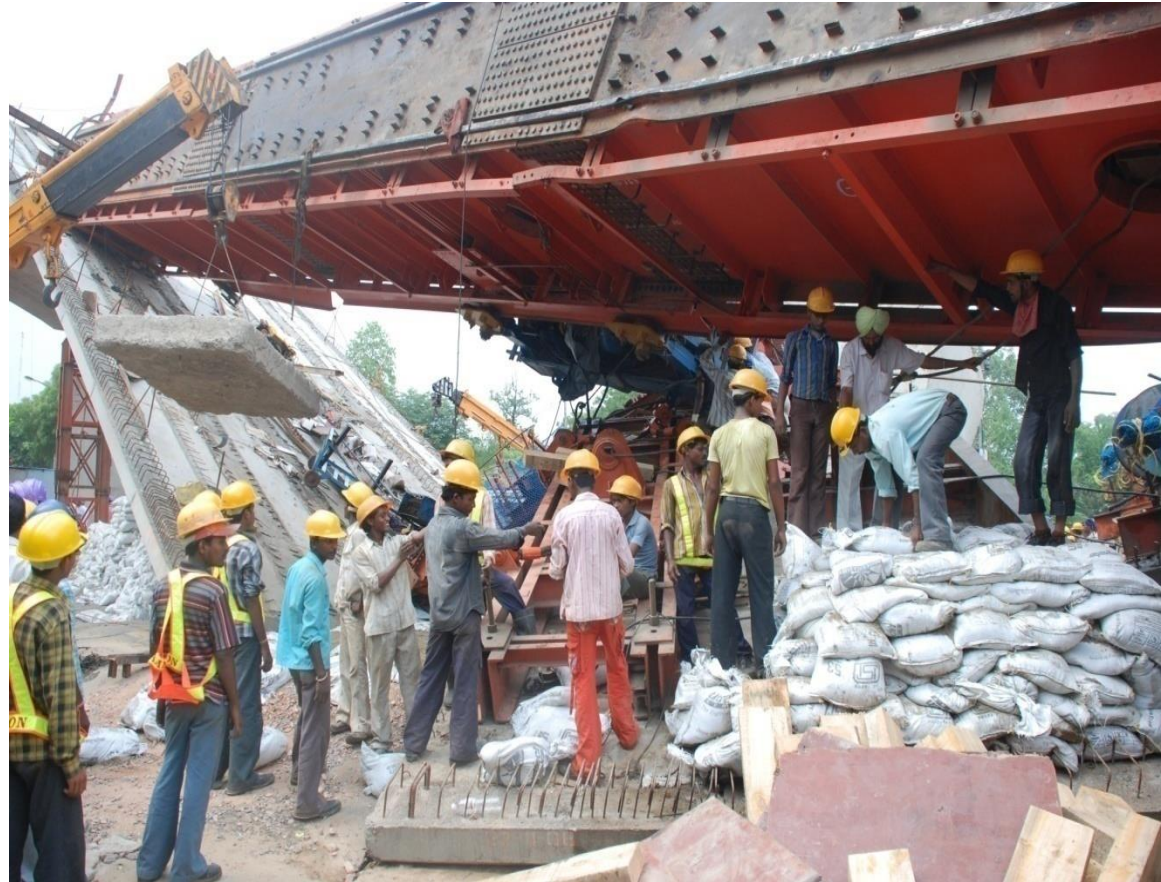
View of  
Zamrudpur  
under  
construction  
metro bridge  
span collapse

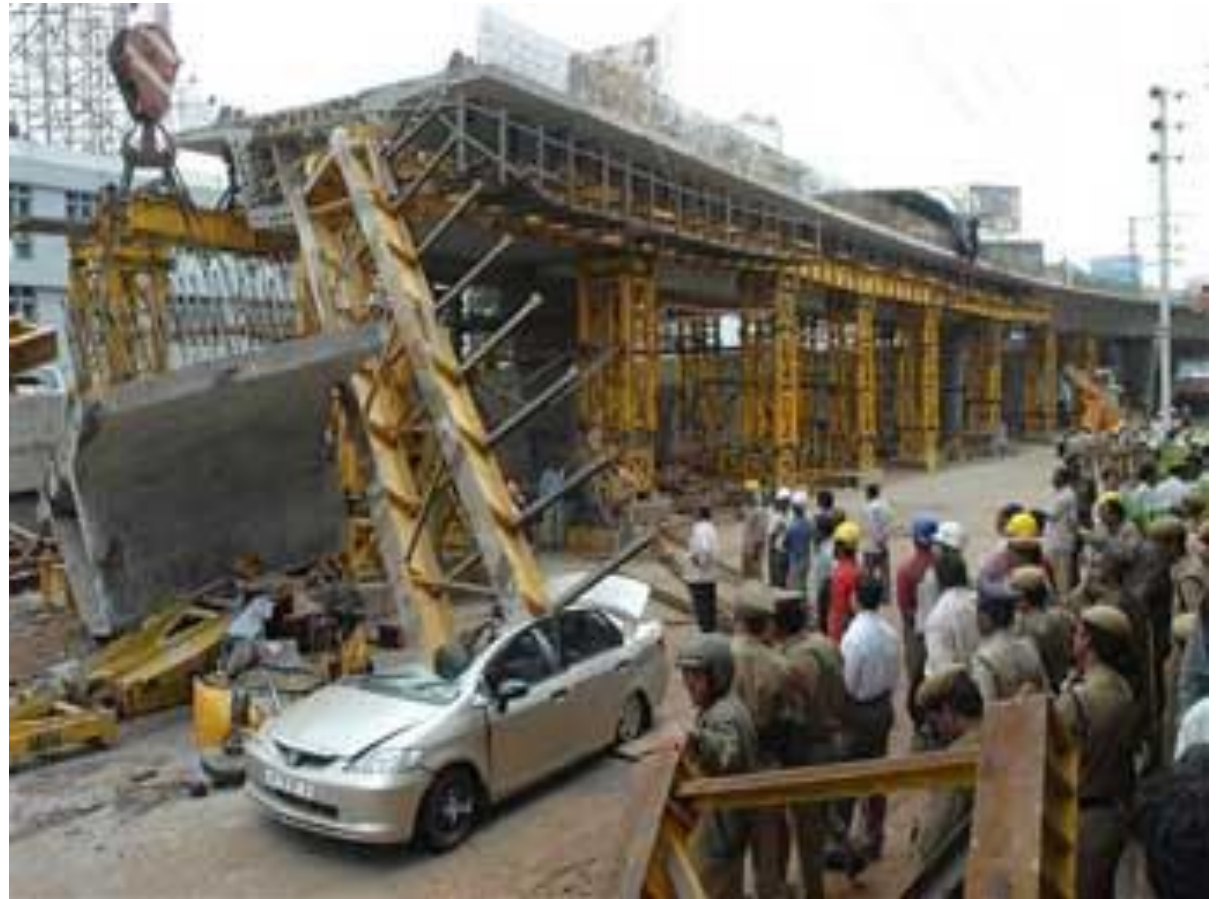
view of the  
accident site  
(photo  
courtesy  
[www.chinapos  
t.com.tw](http://www.chinapos<br/>t.com.tw))

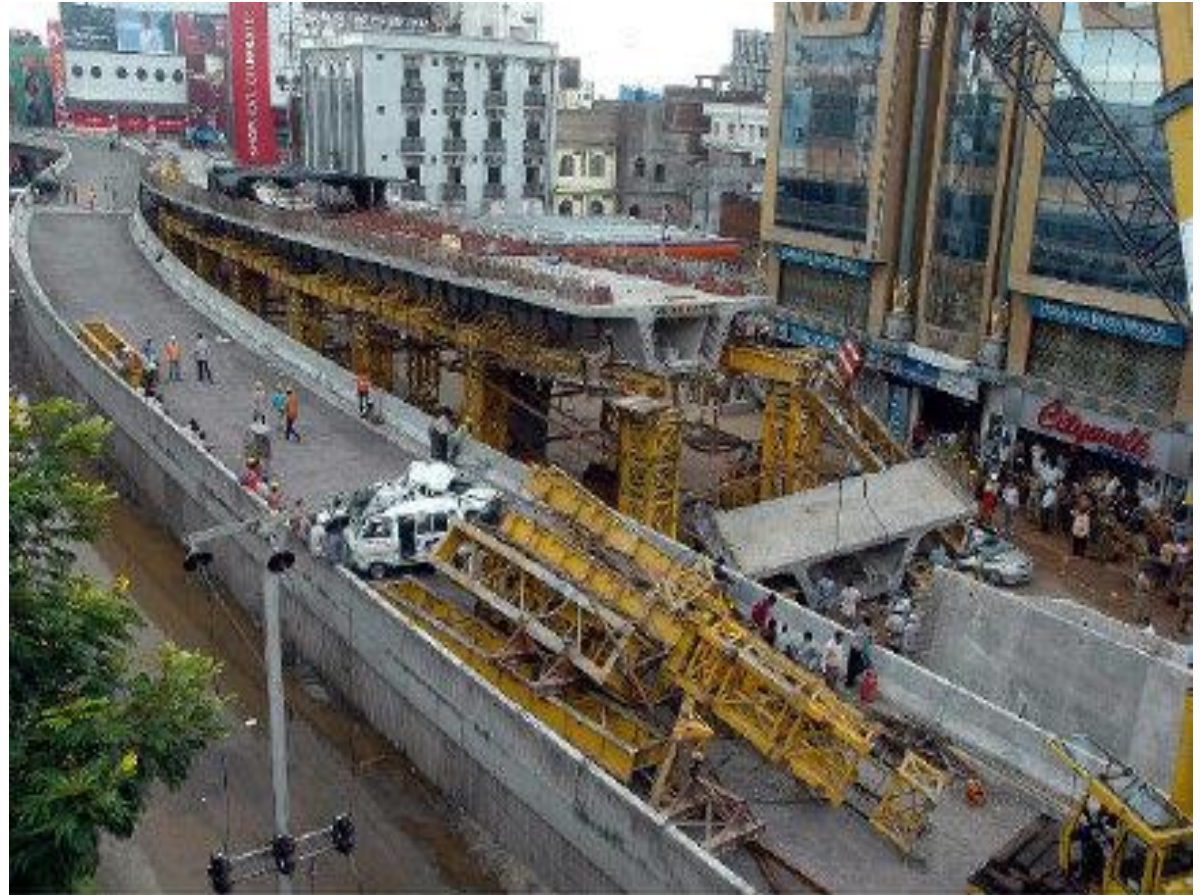
Another view  
of the  
accident site  
(photo  
courtesy

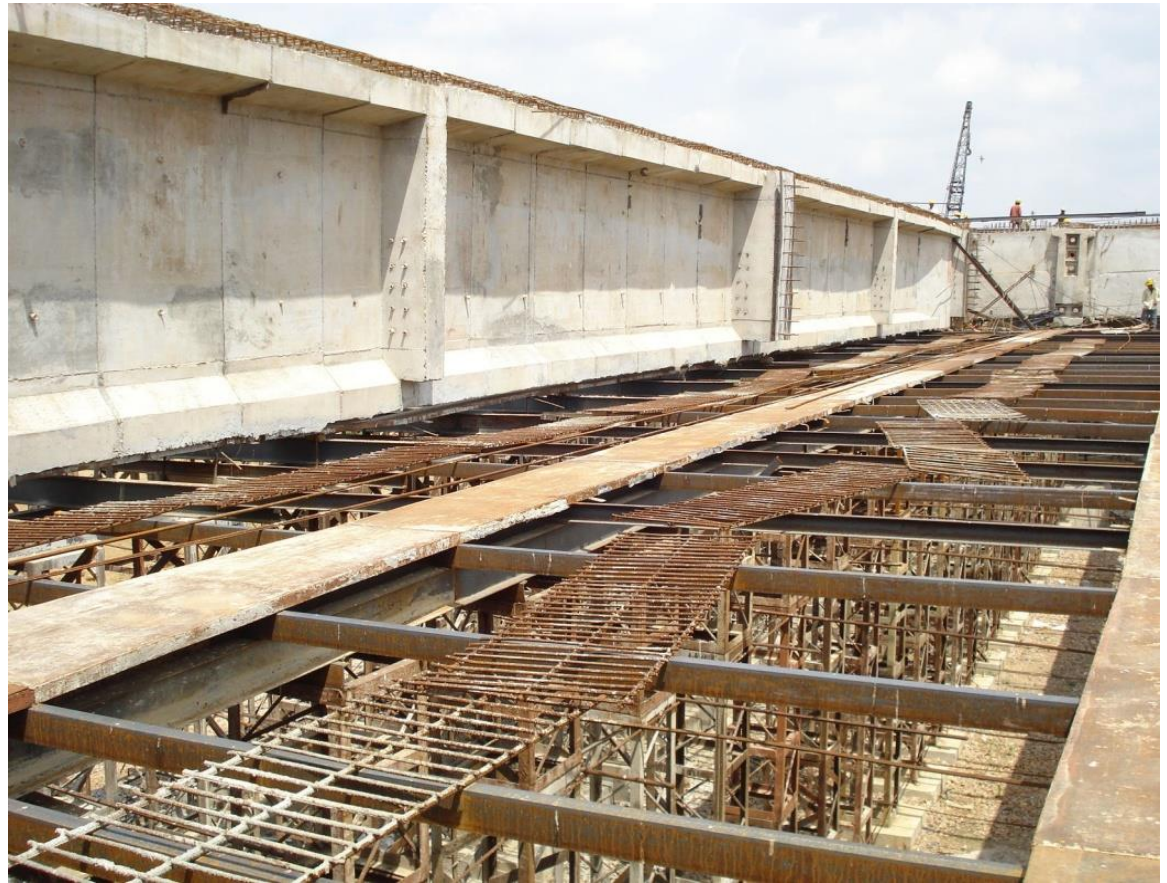
View of  
dislocated  
shutters

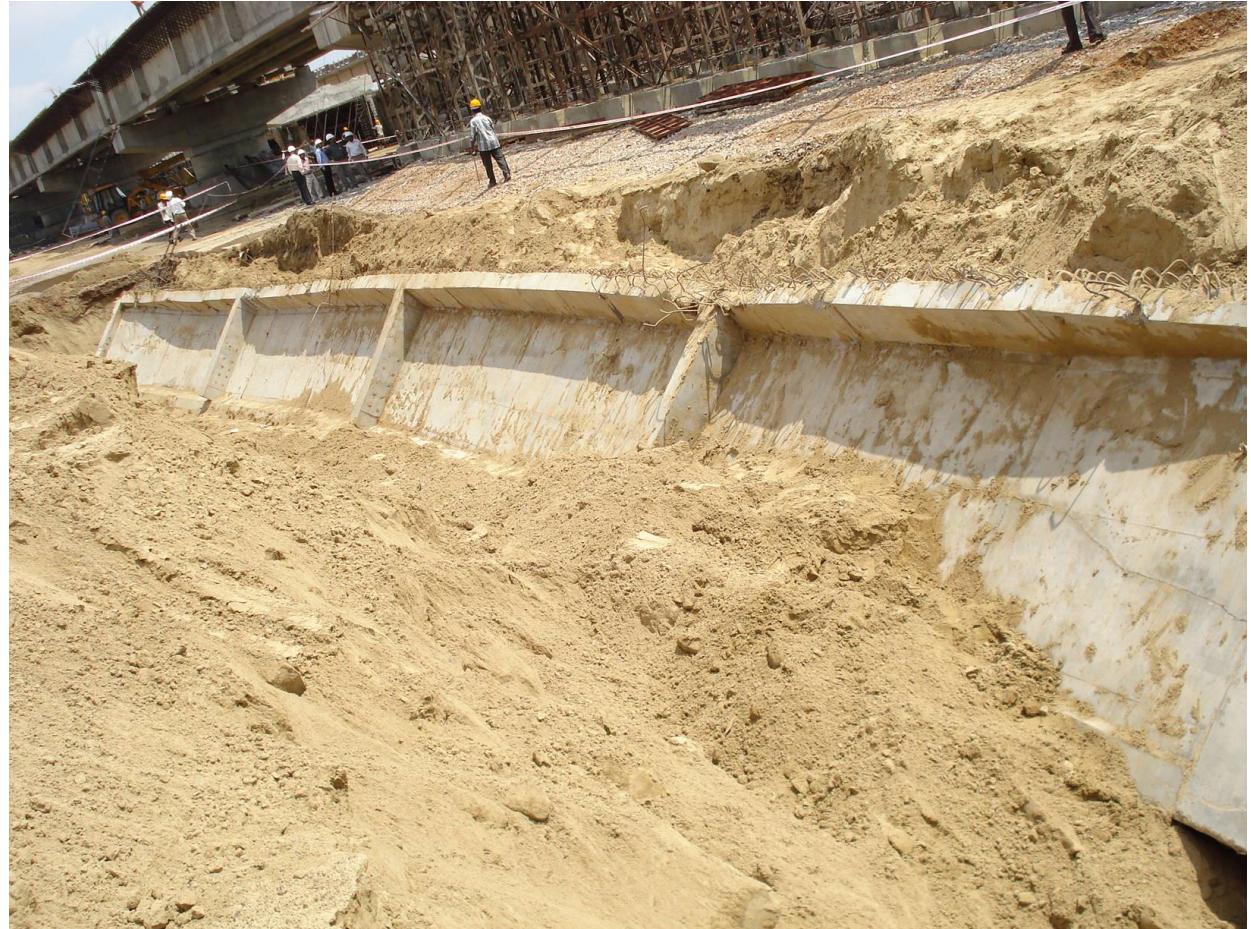
Topped  
Girder lying  
on ground

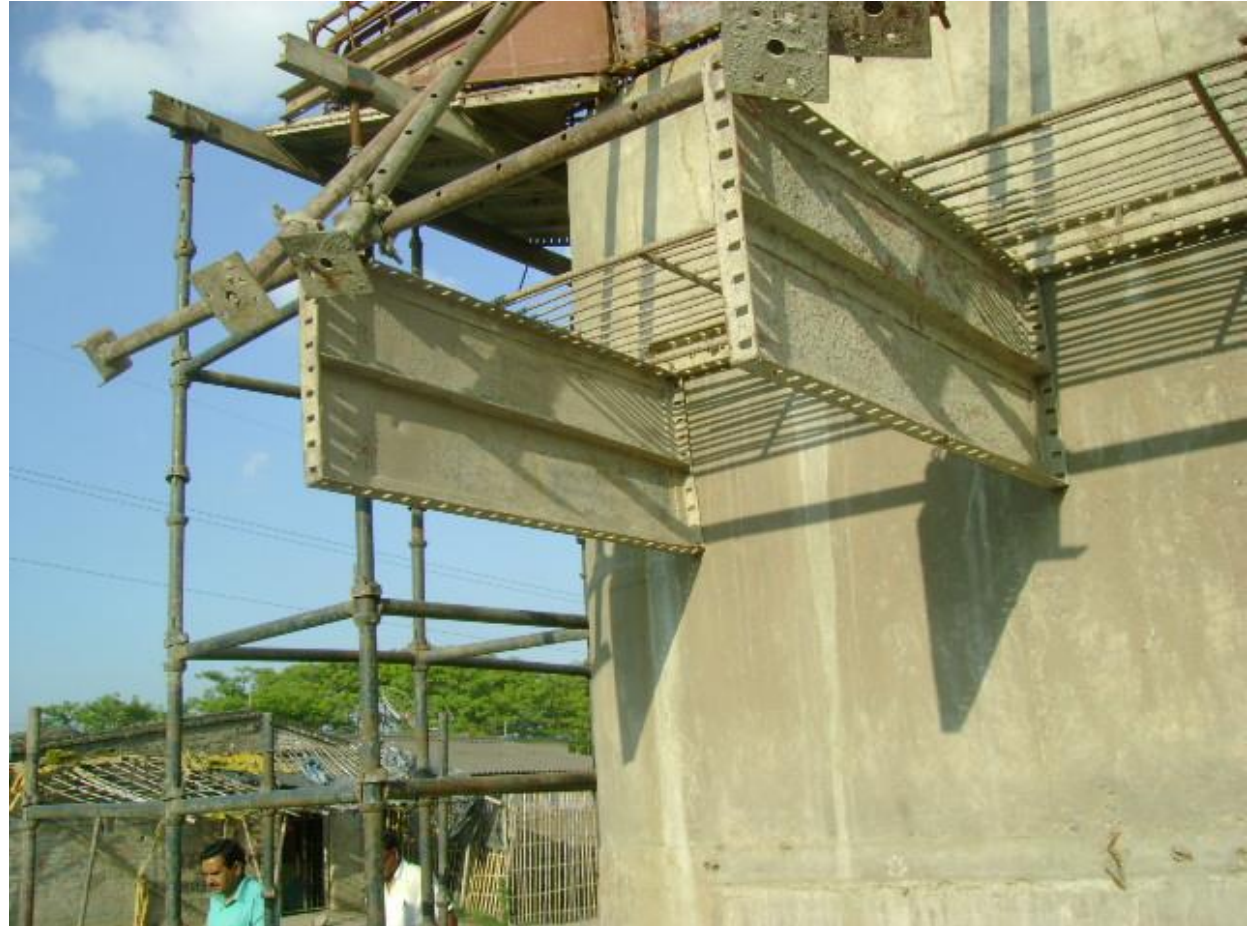
Shuttering plates being used to form brackets to support working platform

Scaffolding materials	Standard built up frames are not used and the contractor uses makeshift arrangement.	The contractor shall use standard built up frames for scaffolding.
Access arrangement	Access arrangement is poor at nearly all the locations. As almost everywhere. These were found to be made of substandard, makeshift type and unsafe	The formwork design should show the access arrangement. They must be well designed and to provide ramp, walkway, access and approach at the work locations
Formwork design and drawings	No vetting by third party. In some cases it is approved by consultants.	The formwork design and drawings must be vetted by third party. A certificate to this effect must be available for inspection by the CSC and a copy send to Employer.
