# Some case studies of construction accidents in India

Special emphasis on safety of temporary structures

**Dr. K.N.Jha**

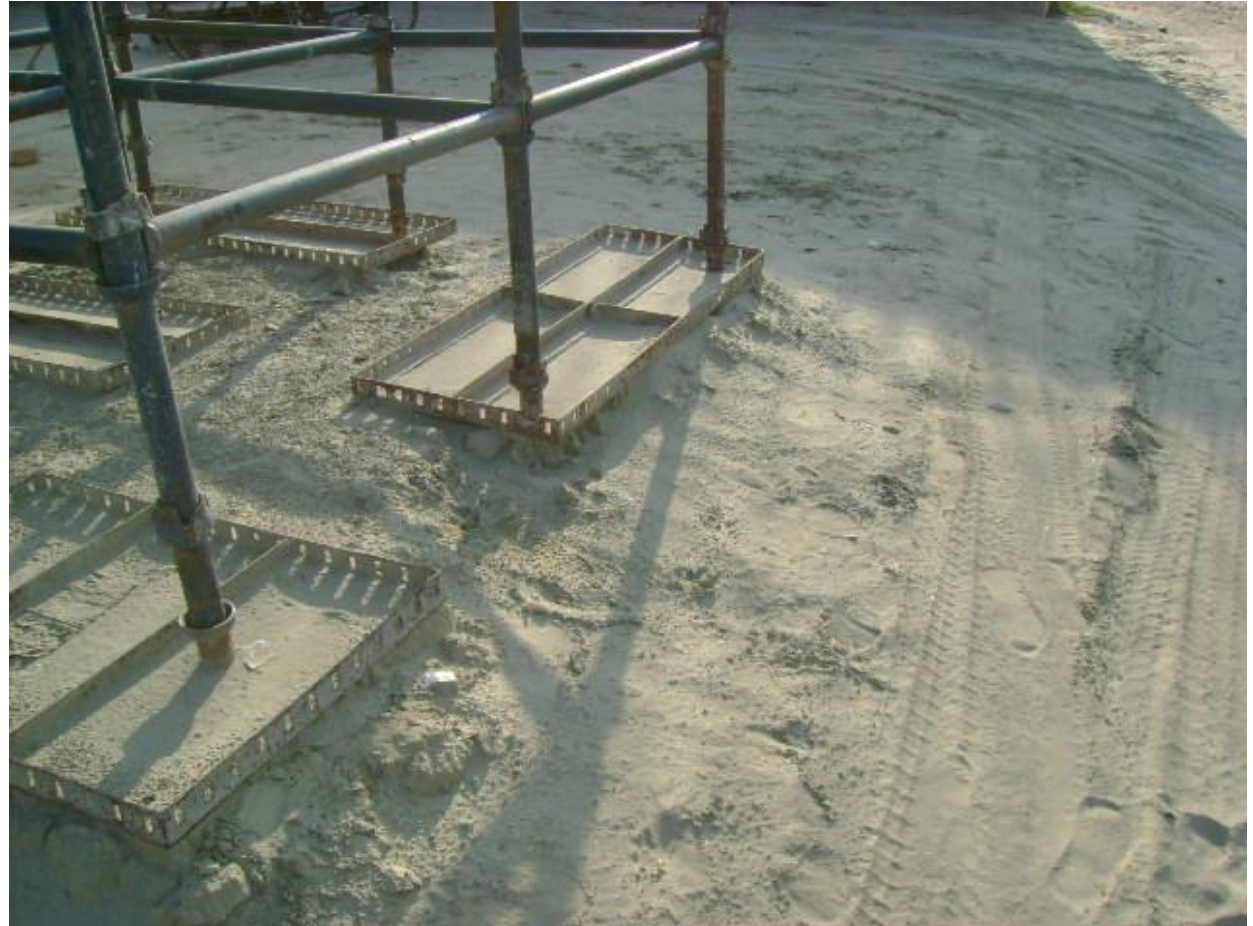
Shuttering plates being used as pedestal (even worse, they are kept on loose soil)

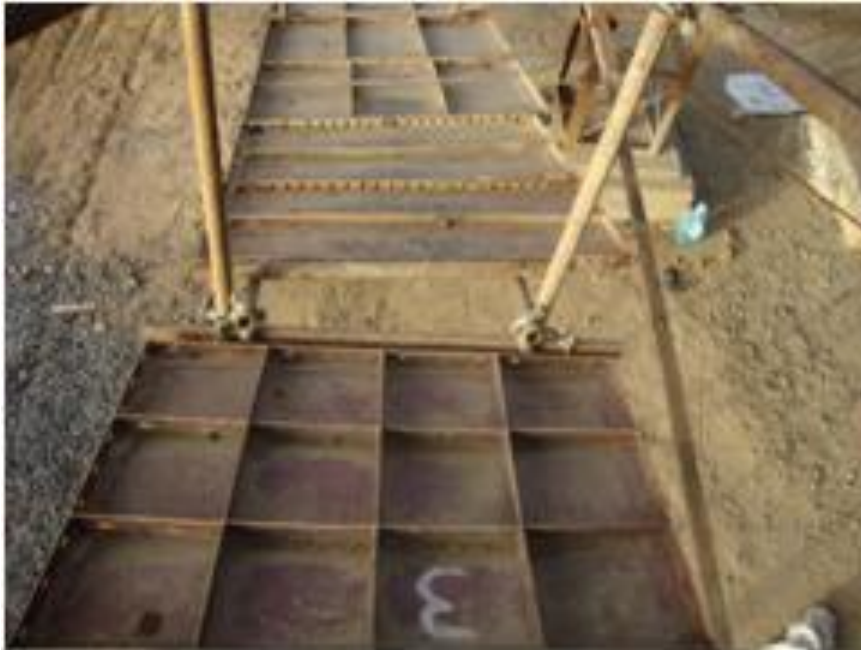
A view of access to workplace-  
misuse of shuttering plate

Scaffolding materials	Standard built up frames are not used and the contractor uses makeshift arrangement.	The contractor shall use standard built up frames for scaffolding.
Access arrangement	Access arrangement is poor at nearly all the locations. As almost everywhere. These were found to be made of substandard, makeshift type and unsafe	The formwork design should show the access arrangement. They must be well designed and to provide ramp, walkway, access and approach at the work locations
Formwork design and drawings	No vetting by third party. In some cases it is approved by consultants.	The formwork design and drawings must be vetted by third party. A certificate to this effect must be available for inspection by the CSC and a copy send to Employer.

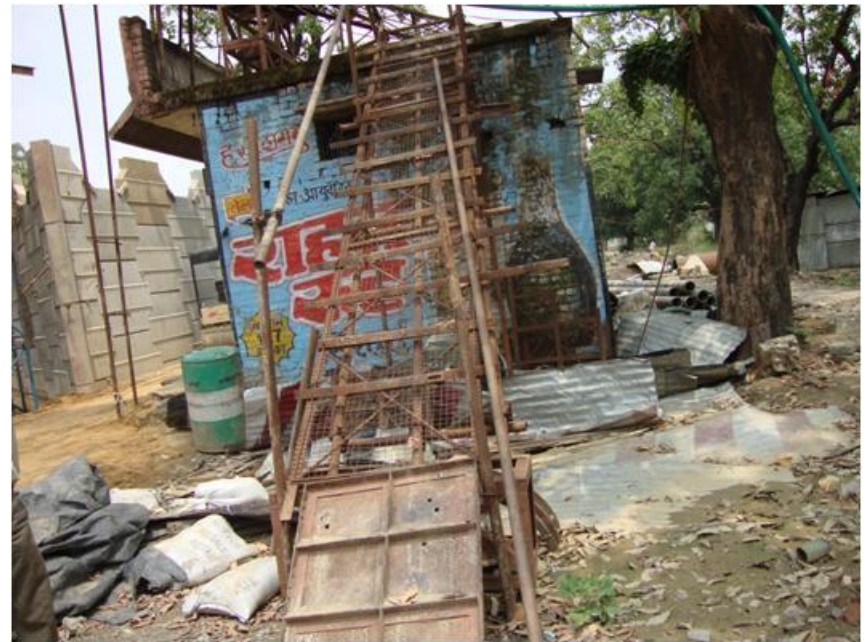
Another view of access to workplace

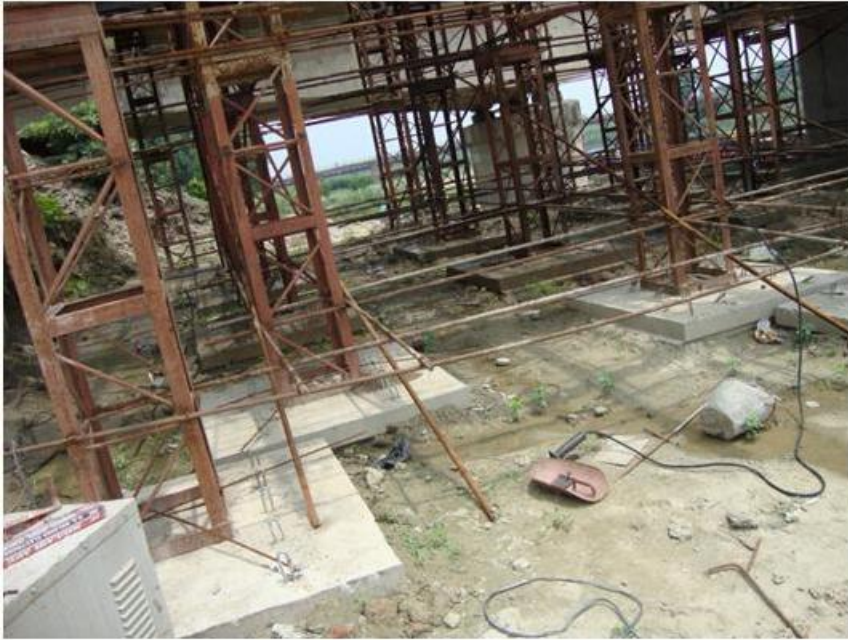
A view of bridge formwork-  
No trestle is anchored

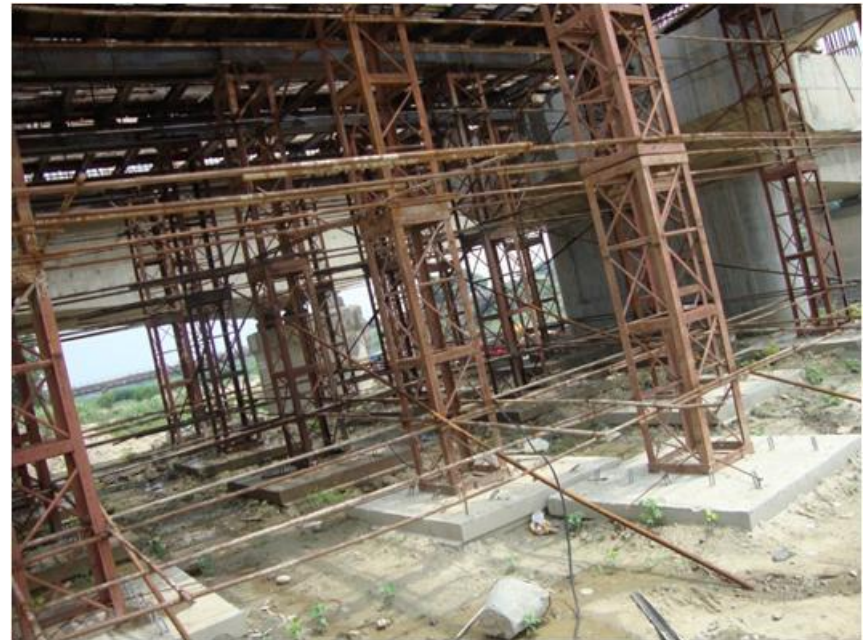
Another view of bridge formwork-  
Reinforcement is being used as bracing

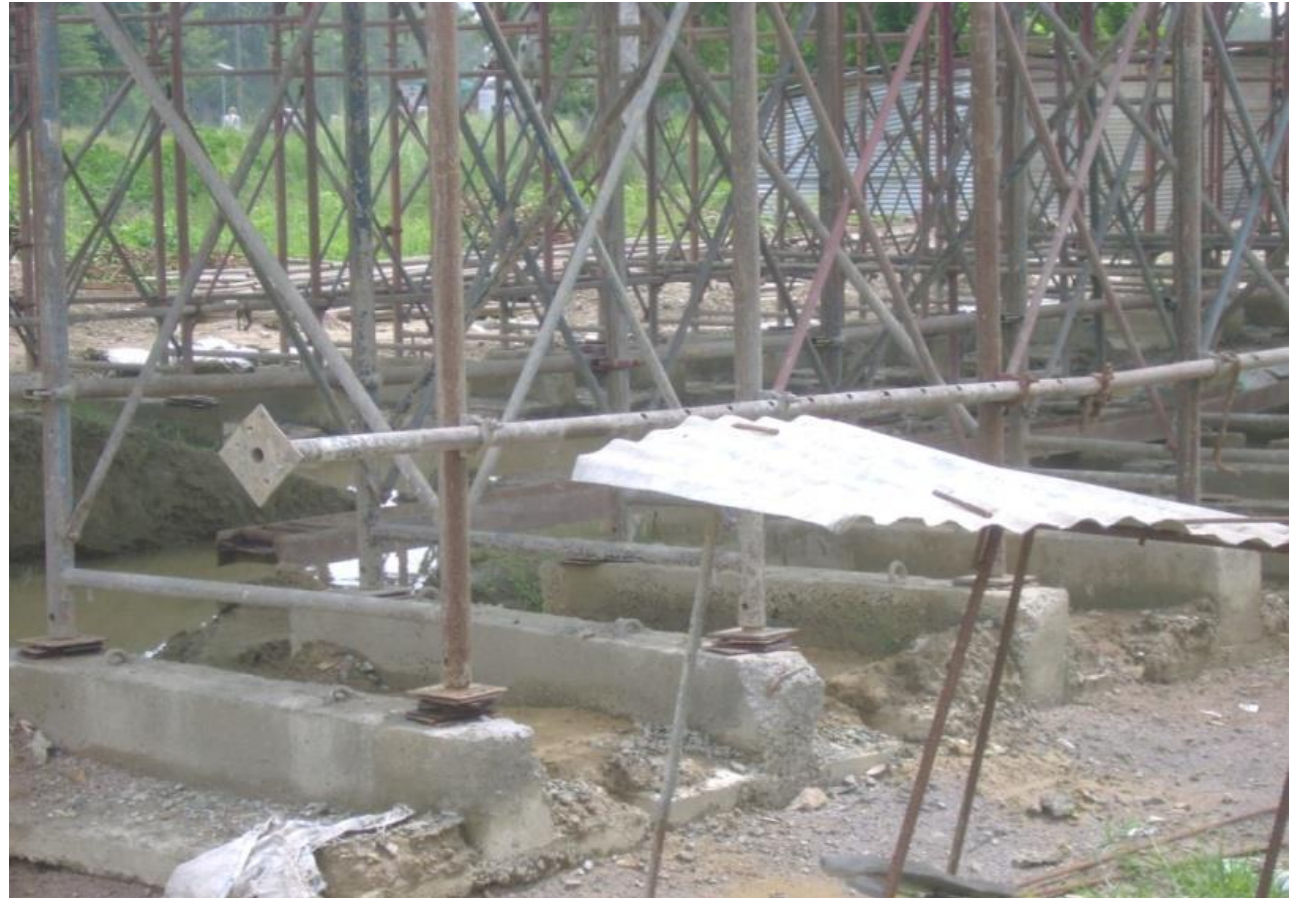
Foot plates  
not in proper  
contact with  
concrete  
pedestals

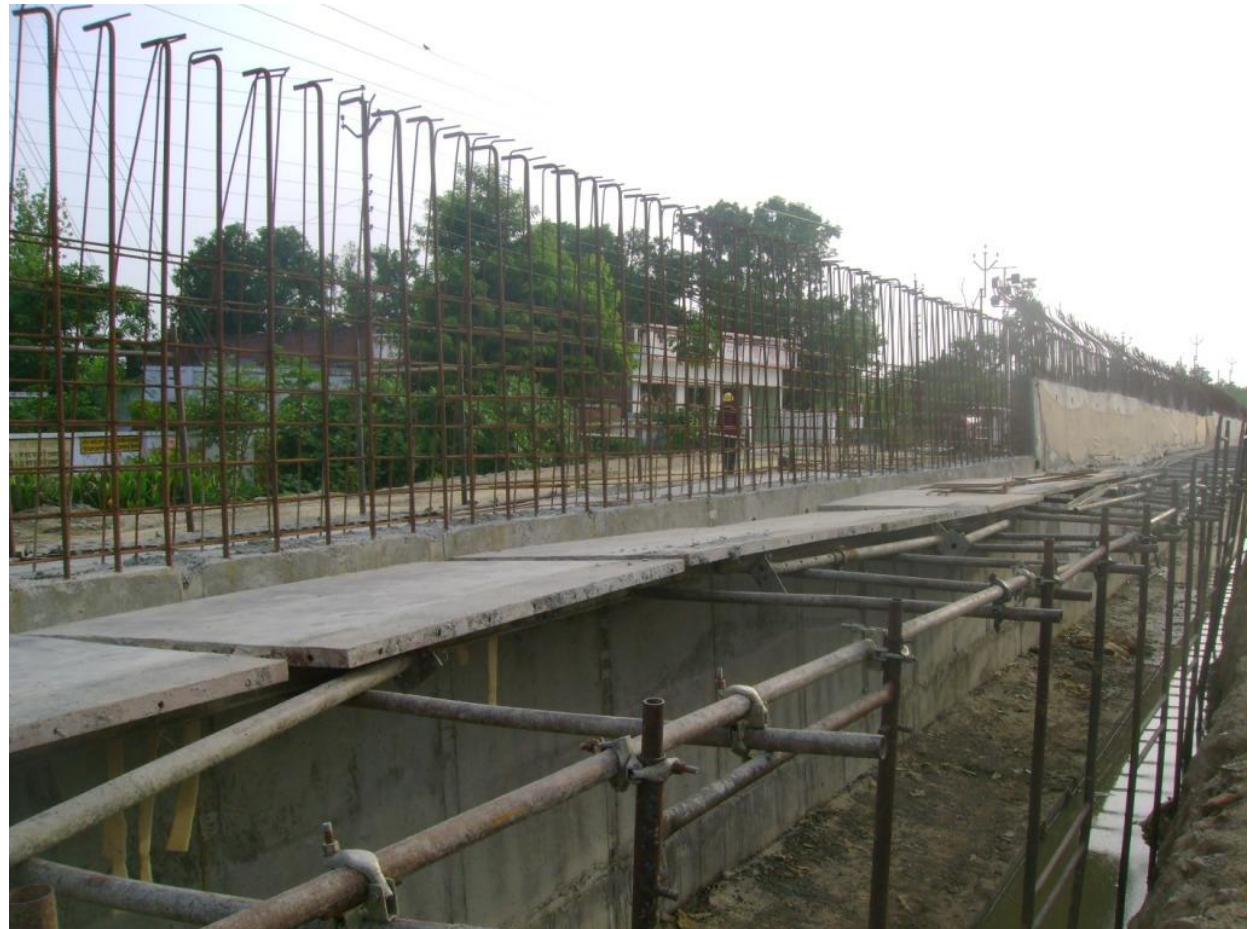
Improper  
working  
platform, no  
hand rails, no  
foot guards

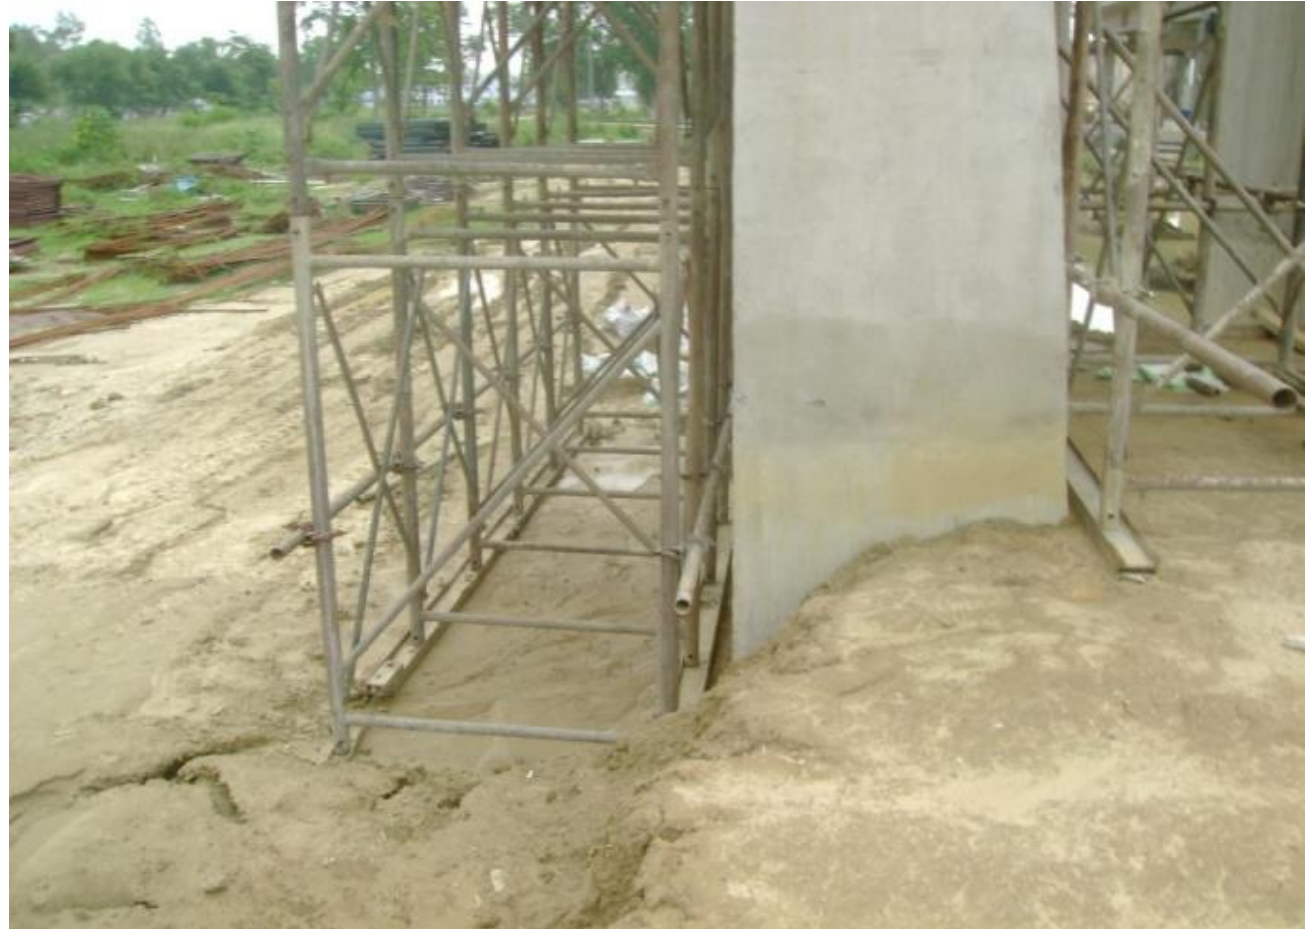
Erosion of soil beneath the shoring was noticed.

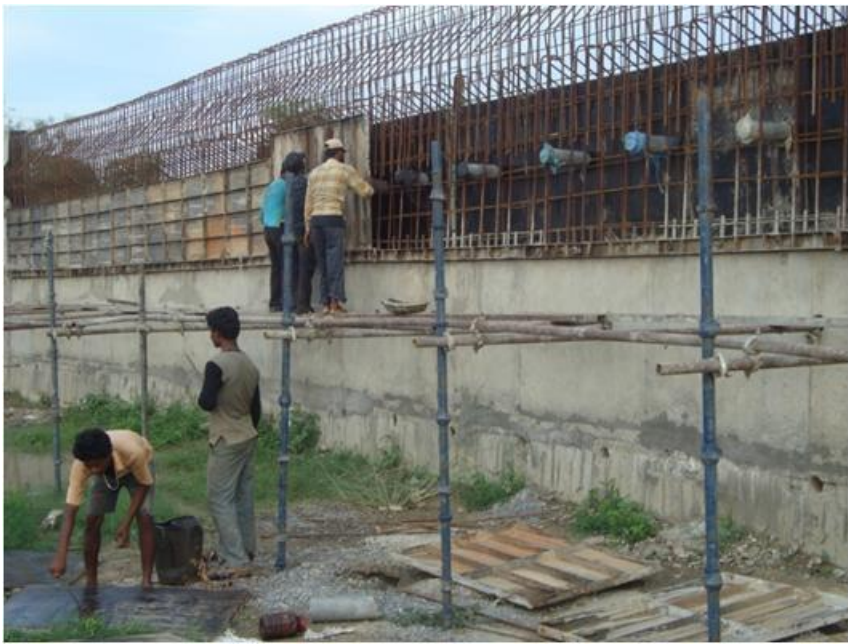
A view of wall formwork-  
the unsafe scaffolding

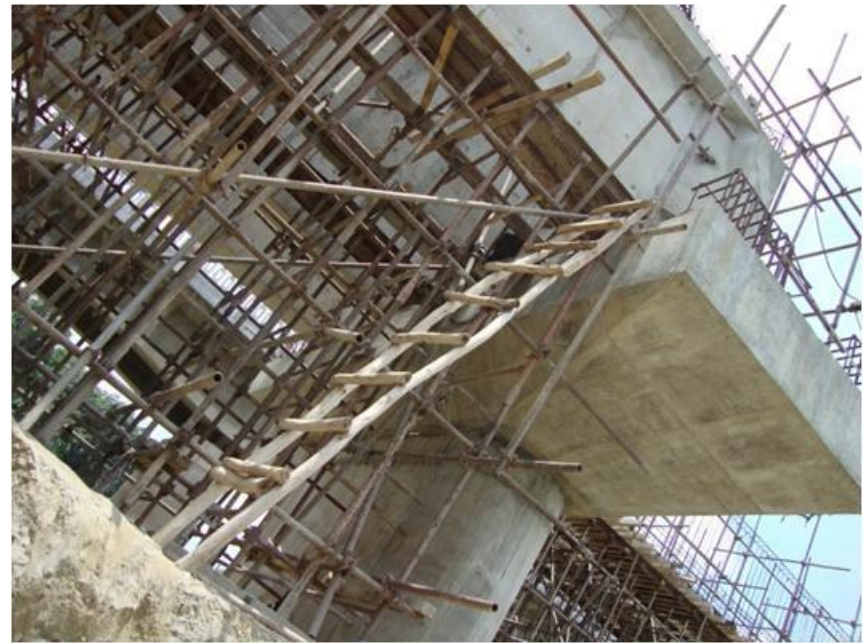
A view of bridge formwork-  
All safety norms violated

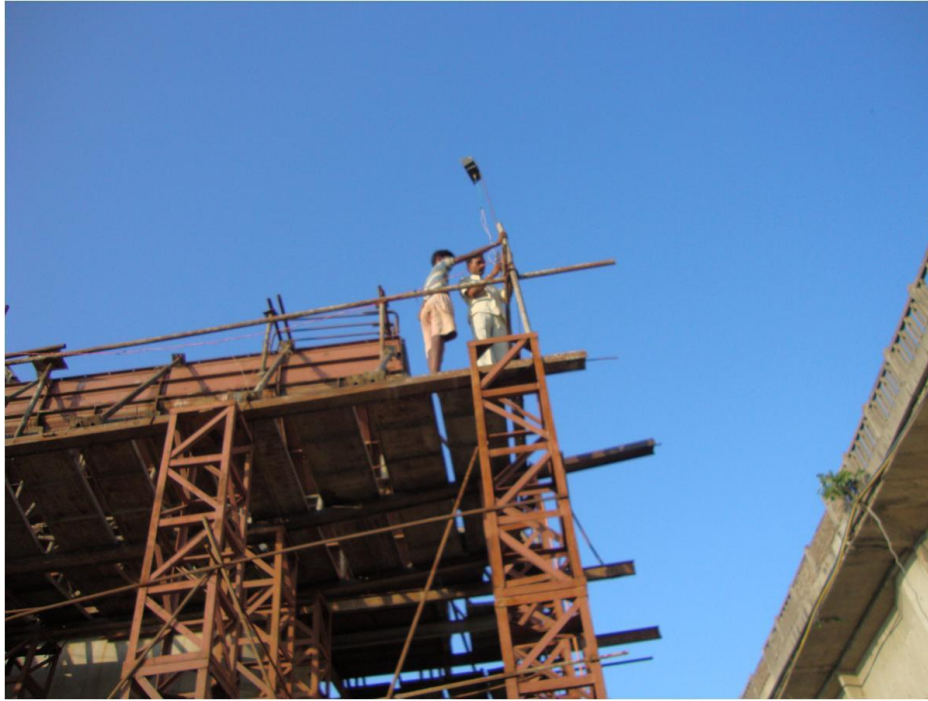
**Children at elevated locations without PPEs.**

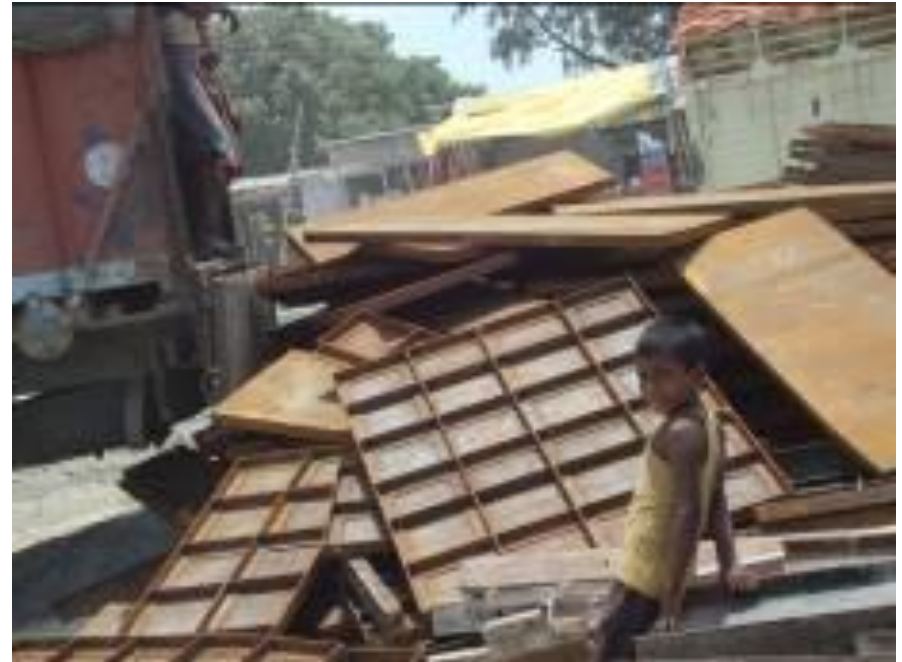
**No control over the public movement in risky working zone.**

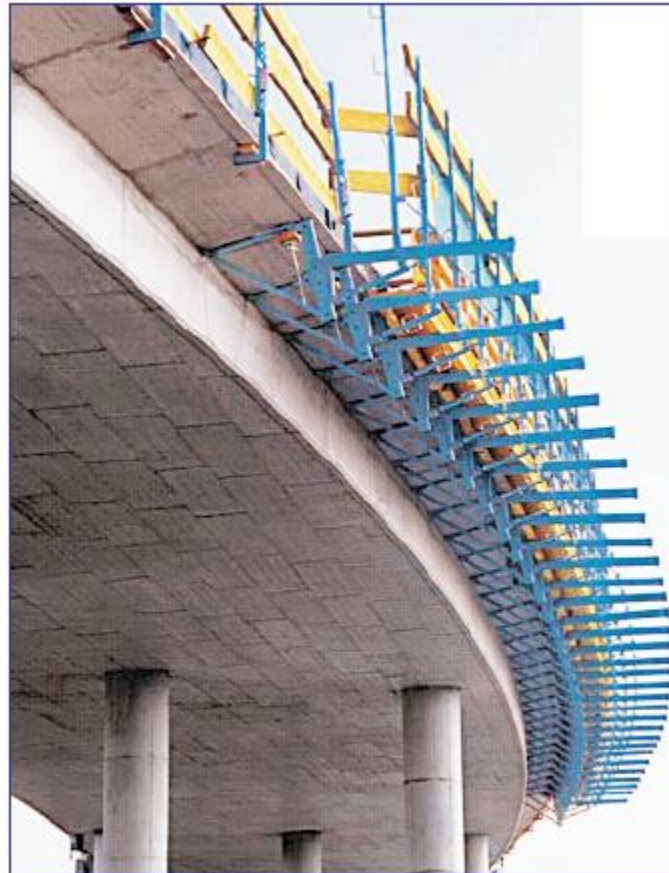
**Fig. 5.7** Edge beam formwork
