DAMAGE TO 11-STORY SRC CONDOMINIUM BY HANSHIN EARTHQUAKE IN 1995

An 11-story SRC condominium in Hyogo prefecture was damaged by the earthquake (M=7.2) in January 17, 1995. The investigation of damage to this building was conducted in order to judge the structural safety and find the repair procedure.

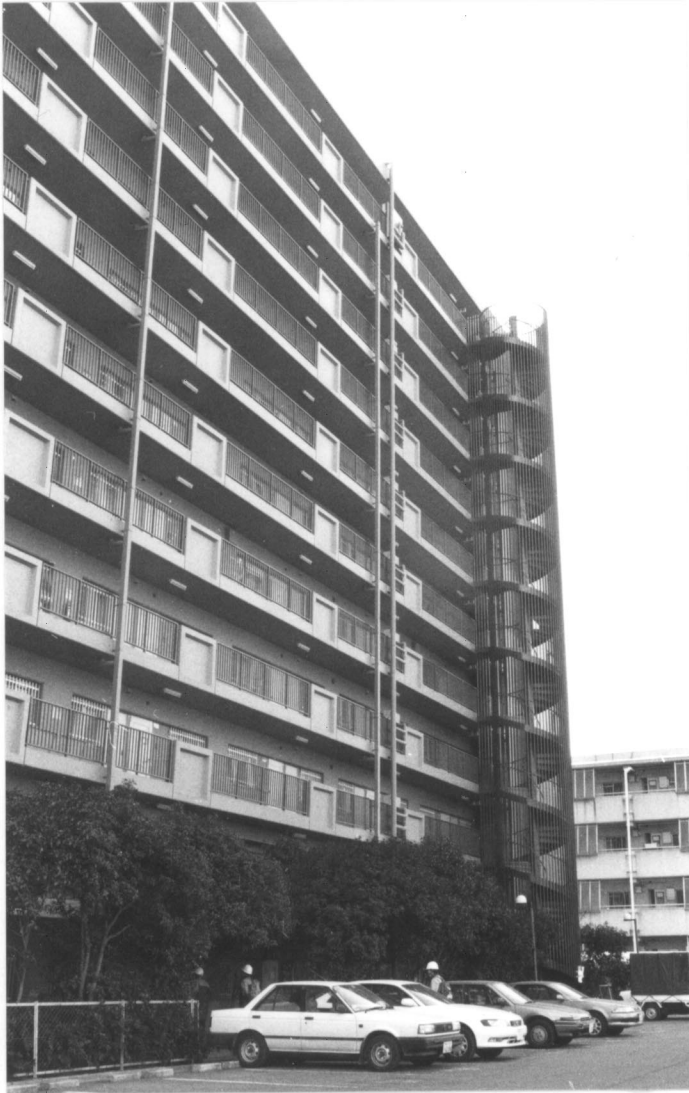
Photo. 1 Exterior view

The damaged building is a 11-story SRC building that was completed in 1981 (see Photo. 1). Fig. 1 shows a typical floor plan. The short side (N-S direction) is based on a continuous structural wall, and the length is about 10 meters. The long side (E-W direction) is based on ductile moment-resisting frames, and the length is about 80 meters. Fig. 2 shows a section of this building. The height of this building is about 30 meters. The lower floor (G-4FL) is SRC structure, and the higher floor (5-11FL) is RC structure.

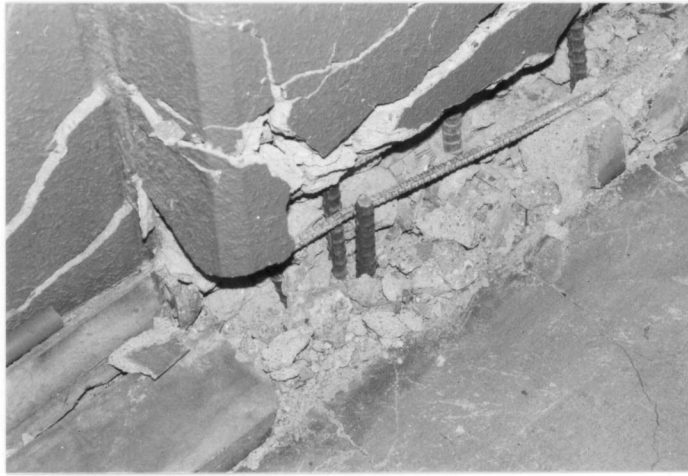
Photo. 2 The first story column destruction

- 1) The tensile fracture of reinforcing bar of the bottom of the first story column was seen (see Photo. 2 & Fig. 3).
- 2) The tensile fracture of anchor-bolts of the bottom of the first story column was seen.
- 3) The tensile fracture of steel of the top of the second story column was seen.
- 4) The destruction of concrete of lower floor was seen.

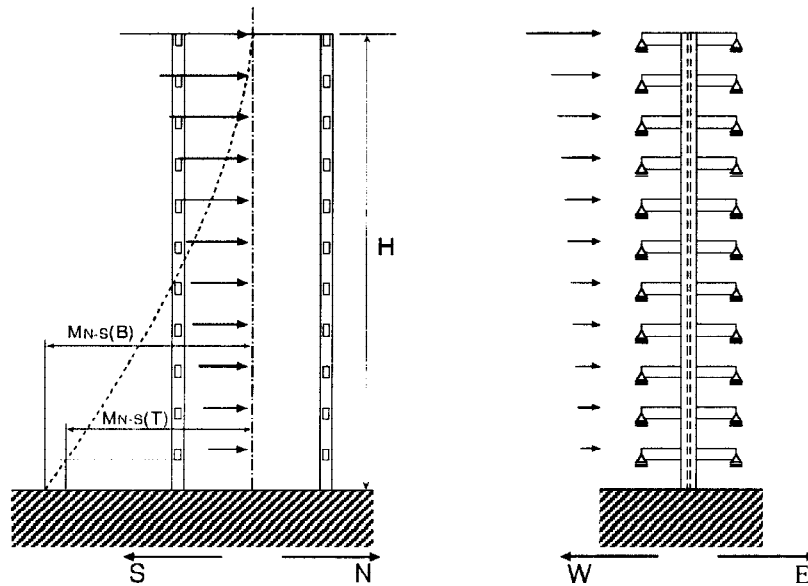
Fig. 4 Modeling of building

The building is assumed as shown in Fig. 4. The height of the building was H , the height from the floor to the bottom of the girder was h , and the weight of each floor was assumed equal.

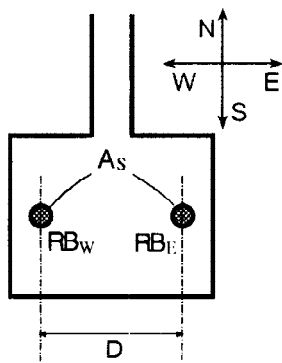
Fig. 5 Modeling of column

The column is assumed as shown in Fig. 5. The sectional area is A_s , the distance from the reinforcing bar of compression to the reinforcing bar of tension is D . The west side reinforcing bar is RB_w , and the east side reinforcing bar is RB_E .

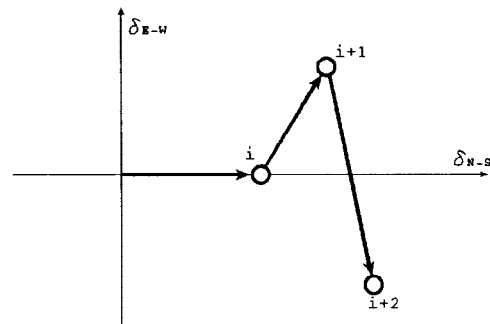
Fig. 6 Modeling of deformation

In this paper three states are discussed as shown in Fig. 6, i.e. :

- State(i) : N-S direction deformation only.
- State(i+1) : after state(i), E-W direction deformation is occurred.
- State(i+2) : after state(i+1), opposite E-W direction is occurred.

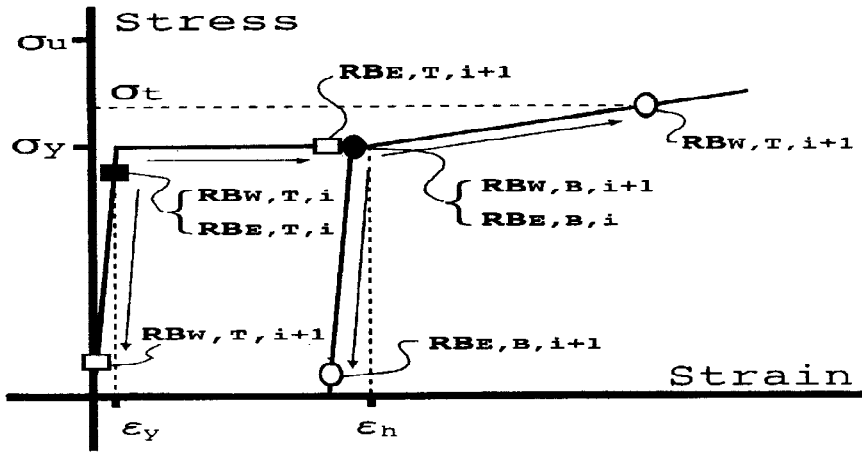
Fig. 7 σ - ϵ relationship

The stress and strain of reinforcing bars is assumed as shown in Fig. 7. The bottom is just before strain hardening at state(i). At state(i+1) RB_w starts strain hardening and RB_E is unloaded. The top is elastic at state(i). At state(i+1) RB_E is yield and RB_w is unloaded.

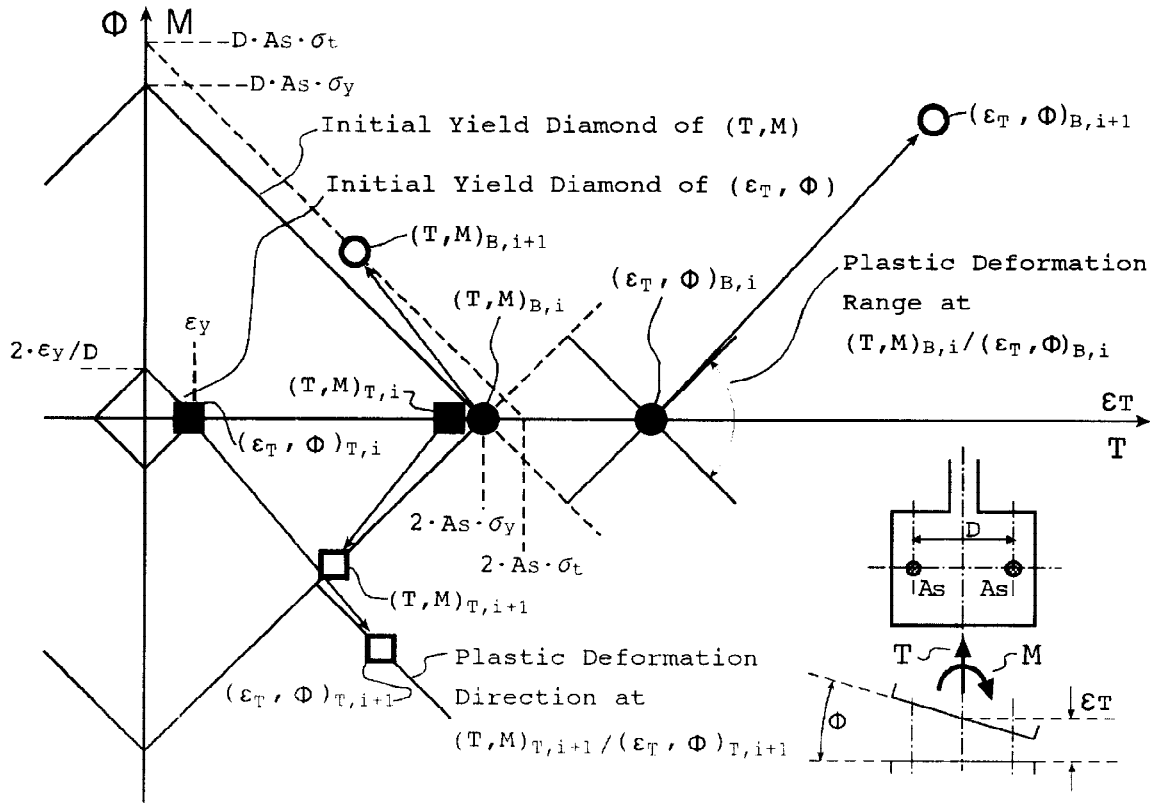
Fig. 8 Analogy of M - ϕ - T - ϵ_T relationship to the theory of plasticity

There is an analogy between bending moment-curvature-axial force-axial deformation relationship and the theory of plasticity as shown in Fig. 8.

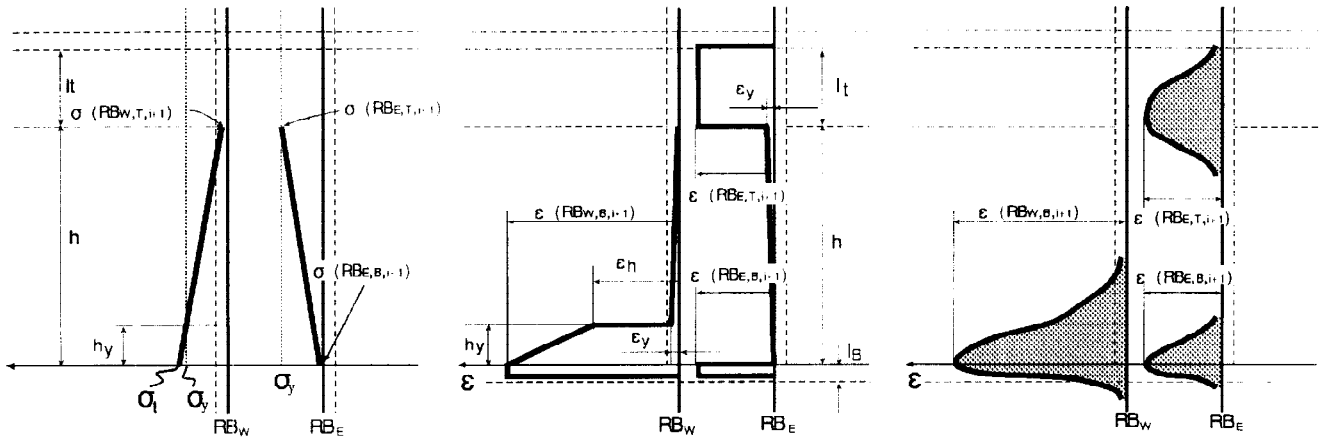
Fig. 9 Stress and Strain distribution of reinforcing bar

The stress distribution of reinforcing bars are assumed Fig. 9(a) from Figs. 7 & 8. The strain distribution of reinforcing bars are shown in Fig. 9(b). And the real distribution is supposed as shown in Fig. 9(c).

The total elongation of reinforcing bars of west side is equal to the total elongation of reinforcing bars of east side without the bending deformation of girders that connects with top and bottom of the column.

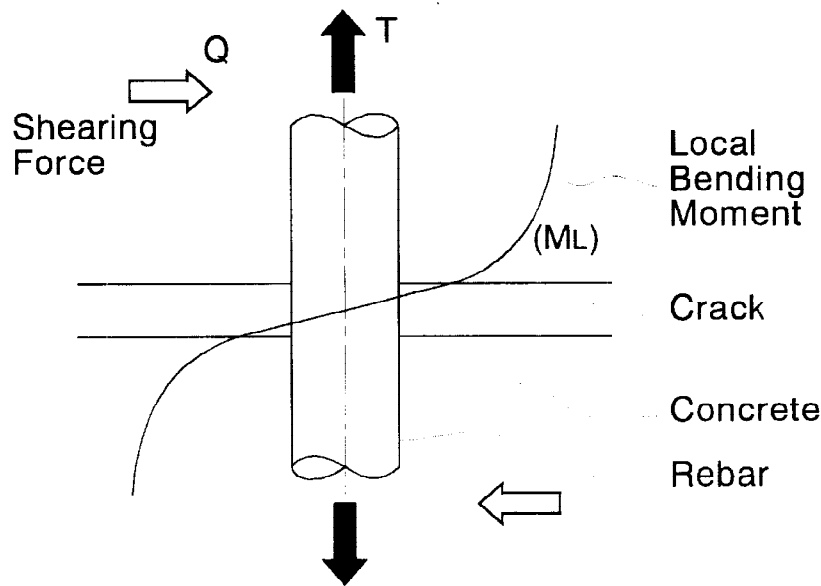
Fig. 10 Local bending moment

If reinforcing bars are yield by tensile force, cracks may be occurred as shown in Fig. 10. In this condition the local bending moment and shearing force of reinforcing bars are occurred as shown in Fig. 10.

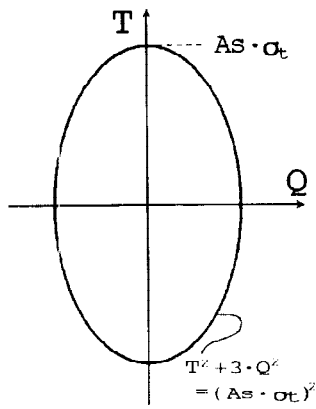
Fig. 11 T-Q relationship

The local bending moment of reinforcing bars is assumed as shown in Fig. 10, T-Q relationship may be expressed as shown in Fig. 11. And also M-T relationship may be expressed as shown in Fig. 12.

Considering these assumption, α_y of reinforcing bar yielded by tensile force decrease.

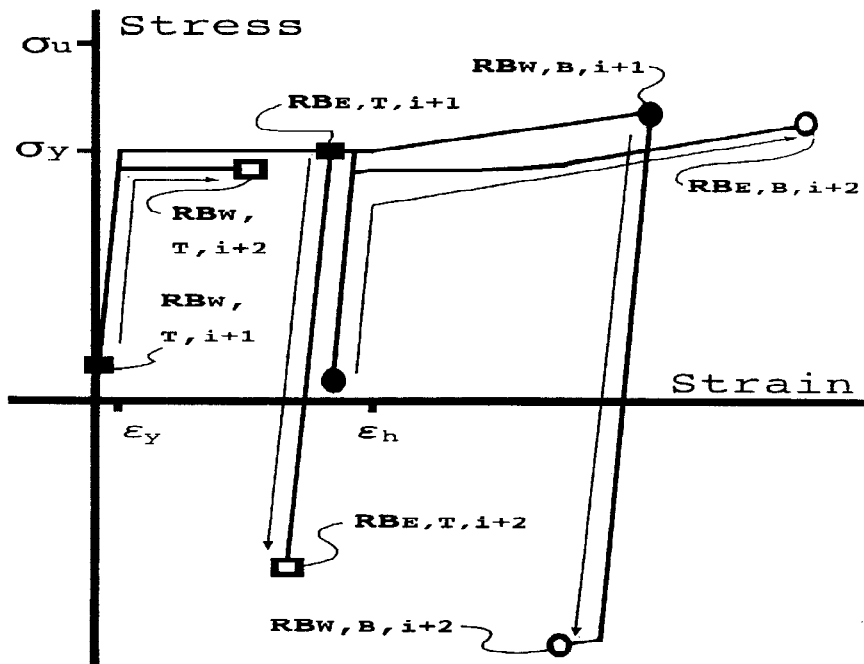
Fig. 13 σ - ϵ relationship

At state(i+2), the stress and strain of reinforcing bars is assumed as shown in Fig. 13. At the bottom of the column, RB_E starts strain hardening and RB_W is unloaded. At the top RB_W is yield and RB_E is unloaded.

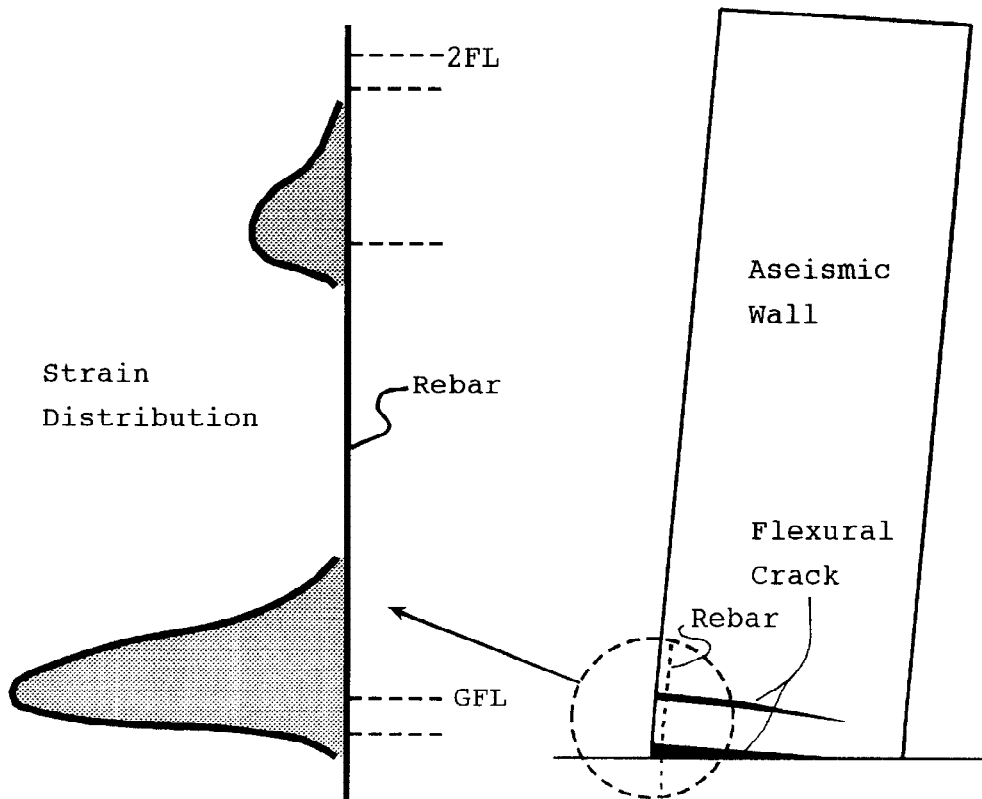
Fig. 14 Strain distribution of reinforcing bar

A continuous structural wall to develop plastic deformation by flexural yielding under the action of bending may be deformed as shown in Fig. 14(right). The strain distribution of reinforcing bars are supposed Fig. 14(left).

This paper explains the reason of the tensile fracture taking account of bi-axial horizontal deformation effect. This deforming model assumed in this paper derives strain concentration to reinforcing bars at the bottom of the first story column which is placed at the edge of continuous structural walls. Assuming to the strain concentrate region is $30d$ (d : diameter of reinforcing bar), main reinforcing bar is D25 ($d=25\text{mm}$) and the elongation of reinforcing bar is 20%, the tensile fracture of reinforcing bar occur when the drift angle reach to $1/100$ - $1/50$ radian.
