**PRELIMINARY RECONNAISSANCE REPORT ON THE 22 NOVEMBER, 1995  
GULF OF AQABA EARTHQUAKE  
(SAUDI ARABIAN SIDE)**

**ABSTRACT**

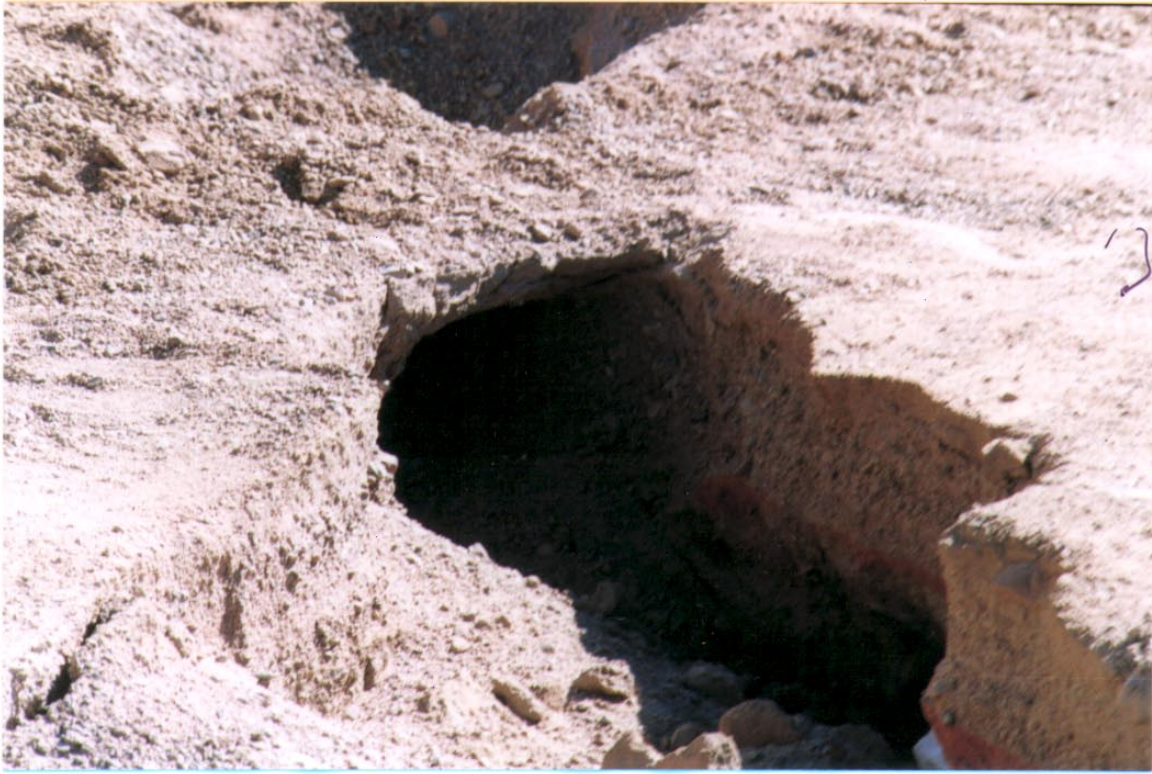
Fig. 2. Typical ground fracture observed in the epicentral area

Geologic effects of the earthquake included widespread of rockfalls and ground fractures. This could be a source of great danger to the traffic on the local roads. Actually, one of the local main roads was blocked for a while by the fallen rocks. Also the concrete fence of a coast guard center was damaged by a big fallen rock in its way into the yard of the center. Fractures in wet ground surface were observed in different sparsely places in areas of inspection. The predominant fractures showed at most only few centimeters of opening. Few wider fractures of up to 40 cm opening were observed 30 km, east and NE from the epicenter. Figures 2 and 3 show examples of observations on geological effects.

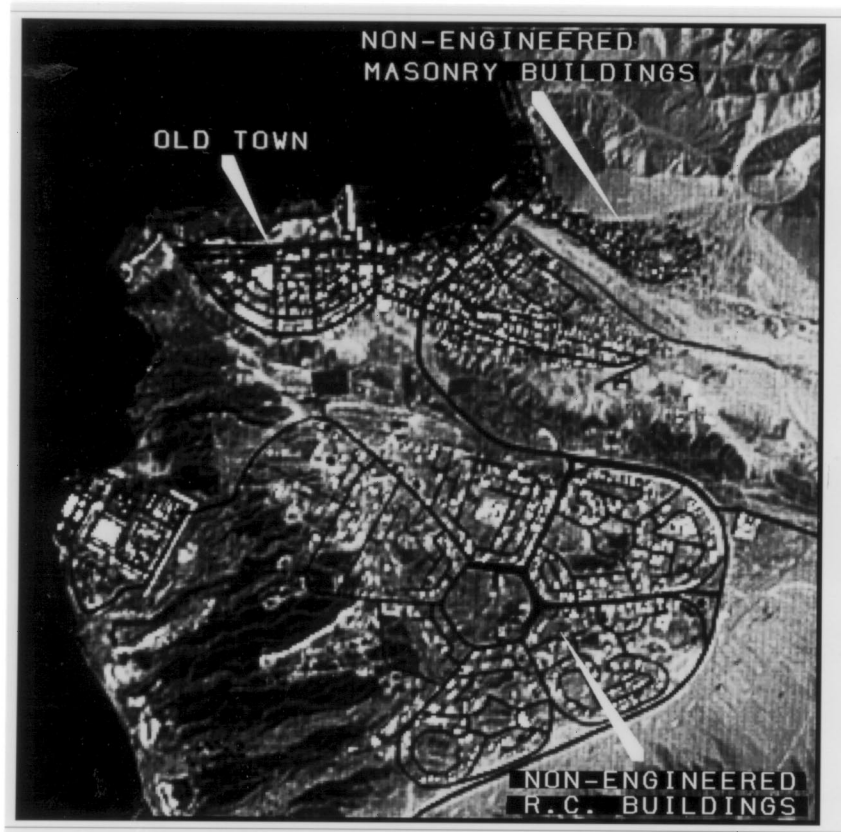
Fig. 4. High pass filtered SPOT-2 Satellite data of Haql town at a scale 1 : 112000

As mentioned earlier the affected area is lightly populated. As shown on map of Fig. 1, within 90 km from the epicenter, there are only sparsely few towns and villages, namely, Haql and Bada towns and Makna and Sharaf villages. The relatively biggest town in the area is Haql which has a population of about 18,000. Figure 4 is a French satellite (SPOT-2) panchromatic data showing Haql town. The image processing was made using the Meridian software at the Saudi Center for Remote Sensing at KACST. The majority type of buildings (more than 90%) are of typical two-story reinforced concrete-framed buildings, with unreinforced masonry infill walls. Except governmental ones, these buildings are with at most, if any, little engineering input. The other existing buildings are single-story masonry dwellings with either concrete or wood roofs, which were mainly constructed without legal permission.

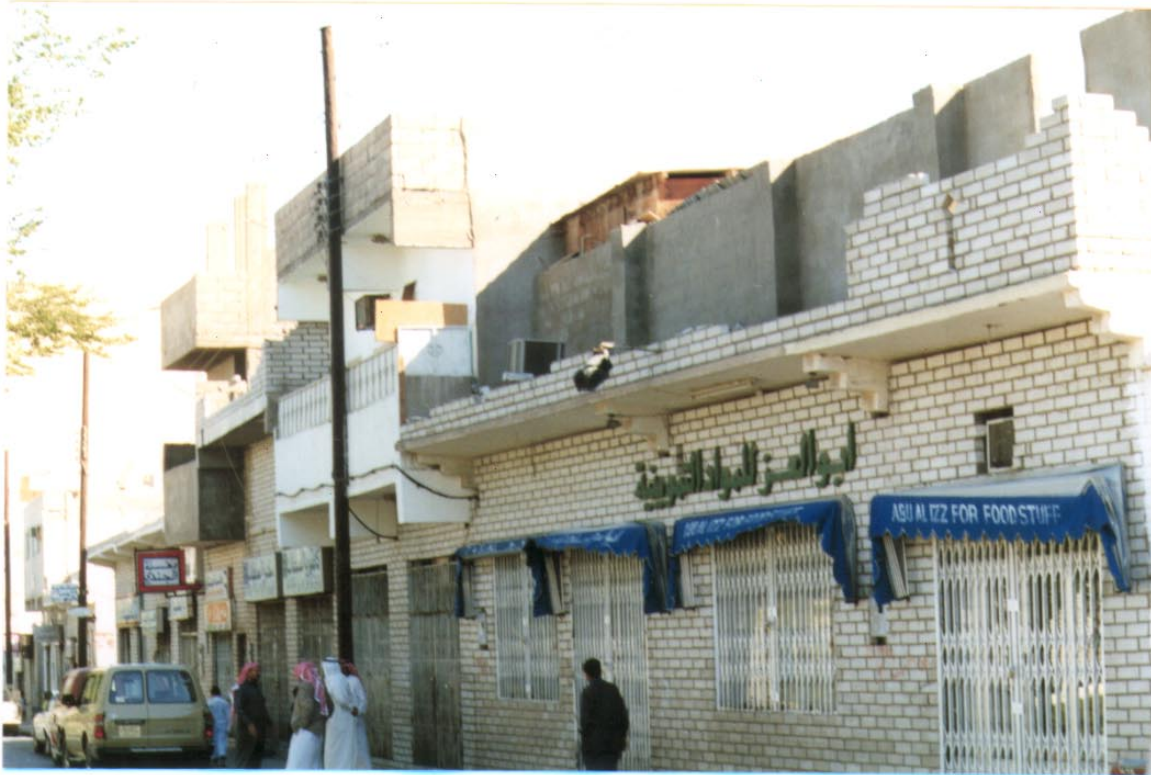
Fig. 5. Sand brick parapets fallen in downtown of Haql

The extensive damage and total collapse observed in the area appear mainly from engineering deficiencies. Most of deficiencies that contributed in the extensive damage observed in isolated locations are exhibited in Figs. 5 to 8. Figure 5 shows serious typical fall of 8 cm thick heavy sand brick parapet in downtown of Haql which caused death of one person. Although several of this type of parapets had fallen, unbraced masonry parapets which are predominantly existing in the area remained intact. In addition to the obvious lack of lateral supporting, the damage in sand brick parapets appear mainly from their heavy weights.

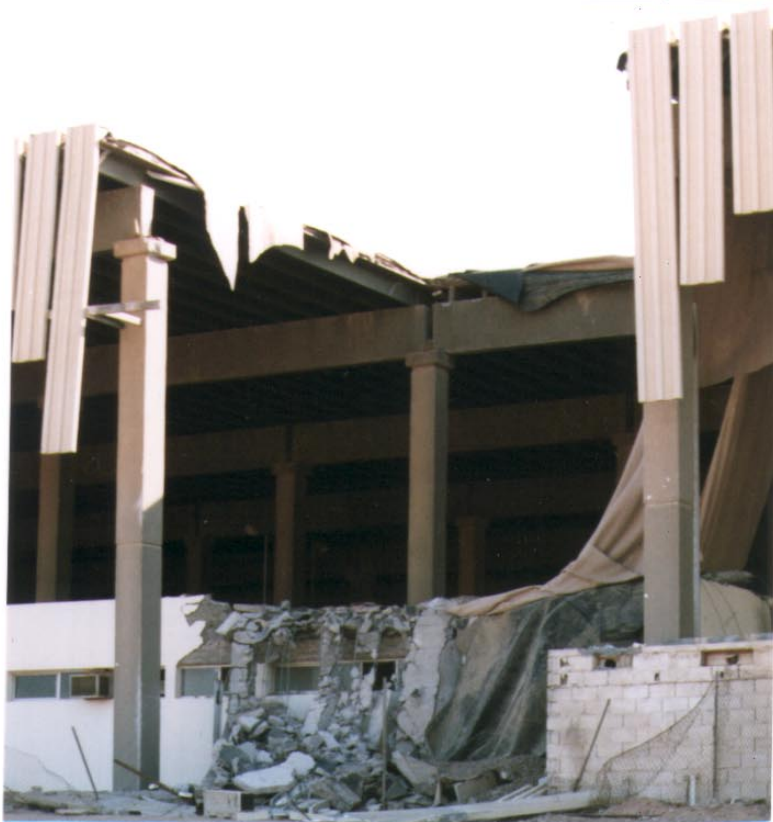
Fig. 6. Precast concrete shed partial collapsed in Ad Durrah customhouse

The most intensive damaged occurred in government structures in Ad Durrah customhouse neighboring Jordan. More specifically, three single story (45m long x 20m wide) reinforced concrete-framed sheds were totally destroyed, a precast shed of wide-span was partially collapsed, and columns of three large warehouses were severely damaged (Unrepairable). Damage in the precast shed shown in Fig. 6 can be obviously attributed to engineering deficiencies in the beam-column joints. The total collapse of the reinforced concrete sheds shown in Fig. 7 appear mainly from random problem encompassing one or more of the following:

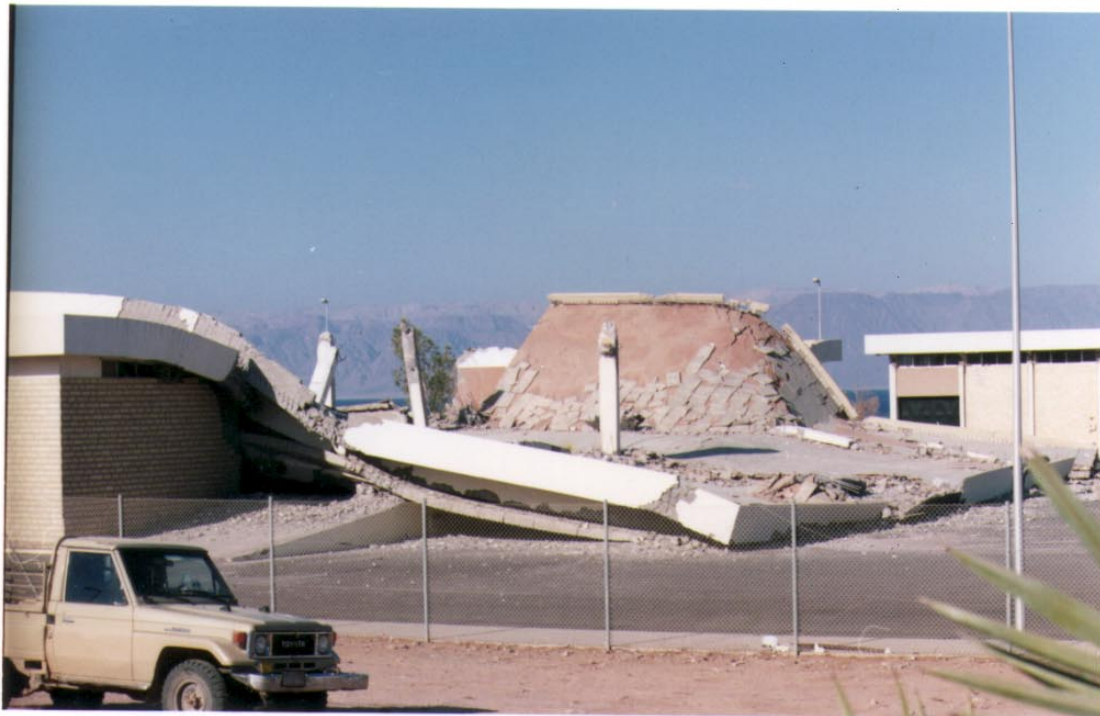
Fig. 7. Reinforced-concrete sheds completely collapsed in Ad Durrah customhouse

- (1) Poor concrete and detailing
- (2) Heavy load of the shed which was built of 50 cm thick joist construction with permanent filler of concrete bricks.
- (3) The foundation soil is loss fill. Great amplification of ground motion is expected at the area. Actually, the preliminary data obtained from the Jordanian strong motion network indicates that the level of the horizontal component of the PGA of the main shock (on rock) was about .05 g in city of Al-Aqaba which is located only 17 km from the site of the collapsed buildings.

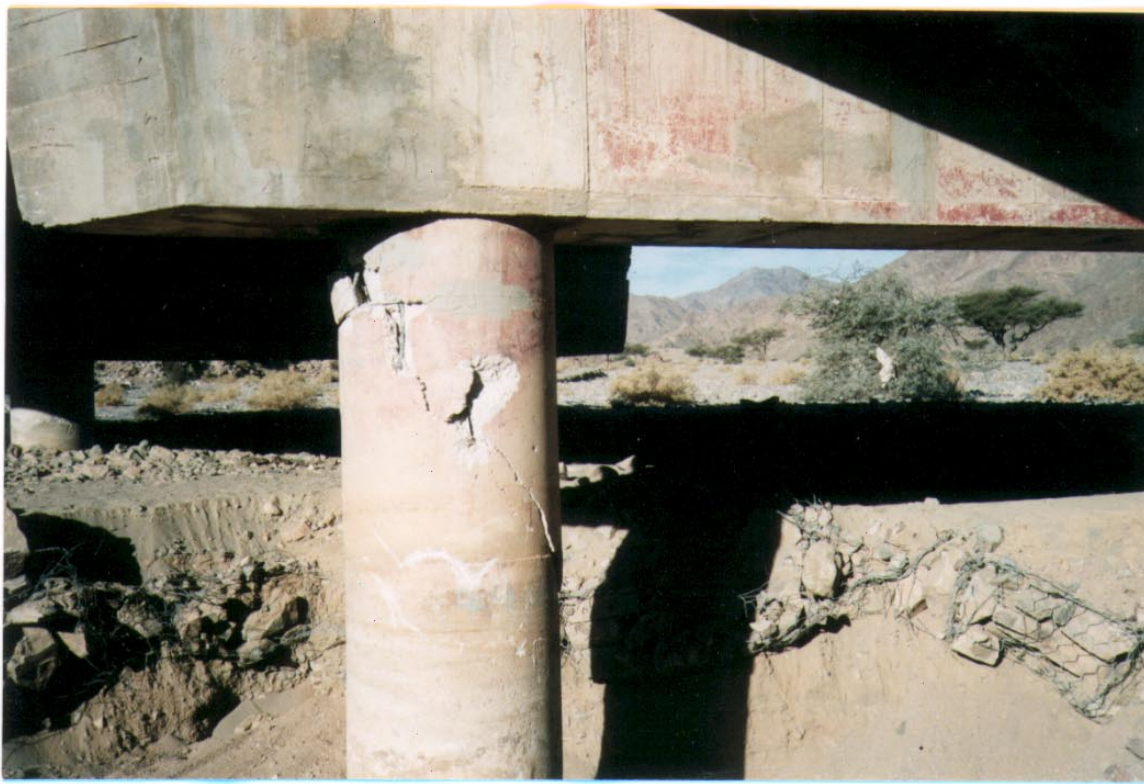
Fig. 8. Severe damage in columns of a main bridge

In general, damage in bridges, roads, and life line system was minimal. Figure 8 show, the only case of damage observed in bridges. The bridge experienced severe cracking in the columns which can be attributed to poor concrete.
