## STATE-OF-THE-ART IN TECHNIQUES FOR REHABILITATION OF BUILDINGS

SHUNSUKE SUGANO

### ABSTRACT

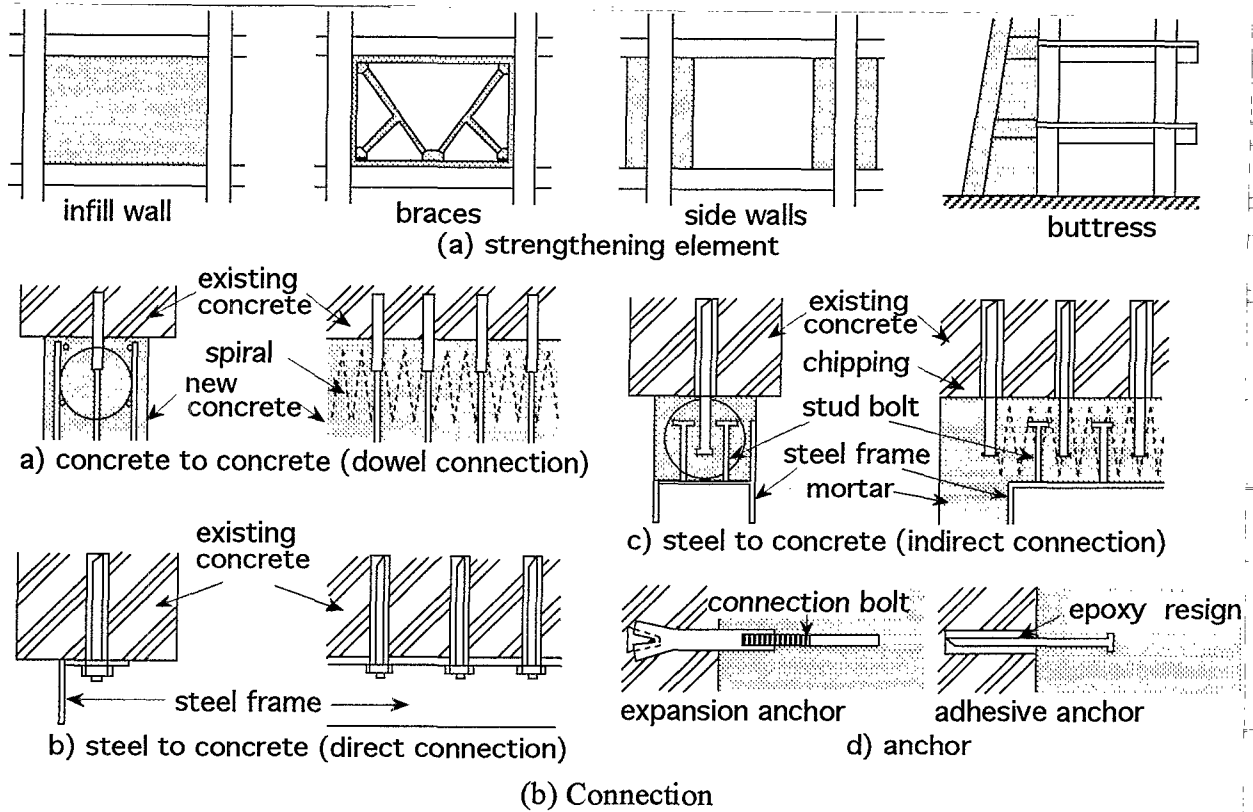
Fig. 4 Typical frame strengthening techniques

Typical details of connections to existing concrete are given in Fig. 4(b). Dowel connections in Fig. 4(a) are used for infill walls and side walls. The expansion and adhesive type anchors for dowel connection are illustrated in Fig.4d). Steel elements may be simply attached to the existing concrete through mortar fill, as shown in Fig. 4c), while they may be directly attached to the frames by bolting (Fig. 4b). Steel systems of braces and panels with peripheral frame were studied by Yamamoto (1983, Fig.11) and Aoki (1992) using the connection in Fig. 4c). The steel elements were welded or bolted to the peripheral frame, and the steel frame was attached to existing frame through mortar fill. Stud bolts were welded to steel frame and adhesive anchors were installed along the existing frame. These bolts and anchors acted as dowels through mortar fill, though they were not connected each other. This connection tolerates more error in dimension of the steel system to be attached to existing frame than the direct connection.

Flexural capacity of frames may be increased with concrete or steel jacket shown in Fig. 4(a) providing with new longitudinal and lateral reinforcements. It is important to adequately arrange lateral reinforcements to achieve ductile behavior. Beam-to-column connection may need confinement with steel element, though the construction is not easy (Alcocer 1995, Hakuto, Park 1995). Column ductility may be improved with jacketing techniques shown in Fig. 5(b). An existing column is jacketed with concrete or steel encasement. In increasing ductility of columns with these techniques, the aim is to increase their shear capacity providing new concrete and/or reinforcement. It is very important to provide a narrow gap at the end of steel or concrete encasement to avoid undesired increase of shear forces resulting from the increase of flexural capacity.

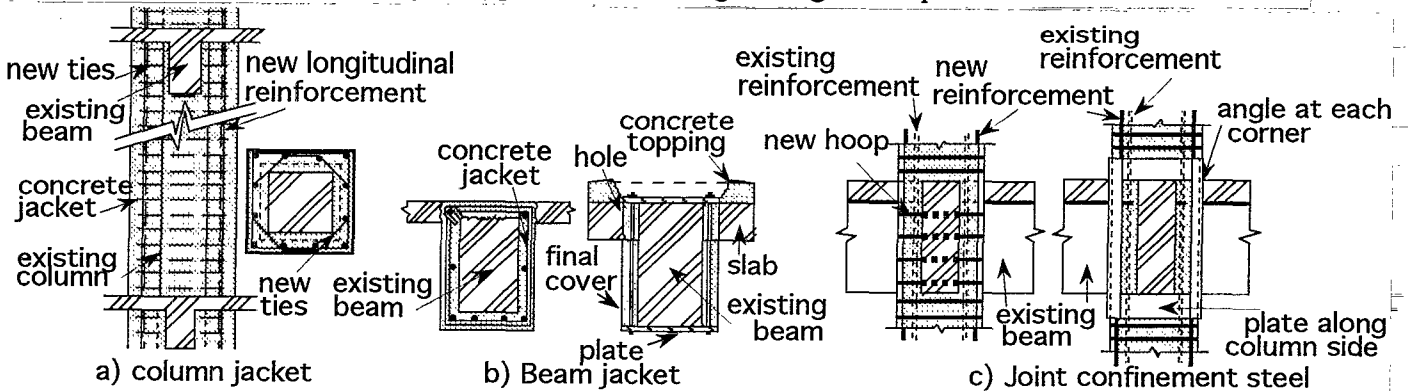
(a) Jacketing techniques to increase frame flexural capacity

(b) Jacketing techniques to increase column shear capacity

Fig. 5 Typical member reinforcing techniques

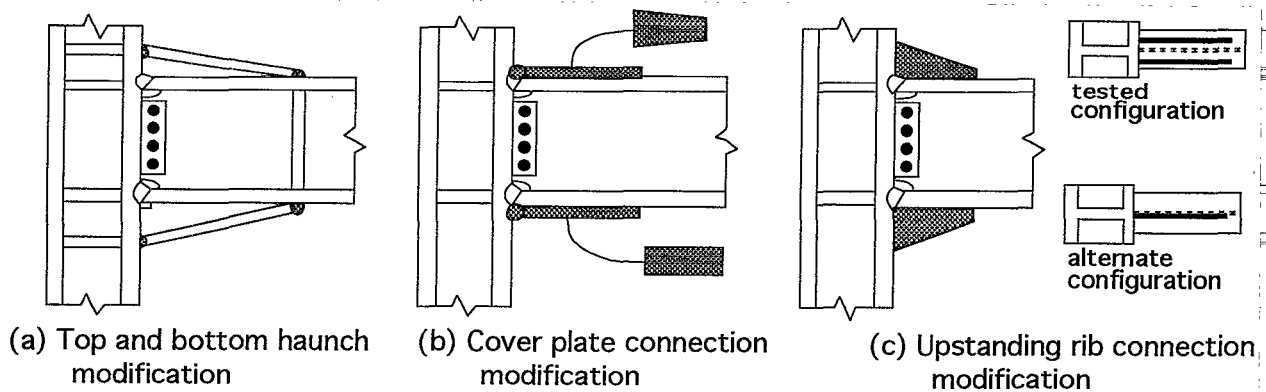
Fig. 6 Examples of post-earthquake modification of steel connection (FEMA 1995)

Based on the lessons learned from the damage to steel connections by the 1994 Northridge earthquake, some modification methods for steel connection are proposed (FEMA 1995). The aim of the methods shown in Fig. 6 as examples is to shift the plastic hinge away from the connection using haunch, cover plate or rib. These

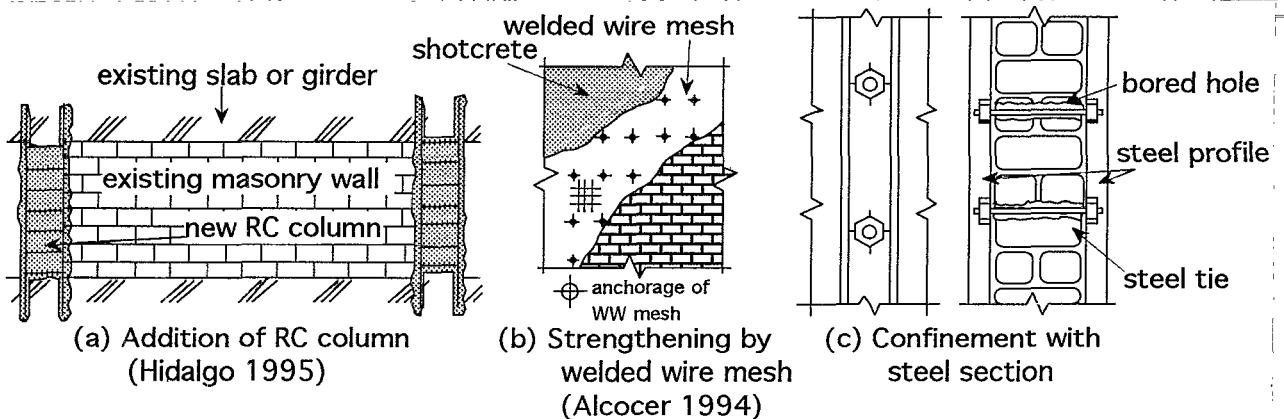
Fig. 7 Strengthening of masonry infill wall

methods can be applied to new construction. Existing masonry infill walls may be strengthened by the addition of new reinforced concrete column (Hidalgo 1995, Fig. 7(a)), by jacketing with concrete and welded wire fabrics (Alcocer 1994, Fig. 7(b)) or by confining with steel section (Fig. 7(c)).

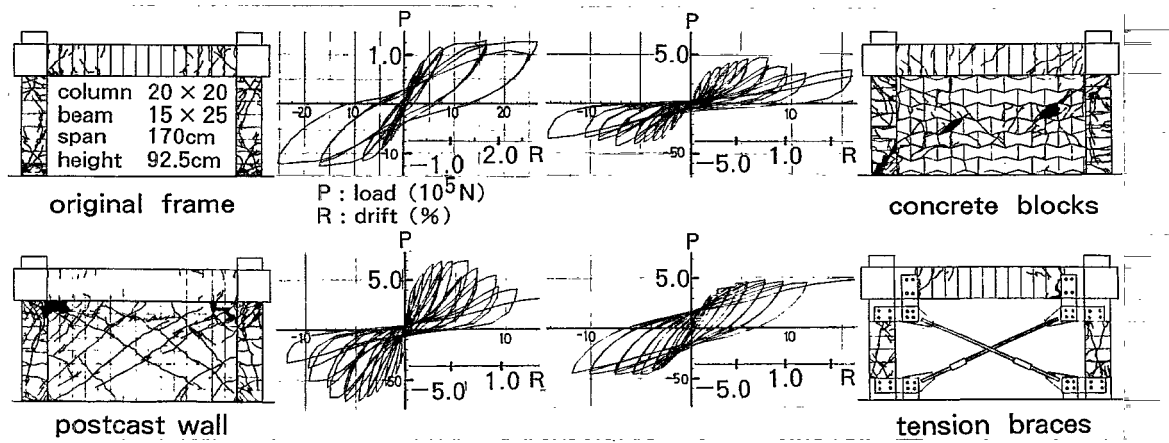
Fig. 10 Hysteretic behavior of strengthened frames with various techniques (Sugano, Fujimura 1980)

Examples of the behavior of strengthened frames with various construction techniques are shown in Fig. 10 (Sugano and Fujimura 1980). Infill wall behaved similarly to monolithic wall, though the strength was slightly less. Concrete blocks also extensively increased the strength of original frame. Tension braces provided good ductility properties while compression braces and steel panel did not develop their yield strength due to the failure of existing columns or connections. The behavior of strengthened frames with steel systems are summarized in Fig. 11 (Yamamoto 1983). Both the X and V braces and a panel with opening were capable of significantly improving not only strength but also ductility of original frame. The double K braces (Aoki 1992) also indicated significantly improved both strength and ductility of original frame. Note that even a steel peripheral frame alone could significantly improve both the strength and ductility. Another recent test of V-braces system with hinge device at the joint to the steel frame (Okada, Seki 1992) indicated significantly increased energy dissipating capability resulting from yielding of shear panel.

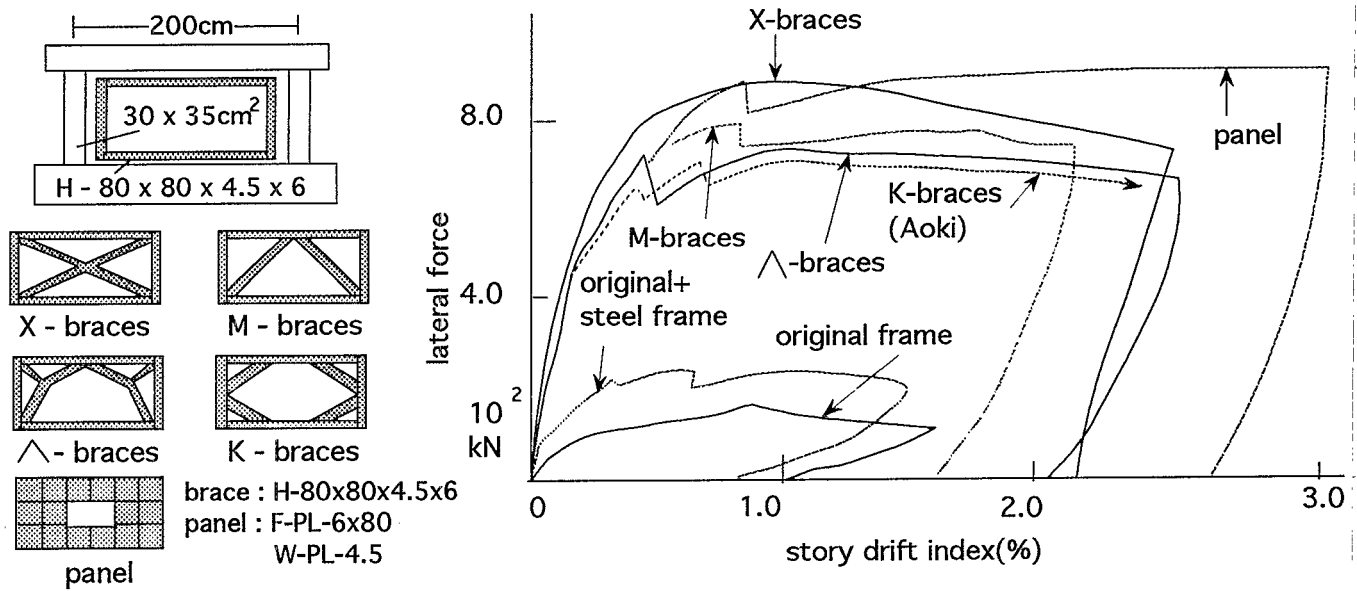
Fig. 11 Behavior of strengthened frame with steel systems (Yamamoto 1983, Aoki 1992)

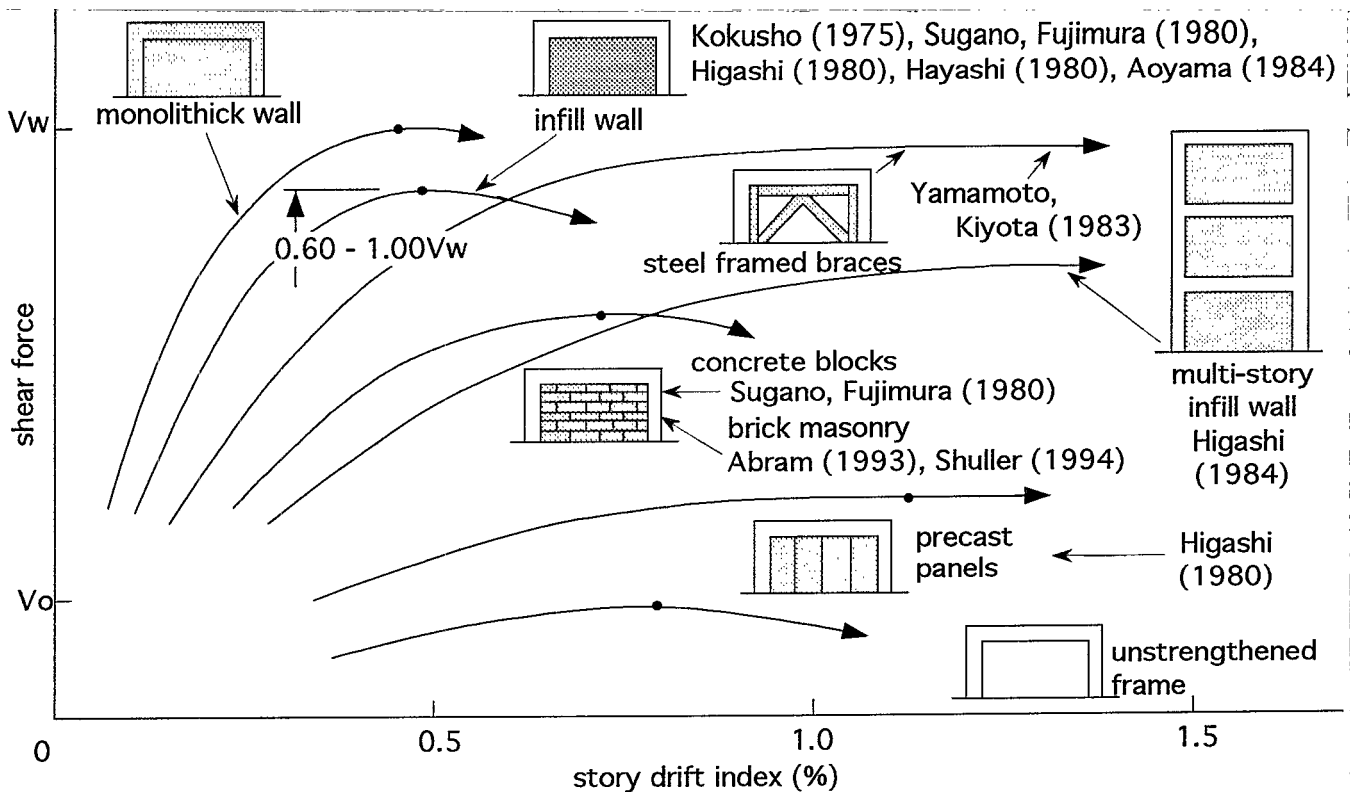
Fig. 12 Typical load-displacement relationships of strengthened frames with various techniques

Typical load-displacement relationships of strengthened frames with various construction techniques are illustrated in Fig. 12. This is only qualitative indication of the order of strength and ductility that might be attained using different techniques. The findings from the figure were summarized as follows. 1) When adequate connections were provided, infill walls exhibited almost the same strength as monolithic wall. 2) Multiple precast panels provided good ductility properties, however as expected, much less strength was attained. 3) The predominance of bending behavior in three story frame was observed in contrast to shear dominance in one-story frames. 4) Steel framed braces indicated significantly increased both strength and ductility. 5) Concrete blocks and brick masonry also significantly increased strength.

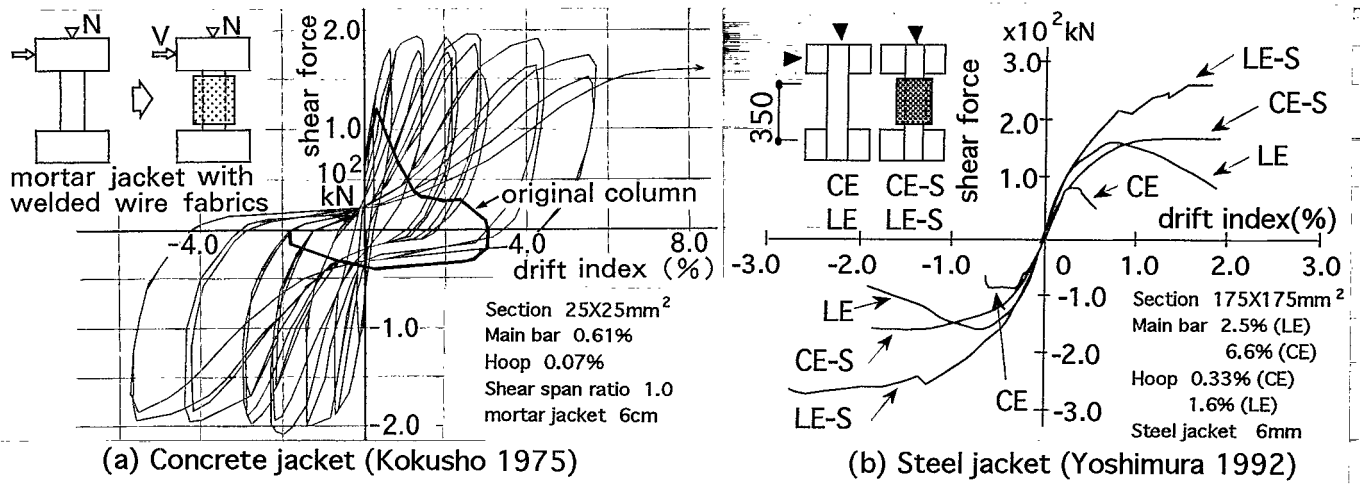
Fig. 13 Behavior of jacketed columns

Fig. 13(a) shows the dramatic improvement of ductility attained by a column using welded wire fabric wrapping and mortar (Kokusho 1975). Thick lines in the figure show the brittle failure of this type of short column that has been observed in many damaged buildings due to destructive earthquakes. Displacement ductility larger than 6 could be attained in this case. Also the significant improvement of ductility by steel encasement is shown in Fig. 13(b) for the test by Yoshimura 1992. While original columns with average and heavy reinforcement failed in shear, jacketed columns could sustain the displacement larger than 2%.

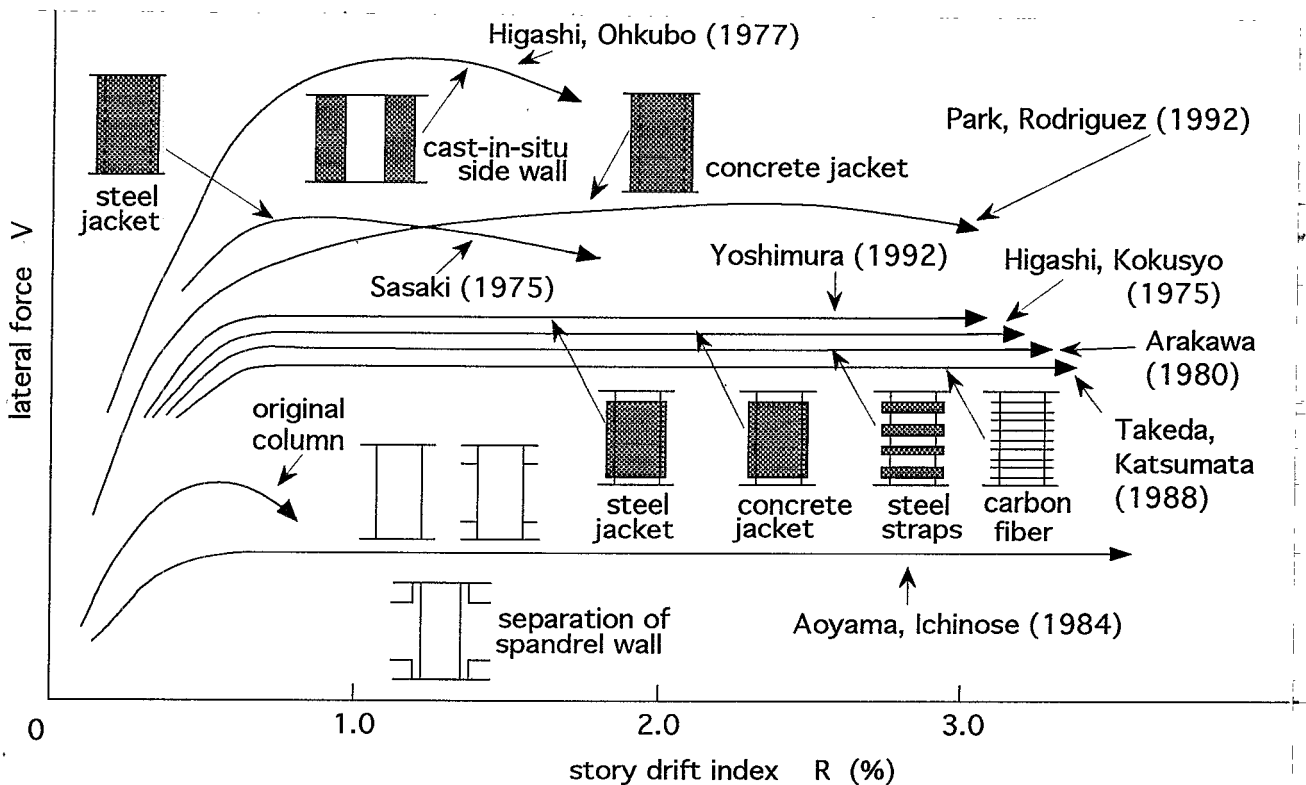
Fig. 14 Typical load-displacement relationships of columns reinforced with various techniques

Typical load-displacement relations of reinforced columns with various techniques are shown in Fig. 14. This is also qualitative indication of the order of strength and ductility that might be attained using different techniques. The findings are summarized as follows. 1) Any one of wrapping techniques to use steel encasement, concrete encasement, carbon fiber and steel straps resulted in considerable increase in ductility, 2) Columns with concrete jacket indicated significantly increased both strength and ductility. 3) Steel encasement without end gaps resulted in decrease of strength, though higher strength was obtained. 4) Separation of spandrel walls considerably increased ductility while the strength was significantly reduced.

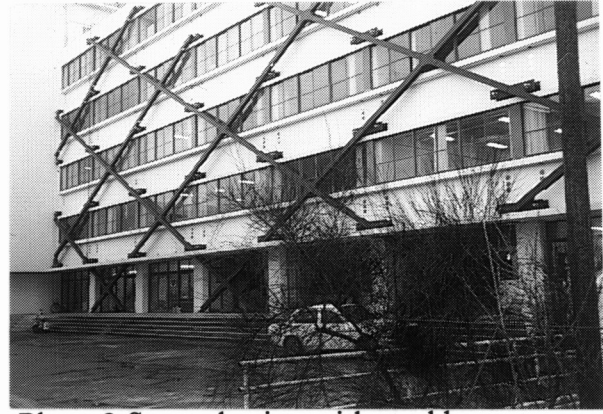
Photo 2 Strengthening with steel braces  
(after 1978 Miyagiken-oki earthquake)

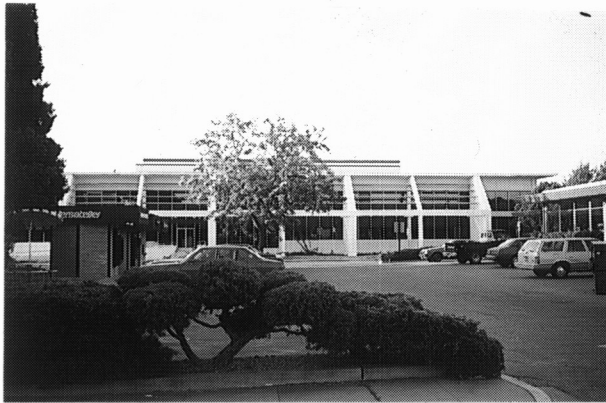
Photo 3 Strengthening with buttresses  
(after 1980 Livermore earthquake)

Buttresses were used for the building in Photo 3 damaged by the Livermore earthquake of 1980 (Freeland 1984). Sharpe 1990 reported another case of buttress strengthening for another building in the same site. The

buttress does not disturb interior building space and function, therefore, it is effective method when outer space is sufficiently provided. Photos 4 and 5 show jacketing of existing frame elements with concrete and steel straps which were seen in Mexico City after the earthquake of 1985. Because of significantly increased design seismic forces after the code revision, massive jacketing was necessary to meet the code requirements. The building in Photo 6, consisting of wooden bearing walls, was affected by the Loma Priete earthquake of 1989 and seismic isolation was adopted for rehabilitation. Friction pendulum system was used for isolation bearing.

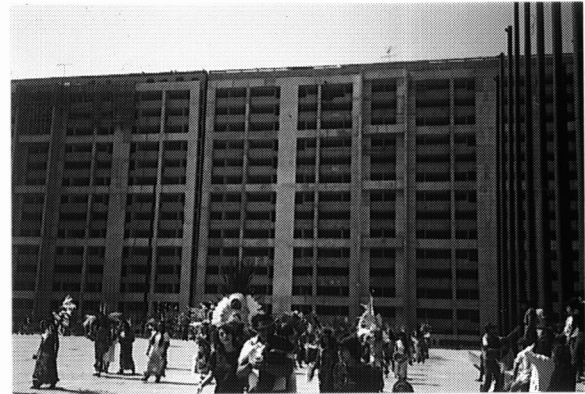
Photo 4 Concrete jacketing  
(after 1985 Mexico earthquake)

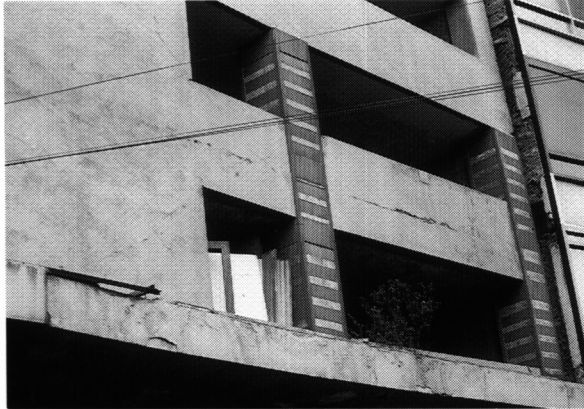
Photo 5 Steel jacketing  
(after 1985 Mexico earthquake)

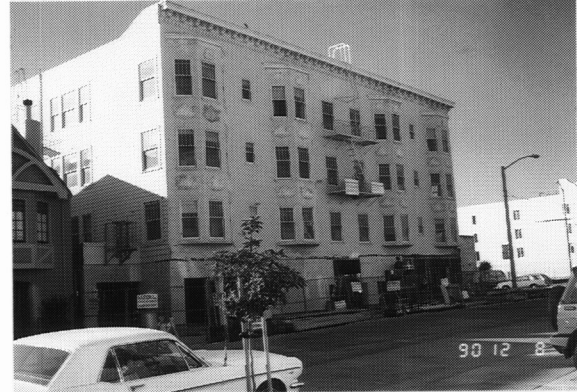
Photo 6 Rehabilitation with seismic isolation  
(after 1989 Loma Prieta earthquake)

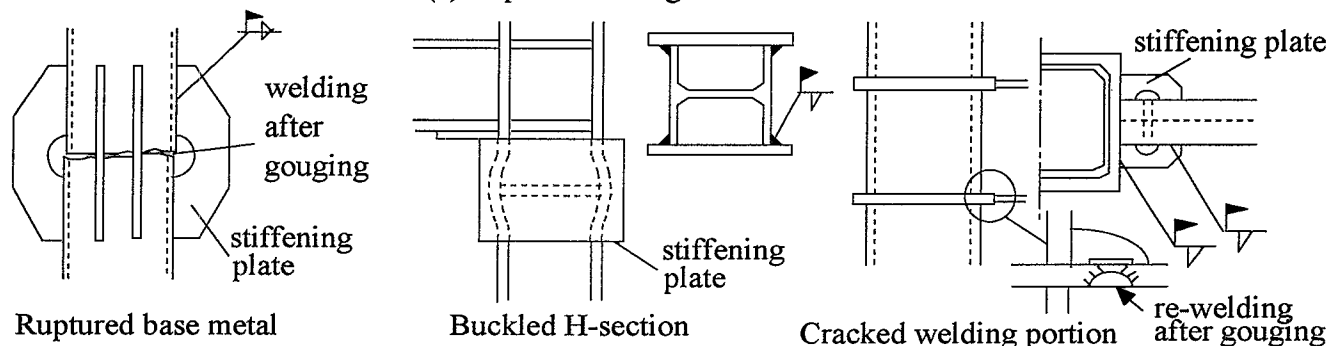
(b) Repair of damaged steel members

Fig. 15 Examples of repair techniques after 1995 Kobe Earthquake (Building Center of Japan 1995)

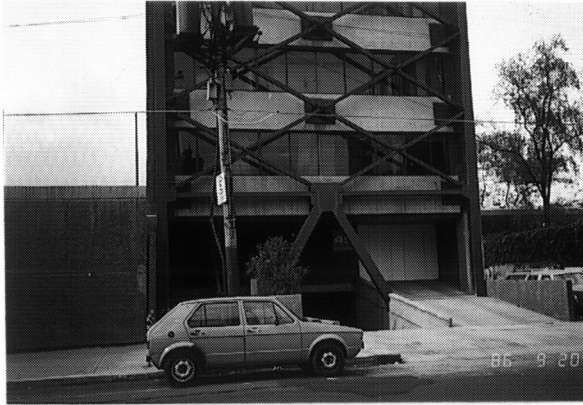
Photo 7 A rehabilitated building in Mexico City before the earthquake of 1985 (no damage)

A twelve-story reinforced concrete frame building in Mexico City was repaired and strengthened after suffering extensive damage during a moderate earthquake that shook the city in 1979 (Photo 7). The building suffered no damage during the event of 1985 even though the shaking was much greater than that in 1979. The results of forced vibration tests and analytical studies indicated that the steel braced frames that were attached to the building for strengthening stiffened the structure, shifting its natural period away from the predominant ground period of 2.0sec (Del Valle 1988). This is the case of successful rehabilitation and similar successful case with steel bracing was reported by Hjelmstad 1988.

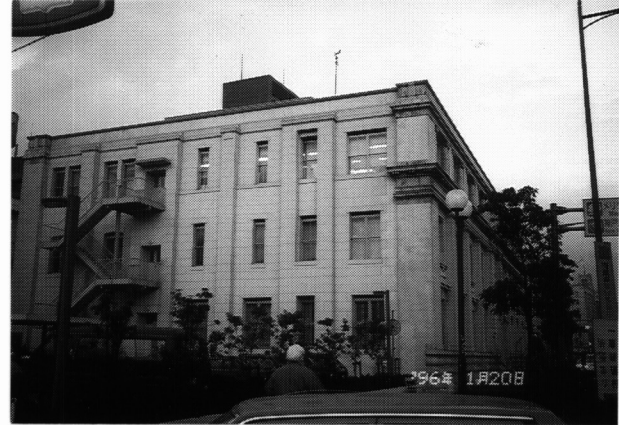
Photo 9 An old building in Kobe rehabilitated ten months before the earthquake of 1995 (no damage)

An old building in Photo 9 was constructed in 1918 in Kobe and ten month before the event of 1995, construction for seismic rehabilitation was completed. Existing brick walls were confined by new concrete frames and existing concrete frames were reinforced with new steel frames arranged along with the existing frames. As a result of the countermeasure, the building did not suffer any damage while some other historical buildings suffer severe damage in the same area. This is very encouraging case to indicate the effectiveness of preearthquake rehabilitation (Nikkei Architecture 1995).

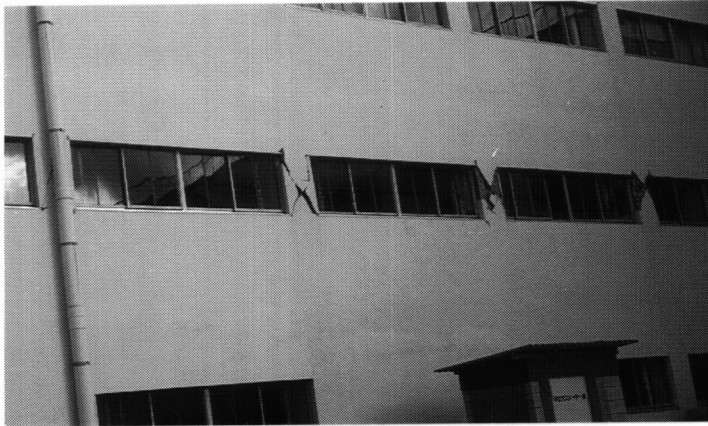
Photo 8 A rehabilitated building with concrete walls after 1968 Tokachi-oki earthquake. Unstrengthened 2nd story suffered severe damage by the earthquake of 1994

A three-story reinforced concrete building in Photo 8, which is structurally identical to the building in Photo 1, suffered severe damage to first story columns due to the earthquake of 1968. The building was rehabilitated with shear walls at the damaged first story only. Unstrengthened 2nd story columns suffered severe shear cracks due to the recent earthquake of 1994. While adjacent building in Photo 1 which were rehabilitated up to 2nd story did not suffer any severe damage. Importance of balanced configuration of strengthening elements is indicated in this case (Nakano 1995).
