EXPERIMENTAL STUDY ON MASONRY WALLS STRENGTHENED WITH STEEL AND PLASTIC STRAPS

Horacio RAMÍREZ DE ALBA¹ and B. Bricia CARREÓN GUARDADO²

SUMMARY

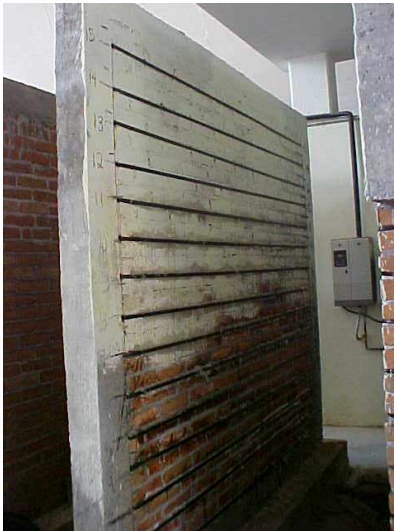
Fig. 2: Confined masonry wall

Methods TR2 and TR9 were applied on wall models 2.60 m in length and 2.30 m high. Two of the models were constructed as confined walls with reinforced concrete elements at the perimeter. The size of the confinement elements were 0.12m by 0.15m with four 10mm diameter deformed steel bars and stirrups spaced 0.25m made of 6mm plain bars, see Figure 2. The nominal yield stress of the corrugated bars was 412MPa and for plain bars 245MPa, concrete compressive strength was 24.5MPa. The other two models were constructed as non-reinforced walls. However, for the application of loads a C shape reinforced concrete element was added at the upper part of the wall with the same characteristics as in previous model, see Figure 3.
