DYNAMIC VERSUS STATIC CYCLIC TESTS OF MASONRY WALLS BEFORE AND AFTER RETROFITTING WITH GFRP

SUMMARY

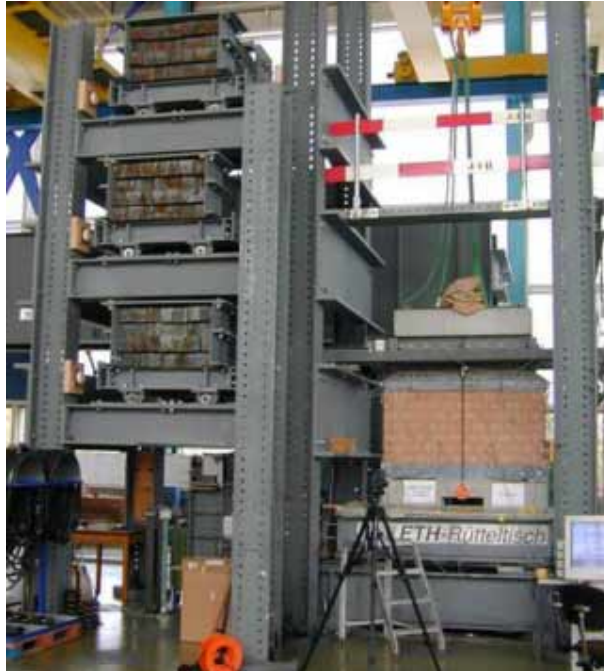
Figure 8: Retrofitted specimen ready to test in the dynamic part

The specimens were instrumented with several devices as shown in Figure 7. The displacements and deformation of the specimen were measured with linear variable displacement transducers (LVDTs). The forces in the post-tensioning bars as well as the lateral forces at the wall top were measured using load cells. During the static cyclic tests, the horizontal strains in the FRP were measured using electrical strain gages (Figure 7 (b)). In addition, for the dynamic tests, the specimen’s instrumentation included several accelerometers for vertical and horizontal acceleration. Figure 8 and Figure 9 show S1-WRAP-G-F and S2-WRAP-G-F-ST ready to test.

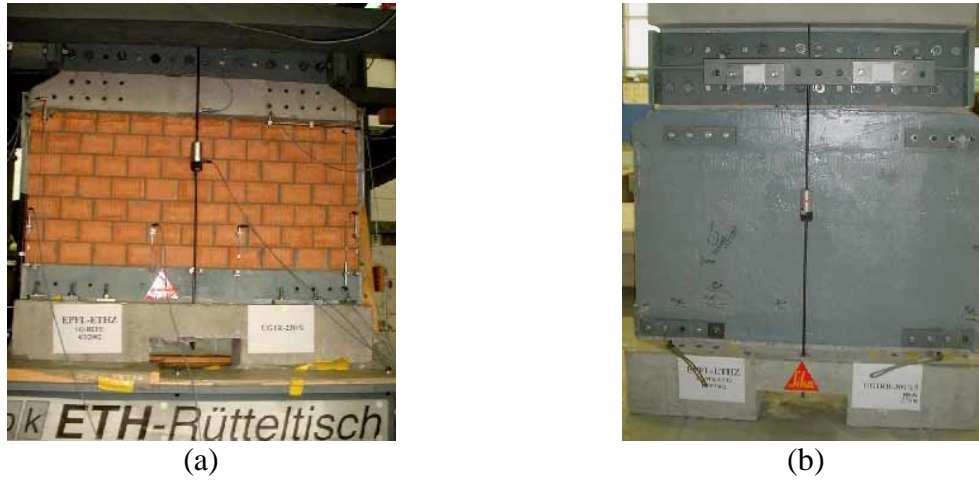
Figure 10: Specimens (a) S1-REFE and (b) S1-WRAP-G-F at the test end of the dynamic tests

Brief descriptions of the experimental results are presented in Table 2; the entire results and measurements are presented in ElGawady [5, 6]. Table 3 and Table 4 present a summary of the test procedure, the measured lateral forces, and drifts for selected test runs. Figure 10 to Figure 12 show the test specimens at the test end and during the test. These tables and figures complemented by the following comments:

- For S1-REFE (dynamic) and after test run 25, the test was interrupted in order to preserve the specimen for retrofitting and retest.
- Before S1-WRAP-G-F (dynamic) was tested as S1-WRAP-G-F, it was tested two times: first it was tested as reference specimen S1-REFE until a predefined degree of damage. It was then retrofitted with diagonal plates of carbon fiber reinforced plastic CFRP. After the specimen with the CFRP failed, the CFRP plates were taken off and a new retrofitting with GFRP was applied.

- For S1-WRAP-G-F and after test run 35, no deterioration was observed either in the composite fabrics itself or the masonry panel. The test was interrupted because the maximum force capacity of the shaking table hydraulic jack was reached.
- For S2-REFE-ST (static cyclic) and after test run 75, the specimen reached its ultimate state with heavy damage at the toes. Also, sliding was recorded.
- Prior to retrofitting of S2-REFE-ST using GFRP, new bricks replaced the damage bricks at the toes. However, the test results of S2-WRAP-G-F-ST influenced by the replacement of bricks as well as heavy damage of S2-REFE-ST.
- For S2-WRAP-G-F-ST (static cyclic) and after test runs 57 and 59, the specimen reached its ultimate state with heavy damage at the toes and GFRP tearing.

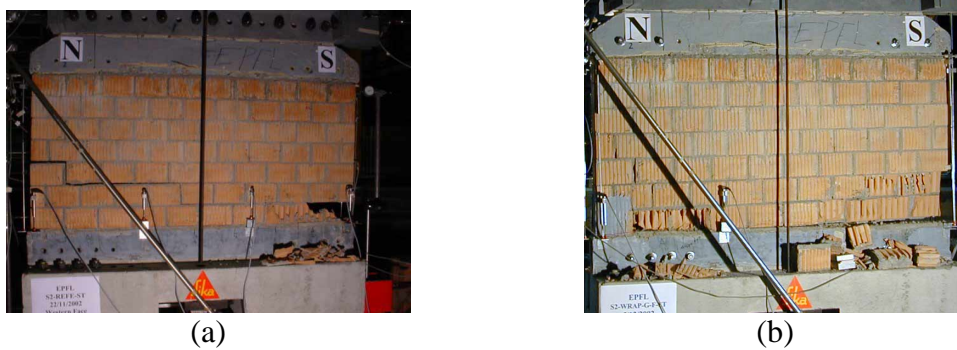
Figure 11: Specimens (a) S2-REFE-ST and (b) S2-WRAP-G-F-ST (unreinforced face) at the test end of the static cyclic tests

- The retrofitting forced a move of the “rocking crack” from 2nd and 3rd course (S2-REFE-ST) to the base of the masonry wall (S2-WRAP-G-F-ST).
- At initiation of rocking, the lateral load in S2-WRAP-G-F-ST is about 3 times that in S2-REFE-ST. However, this high improvement is a consequence of the very weak tensile strength of masonry.

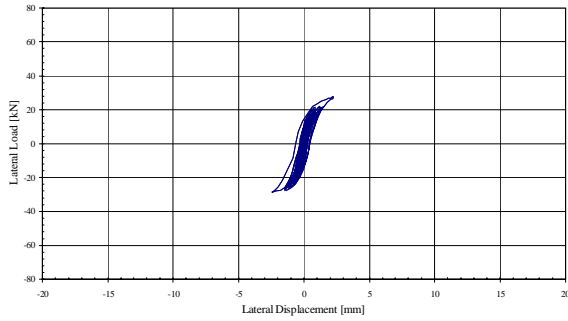
Figure 13: Lateral forces vs. relative top wall displacements for (a) S1-REFE (dynamic), (b) S2-REFE-ST (static cyclic), (c) S1-WRAP-G-F (dynamic), and (d) S2-WRAP-G-F-ST (static cyclic)

Figure 13 shows the hysteretic behavior of each test specimen. The axes are the relative horizontal displacement between the top and base of the masonry wall and the horizontal load at top of the wall. In addition, Figure 14 and Figure 15 show superposition of the backbone curves for the reference specimens and the retrofitted specimens as well as the dynamic and static cyclic tests. The following comments complete the comparison between the specimens:
