RECENT APPLICATIONS OF SEISMIC ISOLATION IN CIVIL BUILDINGS IN ARMENIA

SUMMARY

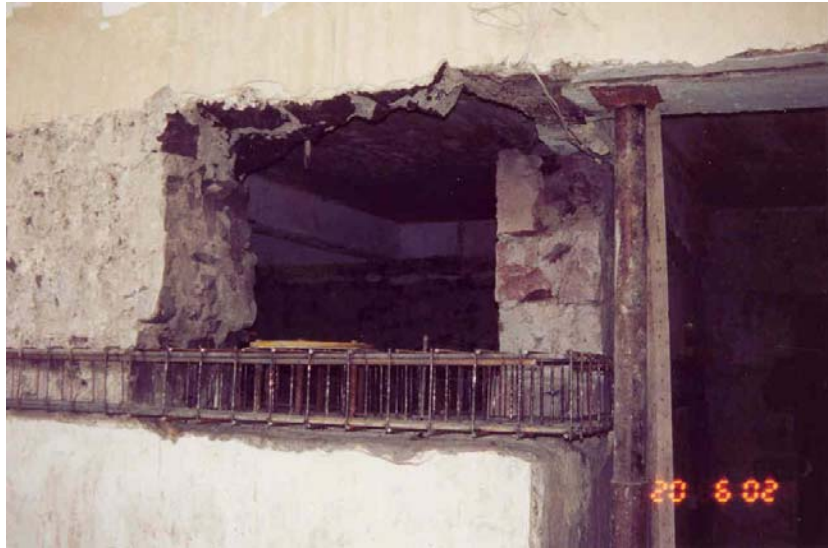
Figure 6. The view of the lower reinforcement frames installed in the opening together with the isolator socket

When the opening is made, the lower reinforcement frame of the lower pedestal with the isolator socket can be placed and after that binding reinforcement lower frames are passed along both sides of bearing wall through the frame of the lower pedestal (Fig. 6). At the next step the concrete of the lower pedestal is casted, the isolator is installed and above it the upper socket and the reinforcement frame of the upper pedestal are placed. Then the binding reinforcement upper frames are passed through the frame of the upper pedestal along both sides of existing bearing wall (Fig. 7). After casting the concrete of the upper pedestal all lower and upper pedestals should be connected to each other forming a two-stage system of R/C continuous beams (Fig. 8).

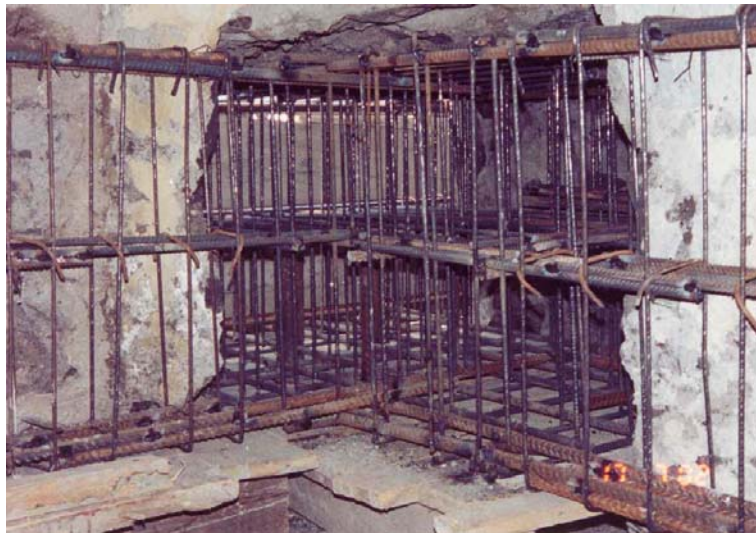
Figure 7. The view of the upper reinforcement frame installed in the opening together with the isolator upper socket after casting the concrete of the lower pedestal

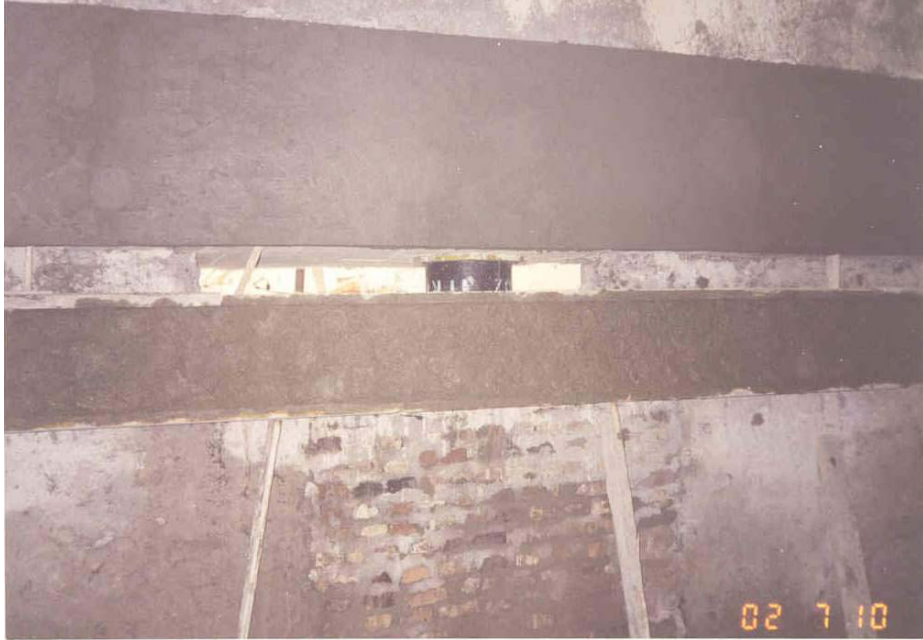
Figure 8. The view of a two-stage system of R/C continuous beams, which separate the building from its foundation and create the seismic isolation system

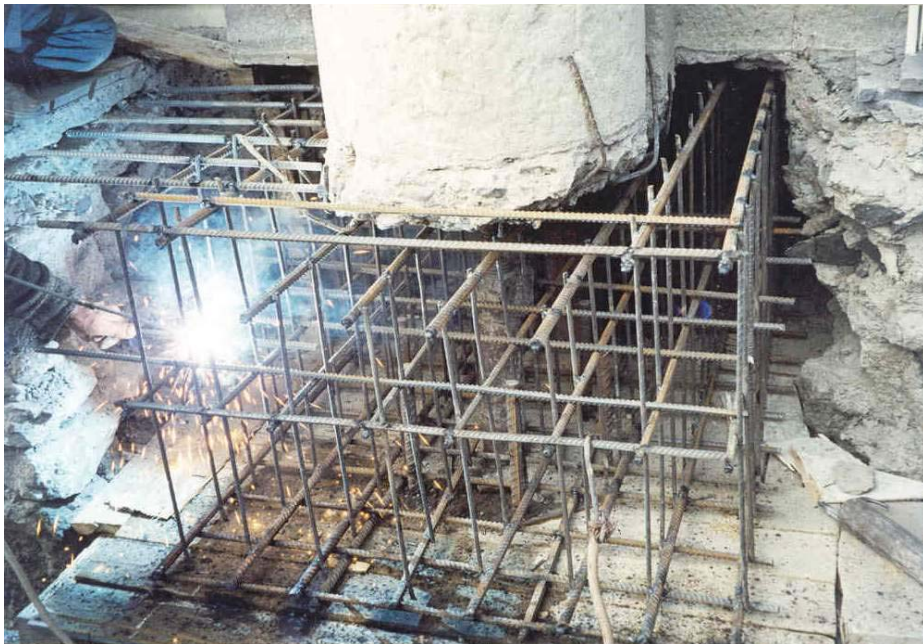
Figure 9. Existing column and the wall behind it are supported temporarily and the reinforcement frame of the upper pedestal is installed

Most complicated case is the one when the opening does not have any part of existing wall above it. For school building such cases happened at the entrance when openings should be made just beneath the columns and the arches. The opening under the column should be made gradually. With this purpose, at the beginning the part of the foundation only under the one quarter of the column section should be taken out. This will allow to install under the column a mechanical jack. In cases like this the reinforcement frames of the lower and upper pedestals cannot be prepared in advance and should be made in situ (Fig. 9).

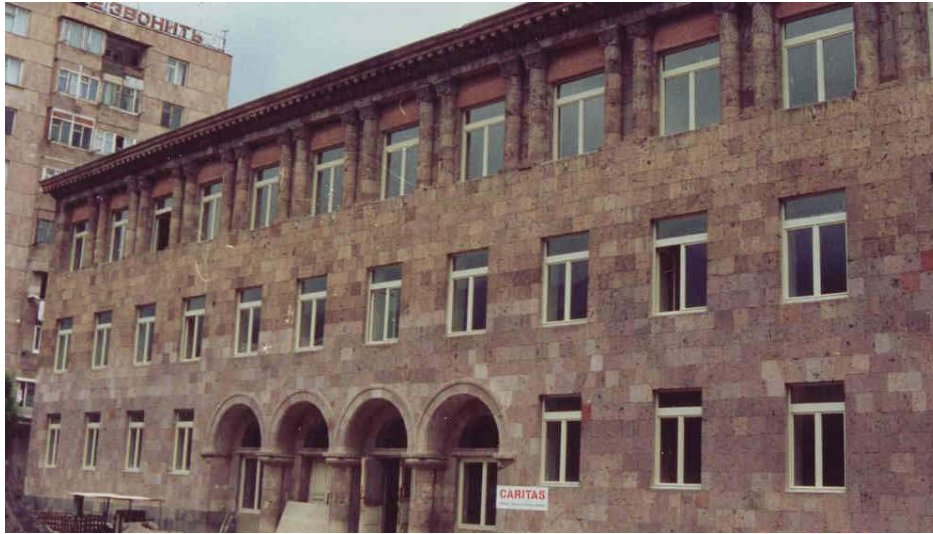
Figure 10. The general view of the retrofitted by base isolation 3-story School #4 building

During every step of implementation of such complicated cases of retrofitting it is necessary to take care of the condition of the existing structures not permitting development of any damages as these structures are part of the valuable architectural appearance of the building. The general view of the retrofitted school building is shown on Fig. 10.
