IMPACT OF THE PISCO-PERU EARTHQUAKE OF AUGUST 15TH 2007 ON HEALTH FACILITIES

J.F. Rios¹ and C.A. Zavala²

3. DETAILS OF THE DAMAGE CAUSED BY THE EARTHQUAKE IN THE INFRASTRUCTURE OF HEALTH FACILITIES

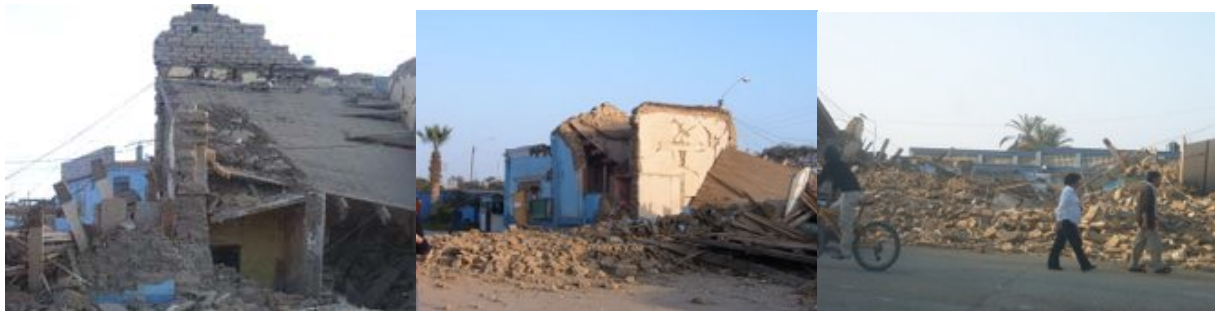
This hospital presents its main structure in severe damage and the collapse impeding normal operation. The old structures (approximately 80 years) and also the new structure (finished in 2007), which is located hyperbaric camera and central gas, are faced with severe damage and partial collapse. These can not be used. The collapsed sectors are built with adobe blocks 50 cm wide and walls of 5 metres high, without any reinforcement vertically or horizontally. Fortunately work in these blocks administrative services and file clinical history. All rooms built with adobe are unused to 100%.

As observed in various past earthquakes in Peru, usually the adobe wall constructions have light and flexible roofs so the wall's upper borders are free to vibrate. Under horizontal seismic forces perpendicular to the wall it fails by flexure. At the corners, cracks caused by negative moment and shear propagate from the upper border downward; and in the wall center, positive moment opens cracks starting in the upper free border. In long walls usually, the upper central part collapses first.

Figure 2: View of adobe buildings collapsed

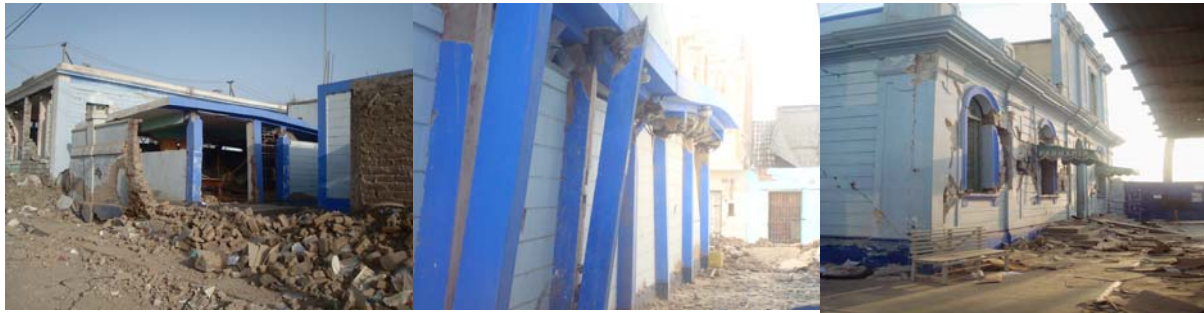
The old adobe structures presented with severe damage and partial collapse with greater possibility of collapse under the influence of replicas. These structures could not be used and would most likely be demolished. Additionally no longer be maintained without an underpinning or strengthening.

The block of two new floors presented severe damage to collapse due to the existence of short columns. The structure is not recoverable. It should be demolished.

Figure 3. Structures of adobe and reinforced concrete with very severe damage and collapse.

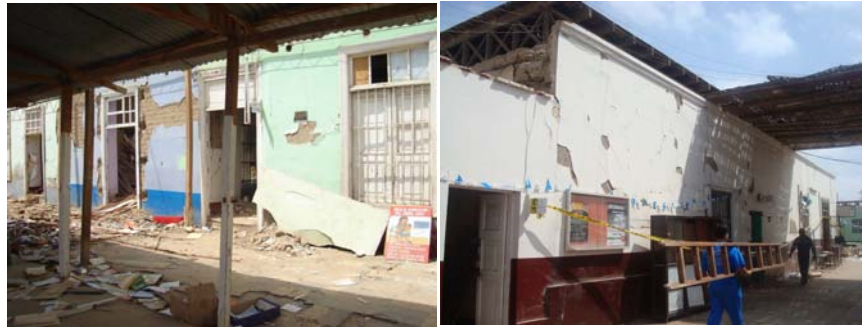
In general is uneven development of structures and spaces connectivity generating relatively complex. Adobe structures, all of a flat, except for the chapel, are severely damaged and evacuated. The services were located in these structures: Admission, Psychology, archiving, chapel, statistics, social service, deposits, physical medicine and other.

At the beginning of the century structures, a flat, with partial damage, cracking widespread average rate of soil and settlements. The structures are partially used. The services are there: Laboratories, X-Ray, Blood Bank. The damage allowed use of low occupancy.

Figure 4. Severe Damage in old buildings of the hospital
