WHY ARE EARTHQUAKES STILL SO DEVASTATING

Hans Hausammann¹

¹ *Professor, Dept. of Civil Engineering, Bern University of Applied Sciences, Burgdorf, Switzerland
Email: hans.hausammann@bfh.ch*

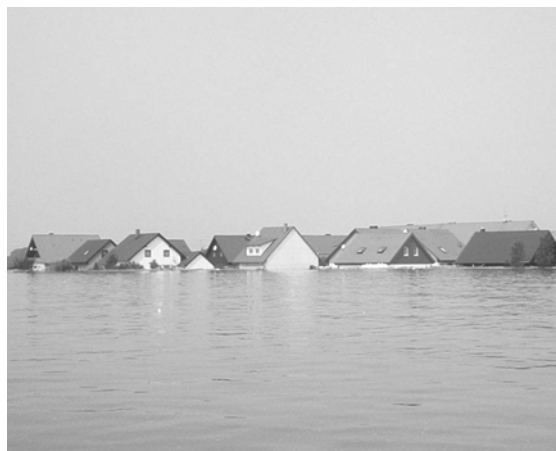
Not only individuals tend to forget hazards but also the authorities. During summer 2002 parts of Germany were flooded. A village suffering much damage was Röderau Süd. The houses were legally built in the 90's [Berliner Zeitung, 2002] and flooded in 2002. After the flooding the authorities decided to relocate the inhabitants of this village and to use the land again for farming. Authorities forget hazards!

Figure 3 Flooded village (Röderau Süd 2002)

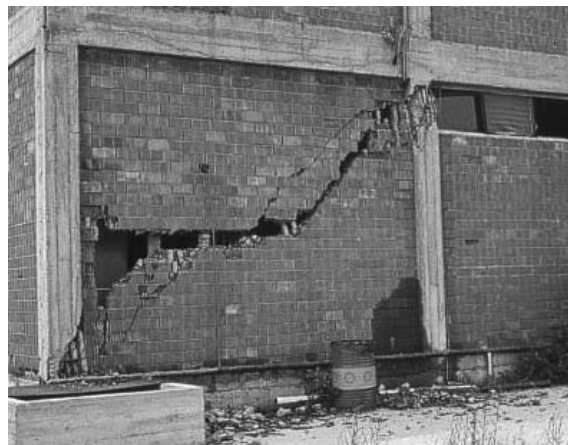
For major buildings the earthquake resistance has to be proved by numerical methods. Codes usually require numerical verifications, but conceptual and constructional measures are also very important to improve the behaviour. Simple rules can be easily understood and applied to buildings at no extra costs. However, if these rules are not understood, they can not be applied correctly. Rules are indicated in the literature e.g. [Bachmann, 2002] these rules can be applied at no significant costs. An example is shown in Figure 6.

Figure 6 Design Rule: Avoid «bracing» of frames with masonry infills [Bachmann, 2002]

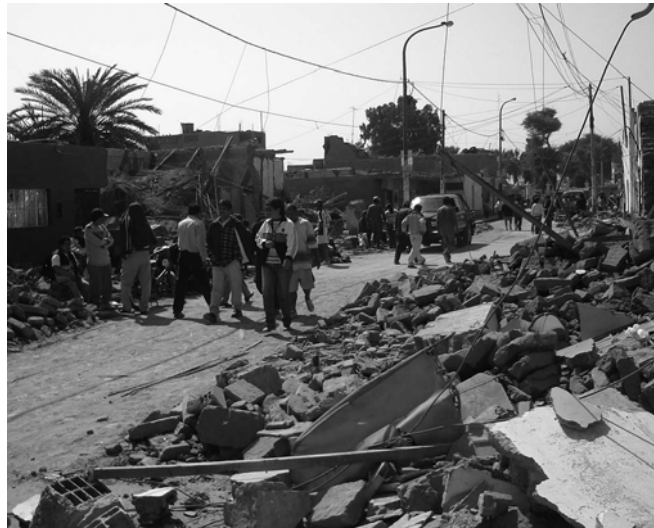
During the Peru earthquake many non-engineered structures were completely destroyed, see figure 7. Simple design rules were not applied.

Figure 7 Non-engineered structures in Pisco, Peru 2007 Earthquake

Many of these buildings had adobe walls and lightweight roofs made of timber. Buildings collapsed but did not bury the inhabitants because of the light roof. It is believed that most of these structures were not designed against earthquake actions. The Peru earthquake hit the population in the rural areas. Houses in the rural areas were mostly non-engineered constructions.
