## TORSIONAL CAPACITIES OF CAP BEAMS IN ELEVATED TRANSPORTATION STRUCTURES

This paper investigates the torsional load capacities of two reinforced concrete cap beams in the elevated guideway structures. One beam has a regular configuration and the other has an irregular configuration. For each beam type, a 1/2-scale model was tested. The failure mechanisms of both beams were dominated by torsion. The load capacity of the regular beam was governed by the yielding of the main longitudinal reinforcement induced by a truss action. The capacity of the irregular beam was governed by a torsional crack through the columns zone, which can be attributed to the lack of confinement in the region. The large spacing of the top horizontal ties in the regular beam led to vertical splitting cracks when the beam was loaded through the shear keys. Nonlinear finite element analyses have been conducted on the beams. The finite element models are able to reproduce the nonlinear behaviors observed in the tests with reasonably good accuracy. Based on the experimental observations and numerical results, strut-&-tie models have been developed to evaluate the load capacities of the beams. Both types of mode

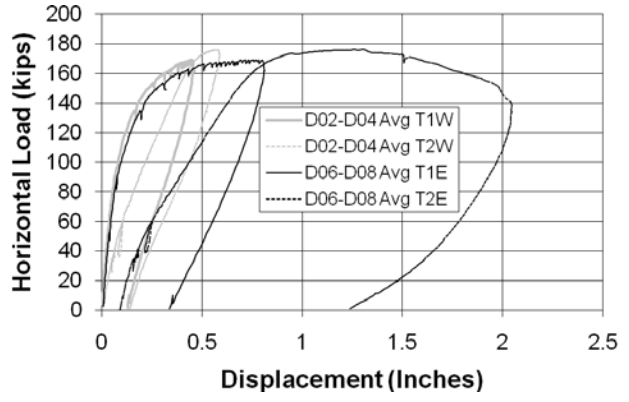
Figure 4 Horizontal load-vs.-averaged end displacement curves for the regular beam (1 in. = 25.4 mm; 1 kip = 4.45 kN)

In testing the regular beam, a vertical load of 150 kips (668 kN) was first applied on each side of the beam and maintained constant afterwards. Two horizontal load tests (T1 and T2) were conducted on this beam. The load-averaged displacement curves are shown in Fig. 4. The averaged end displacement is calculated with the readings from one top and one bottom displacement transducers to take out the rotation of the beam. In the first test, the horizontal loads were transmitted through the shear keys. The horizontal loads were applied towards south. During this test, a vertical splitting crack occurred in the beam on the east side adjacent to the shear key, limiting the capability of the shear key to carry additional load. The test was, therefore, stopped. Neoprene pads, which were 1-1/2-in. (38-mm) thick, were then inserted in the gaps between the north face of the beam and the load blocks. The beam was then tested again by pushing against its north face through the pads.

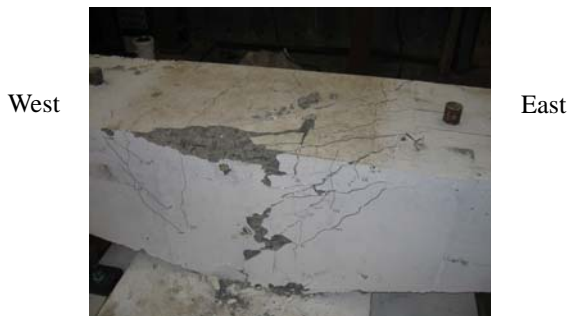
The damage of the regular beam at the final stage is shown in Fig. 5. It can be observed that the east side of the beam had the most severe damage while the west side suffered relatively light damage. In the first test (T1), diagonal torsional shear cracks were first observed on the south face at a horizontal load of 135 kips (601 kN) per actuator, and slightly inclined flexural-torsional cracks were observed in the lower part of the north face along the two sides of the column zone. A vertical splitting crack initiated on the east side of the beam at a load of 149 kips (663 kN). This crack started from an inclined torsional crack on the top face of the beam and propagated along the north edge of the steel plate for the shear key all the way to the east end of the beam. This limited the capability of the shear key to transmit any load beyond 169 kips (752 kN).

Figure 5 Damage in the regular beam

In the second test, the horizontal loads were transmitted through neoprene pads that filled the gaps between the north face of the beam and the load blocks. In this test, severe torsional cracks developed. The crack pattern in Fig. 5 shows the development of compression struts in a truss mechanism. This induced tension in the main longitudinal reinforcement as indicated by the measured strains. The maximum load reached in this test was 176 kips (783 kN). Because of the short span length of the beam, the inclined torsional cracks propagated into the column zone. Hence, the spiral confinement that extended into the column zone should have contributed to the torsional resistance of the beam.

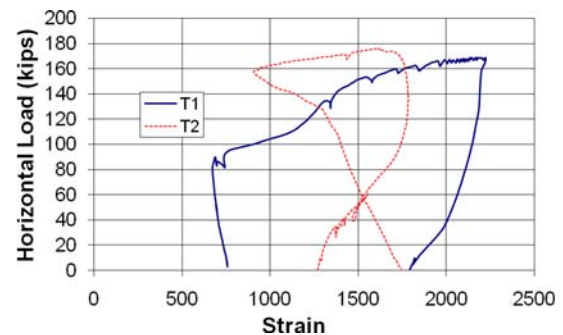
Figure 6 Horizontal load vs. bar btrain (in micro-strain) from gage ST3B in the regular beam (1 kip = 4.45 kN)

Figure 6 shows a plot of the horizontal load vs. the strain measured by Gage ST3B, which was located on the east side close to the south face of the beam. The horizontal load acted towards south. It can be noted that the bar had an initial tensile strain of about 0.0008 in the first test (T1), which was induced by the 150-kip (668-kN) vertical load. As the horizontal load increased, the tensile strain decreased at the beginning due to bending until a horizontal load of about 80 kips (356 kN) was reached. Beyond 80 kips (356 kN), the trend was reversed and the tensile strain increased with the horizontal load due to a truss mechanism. The bar barely reached yield at 169 kips (752 kN) and the residual strain after the removal of the horizontal load was about 0.0018. In the

second test (T2), the initial tensile strain was about 0.0013 and it increased with the horizontal load until a load of about 130 kips (579 kN) was reached. After this, the tensile strain started to decrease as the bending action began to dominate, probably due to the loss of the compression strut action. The decrease in tensile strain accelerated after the peak load of 176 kips (783 kN) was passed.

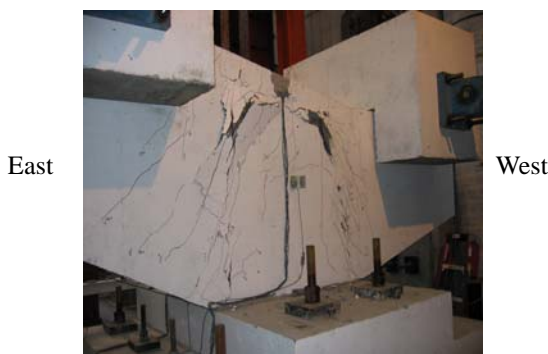
The damage of the irregular beam induced by the horizontal displacement cycles is shown in Fig. 7. When loaded towards south, vertical cracks first developed in the column zone and some slightly inclined flexural-torsional cracks developed in the lower part of the north face, and a diagonal torsional crack developed on the south face of the west side of the beam at about 166 kips. At about 170 kips (757 kN), a more or less horizontal crack developed in the column zone on the north face right at the elevation where the vertical steel was terminated, as shown in Fig. 8. After the development of this crack, the south face of the column zone tended to rotate more than the north face as the beam was pushed further towards south. This is very likely due to the development of a vertical or inclined crack plane in the column zone separating the region into two portions. However, the load continued to increase to a peak of 180 kips (801 kN). At this point, cracks on the south face were very minor. After the peak load, the horizontal crack on the north face was joined by the flexural-torsional cracks from the bottom and some concrete spalling was observed as shown in Fig. 8.

Figure 7 Damage in the irregular beam

For the irregular beam, the numerical results also match the test results reasonably well. Figure 10 shows the deformed mesh of the finite element model, which has a similar damage pattern as that observed in the test (see Fig. 7).

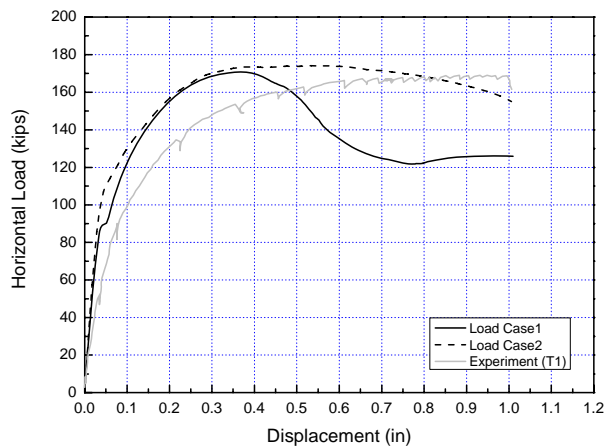
Figure 9 shows the plots of the horizontal load vs. horizontal displacement at the east end of the regular beam for both load cases. The numerical result for Load Case 1 shows a significant drop of load resistance after the peak. This is accompanied by the yielding of the top transverse ties and tensile splitting cracks occurring along the edges of the steel plates. This resembles what that is observed in the test.

Figure 9 Horizontal load-vs.-displacement at the top of the east end of the regular beam (1 in. = 25.4 mm; 1 kip = 4.45 kN)

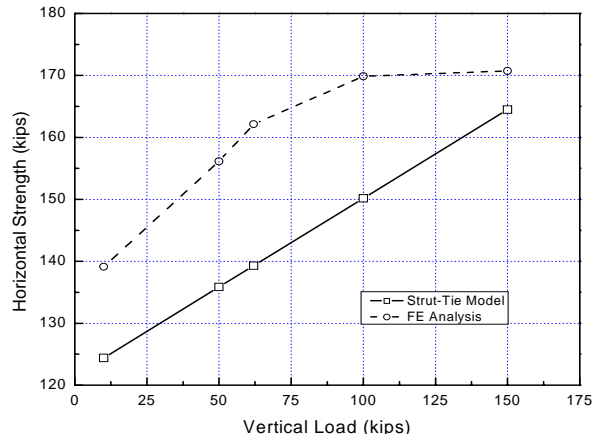
Figure 12 Influence of vertical load on the horizontal resistance for the regular beam (1 kip = 4.45 kN)

In actual structures, the vertical loads exerted on a cap beam may vary depending on the live-load condition. A study is conducted to examine the influence of the vertical load on the horizontal load capacities of the cap beams using the finite element and strut-&-tie models. The results obtained for the regular beam are shown in Fig. 12. Similar influence has been observed for the irregular beam. In both cases, the horizontal load capacities increase with the vertical load.

In the test, a 150-kip (668-kN) vertical load was applied on each side of the regular beam. This is 20% higher than the maximum expected dead and live loads. However, a cap beam could be subjected to the weight of the girders alone. The dead load due to the girders is estimated to be 62 kips (276 kN) for the 1/2-scale model. As shown by the finite element analysis results in Fig. 12, the horizontal load capacity of the regular beam will drop from 170 to 162 kips (757 to 721 kN) when the vertical load is reduced from 150 to 62 kips (668 to 276 kN). For the irregular beam, the dead load of the girders is estimated to be 86 kips (383 kN) while that applied in the test is 175 kips (779 kN). When the vertical load is reduced from 175 to 86 kips (779 to 383 kN), the horizontal load capacity on the west side (which is the weak side) will drop from 180 to 151 kips (801 to 672 kN) according to the finite element model. The strengths calculated with the strut-&-tie models are even lower. According to the strut-&-tie models, the horizontal load capacity of the regular beam is governed by the tensile yielding of the bottom longitudinal ties while that of the irregular beam is also influenced by the yielding of the middle vertical ties adjacent to the column zone. In either situation, the vertical loads tend to lower the force demands in these ties, and thereby, increase the horizontal load capacities.
