INTERLOCKING BLOCK INFILL CAPABLE OF RESISTING OUT-OF-PLANE LOADS

ABSTRACT :

KEYWORDS: experimental study, masonry, reinforced concrete, seismic performance, seismic retrofit

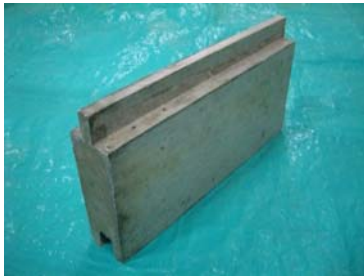
Figure 1 Prototype of interlocking block capable of resisting out-of-plane loads

Our previous study [Sanada et al., 2006] concluded that masonry structures could be seismically enhanced using interlocking blocks. In this study, although the interlocking mechanism was applied only to improve the in-plane performance of masonry walls, it seemed to be effective for out-of-plane performance. Therefore, in this study, a new interlocking block, capable of resisting out-of-plane loads, was designed as a prototype, as shown in Figure 1.

The interlocking mechanism between blocks illustrated in Figure 1 is effective only for out-of-plane loads. On the other hand, bond and friction between blocks contribute as lateral resistance for in-plane loads. Therefore, the in-plane lateral strength of a stand-alone wall made of this block is expected to be very low, in particular, under low axial loads. According to our past study [Choi et al., 2005], however, unreinforced concrete block infills, installed into reinforced concrete frames, could contribute to enhance in-plane strength of frames, although axial loads hardly acted on post-installed infills. This was due to an inclined compression strut forming in the panel when the infill was subjected to shear deformation by the surrounding frame, as illustrated in Figure 2. In this study, focusing on this interaction effect, the blocks presented were planned to apply to post-installed infills so that the structures could exhibit relatively high in-plane lateral strength. Moreover, they were also expected to support axial loads after their surrounding frames failed.

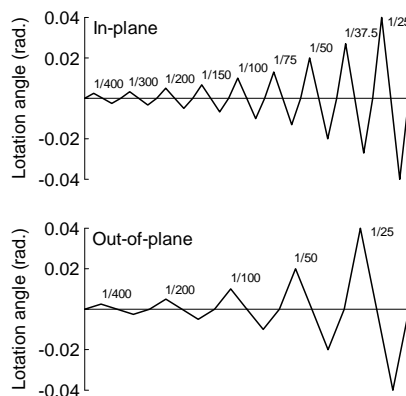
Figure 7 Loading histories

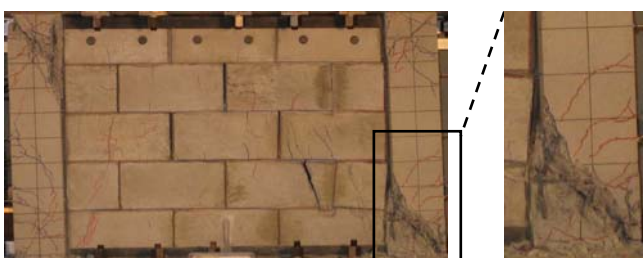
Photo 2 Damage to I-Frame (R) after in-plane loading

the I-Frame (R) followed by in-plane loading. Photo 2 shows the I-Frame (R) after in-plane loading, which indicates that the columns seemed to have been lost their axial resistance. Figure 14 shows the relationship between lateral force and top drift in the out-of-plane direction. The specimen could exhibit stable hysteresis loops as well as sufficient axial support throughout out-of-plane loading.
