EARTHQUAKE ANALYSIS AND STRENGTHENING OF THE HISTORICAL MEHMET AGA MOSQUE IN ISTANBUL

Y.H. Gedik¹ and Z. Celep²

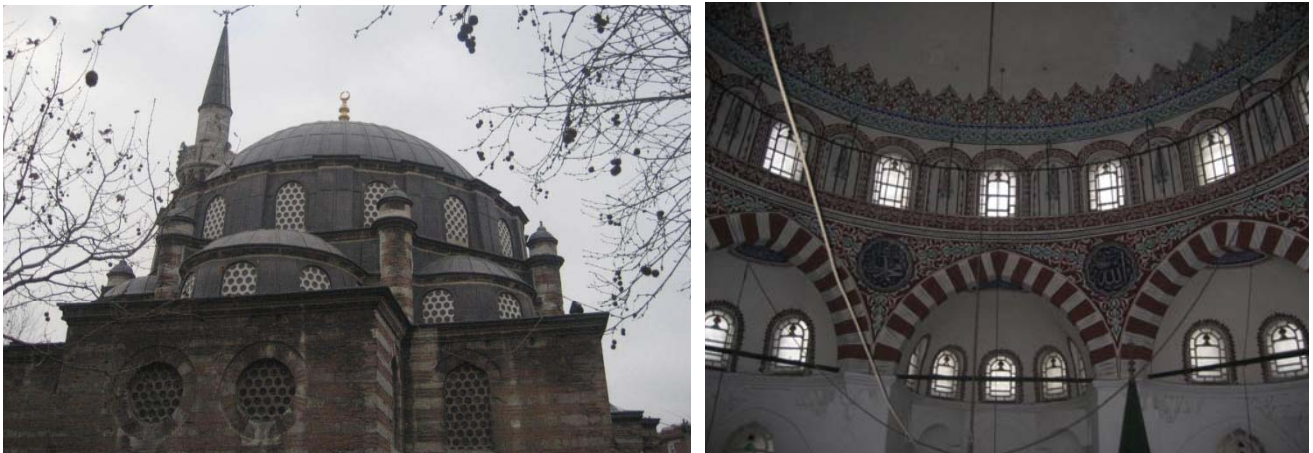
Figure 1 Exterior and interior view of the mosque

The mosque was constructed in 1585 by Architect Davud Aga, who is a student of the great Ottoman Architect Sinan. It was commissioned by Mehmet Aga. The building has been used ever since. The mosque has a main area of square shape in plan. The main area is covered by a main dome having a height of 17.3 m and a diameter of 11 m. There are pendentives and tromps as secondary components for covering the mosque. The main dome

is supported by four pilasters and by four corners of the external walls. There is a wooden balcony having a height of 2.8 m inside the mosque. The external walls of the historical building consist of one stone row alternated with three brick rows having an average thickness of 1.3 m. The main dome is made of brick. The cloister of the mosque consists of five parts which are covered by five small domes. The domes are supported by the six marble columns. All arches of the mosque have iron lateral ties. The mosque has a minaret having a height of 29 m and it is made of ashlar. There are still original nice ceramics, beautiful calligraphies and handicrafts on the walls; however most of them were changed (Figure 1 and 2).

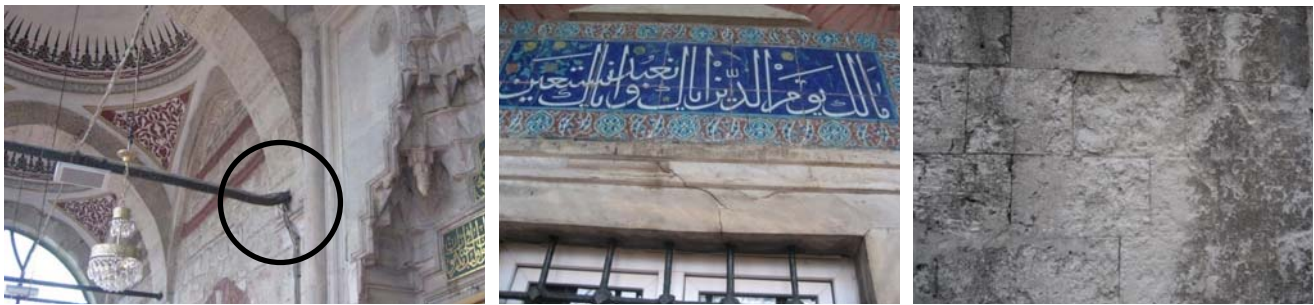
Figure 3 Observed damages

The mosque has experienced several earthquakes including the great earthquakes of 1766, 1894 and 1999. It was repaired in 1743 and restored in 1982 (Branch of Fatih of P.R.A., 1991). Moreover, the mosque is still in service and regular maintenance works for the building has been done continuously. Consequently, the damages of the past earthquakes could not be identified easily by simple in situ investigations. In addition, no damage originating from the soil is observed. Damages appear at the edges of window openings as cracks. Some ashlar of the cloister are deteriorated. One of the tromps has slight radial cracks and damages. Buckling and corrosion are observed in several iron ties of the arches (Figure 3).

As it mentioned above, stress concentrations occur at the corners, around the openings of the walls, which support of the main dome, under the self weight and the earthquake loading. These stress concentrations around the openings may explain the cracks that are observed in situ investigations. The maximum normal stress in the structure is around 2 MPa both in tension and compression. The maximum normal stresses in the ties of the arches under the design earthquake loading are around 44 MPa in compression and 80 MPa in tension. Existing buckling damages at the iron ties indicate that the ties are overstressed. The maximum compressive stress along meridians of the main dome appears to be about 0.3 MPa where the maximum circumferential tensile stress is over 0.35 MPa on the lower part of the main dome. Stress concentrations are formed on the pendentives and around the openings in the tromps, pendentives and drums as well (Figure 8). The maximum soil settlement was obtained as 2 cm under the design earthquake loading and the self-weight, it increases up to 2.8 cm for the maximum earthquake loading.

stress concentrations occur at the corners, around the openings of the wall, which support the main dome. This finding may explain why the edges of the openings have small cracks. Existing buckling damages at the iron ties of the arches may be explained by the existence of larger compressive stresses under the self-weight and the earthquake loadings. These iron ties may be replaced by the new ones as a simple repair intervention. The maximum stress varies around 2 MPa in the structure both in tension and in compression. Especially, tensile stress of 2 MPa is very high value for this type of masonry structures. However, it is believed that there are wooden lintels and iron elements and other connection components within the structural walls that are used to resist the tensile stresses and to provide the structural integrity for this type of historical structures. It is the most probably why there is no damage in these parts, although high tensile stresses are expected.

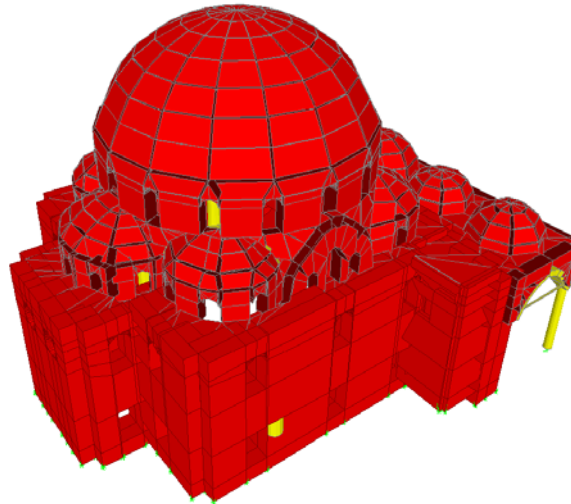
Figure 4 Structural analysis model

Micro and macro modeling strategies for masonry structures exist due to various accuracy level of the analysis. Macro modeling is better in case of necessity compromising between efficiency and accuracy and it is used when the building has solid walls with large dimensions (Lourenco, 2002). Thus, the mosque was assumed to be made of a unified material that has an elastic modulus $E = 2 \text{ GPa}$, a unit weight $\gamma = 20 \text{ kN/m}^3$ and Poisson's ratio $\nu = 0.2$. These values were determined by literature survey and by comparing the properties with similar type structures which belong to the same era. The three-dimensional analysis model is developed by using SAP2000 structural analysis software (Habibullah and Wilson, 1998) and architectural plans and sections of the mosque, which are drawn in AutoCAD format. Three different types of elements are used for preparing the analysis model. The external masonry walls were modeled by three-dimensional solid elements, whereas two-dimensional shell elements are used for modeling the domes, tromps, thick arches and pendentives. Pilasters, thin arches and iron ties were modeled by frame elements. Totally, 2418 solid, 1530 shell and 201

frame elements were used for the analysis model (Figure 4). It is important to use reasonable number of finite elements to obtain response of the structure having acceptable level of accuracy. Using large number of elements may yield results where the global behavior of the building can be difficult to extract. However, the very small number of elements is generally not able to capture the behavior of the building with efficient level of accuracy. Various minor simplifications are carried out in order to avoid geometrical complexity of the structure and the number of the finite elements is kept at a minimum level as possible. However, it is elaborated for obtaining the response of the structure with a reasonable accuracy.
