EXPERIMENTAL STUDY OF A ONE SIDE MASONRY WALL REHABILITATION DESIGN FOR EARTHQUAKE DAMAGED BUILDINGS

KEYWORDS: Infill, Masonry, Rehabilitation.

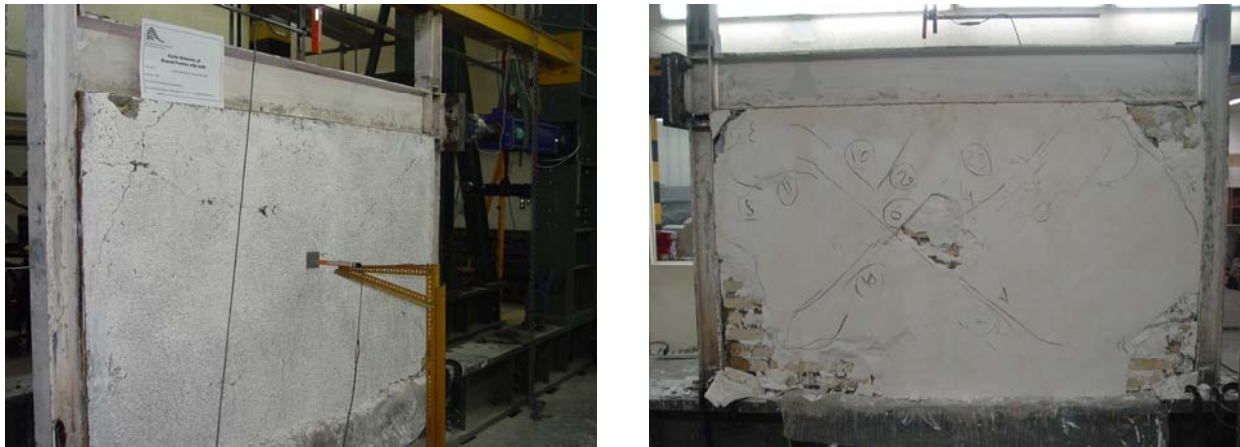
Figure 3 Crack developments on each of the two sides

After the preparation and control of measurement equipment, it was the time of loading the specimen. Since there was no gap between the wall and the frame, the load rate increased rapidly. At the first step, with the displacement of 4 mm, the force of 12 ton exerted which in the following steps increased to 22 and 26 ton and then remained constant. After the wall failure in the displacement of 28 mm, the experiment stopped. But for further examination of more destructive effects, the loading started after a short pause and finally the displacement of 44 mm was reached for the specimen. The corners and angles were cracked first, and then it expanded to the centre and diameters. Figure 3 shows stage of cracking process. Because of the excess of deformation, the joints were damaged and some of the welding lines were failure. But there was no deficiency on experiment time.

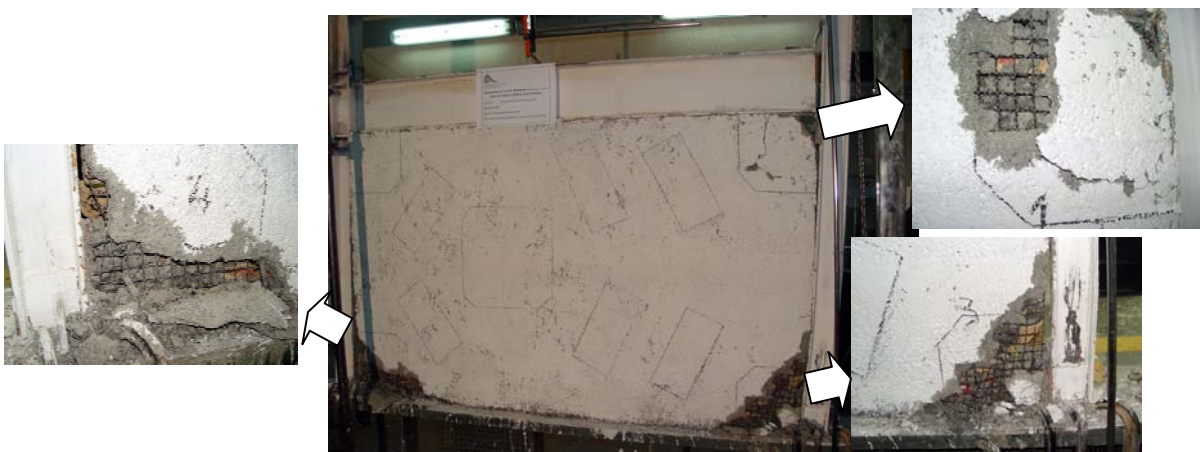
Figure 6 Retrofit side of the wall after test

As the load increased, first, some cracks at the lower corners of the wall appeared at the joints 3 and 4, then at the upper corners, the joint 1, then, it expanded to the other parts. So during the sixth cyclic of the loading, the lower corner of joint 1 broke. Moreover, joint 3, was damaged extensively that causes the crushing of column at that part, also joint 4 failed. Finally, the experiment was finished with applied displacement and the retrofitted side of the wall had only some cracks at the three corners. There were no cracks neither in the diameters nor in the damaged crack track (Figure 6).

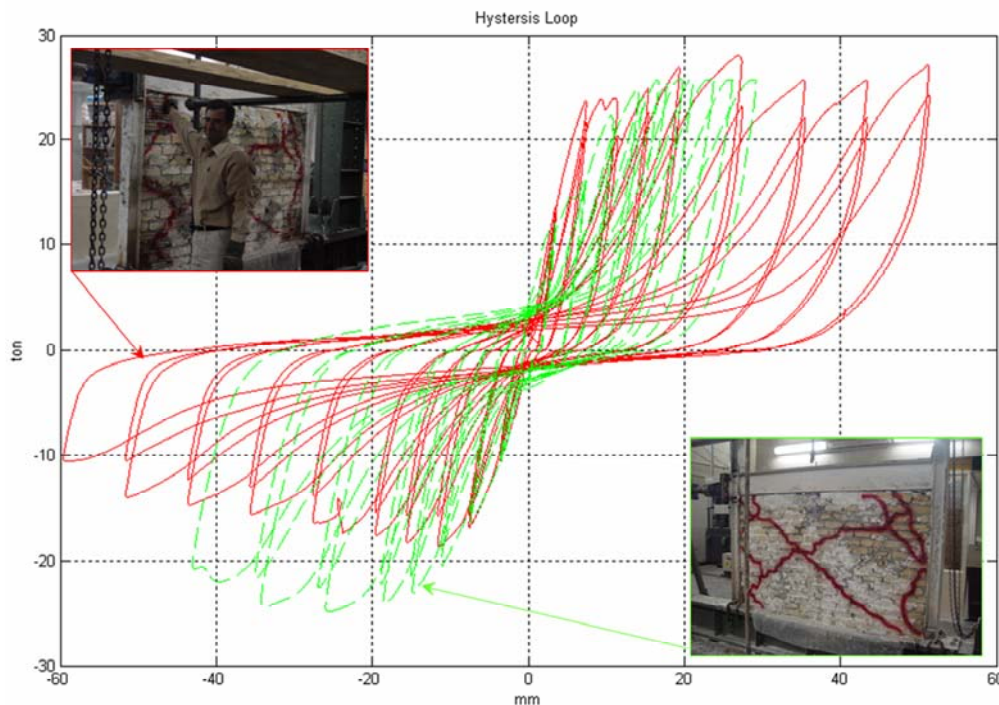
Figure 8 The comparison of the hysteresis curves of both experiments

The comparison of the hysteresis curves of both experiments is shown in Figure 8.

It is concluded that this local retrofit technique restores 90 percent of the characteristics of a cracked wall. While, in this project, the common materials with preliminary equipment with the minimum thickness were applied only to one side of the damaged infill, this local retrofit project shows promising results and is practical and efficient in reducing future damage.
