STUDY ON PSEUDOSTATIC TEST OF FRAME-SUPPORTED MULTI-RIBBED SLAB STRUCTURE

ABSTRACT:

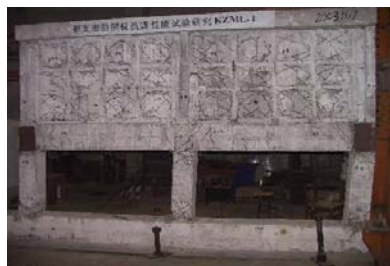
Failure phenomena of the specimens are shown in Figure 6~9. The failure modes of the specimens presented shearing failure characteristic. Under low cyclic loadings, for specimen KZML-1, at initial stages of loading, infilled silicate bricks of multi-ribbed wall slab appeared several slight cracks; loading to metaphase, the cracks of infilled silicate bricks increased markedly, and extended to reinforced concrete rib beams and rib columns; continuing loading, there is a small cracking and slipping between interface of the wall and trimmer beam; loading to yielding of the specimen, interface of the wall and trimmer beam arose big cracking and apparent slipping; after entering cycles loading of displacement control, infilled silicate bricks desquamated slightly in the seaming, failure of specimen KZML-1 mainly took place in the bottom frame post, occurring of post root plasticity hinge brought on serious deformation resulting in specimen not being continued loading. Failure of specimen KZML-2, KZML-3 and KZML-4 mainly concentrated on second storey (multi-ribbed slab structure storey) while damage of frame-supported post was slight, trimmer beam showed shearing failure of beam end; failure procedure of second storey wall took place in the order of infilled silicate bricks, reinforced concrete rib beams, reinforced concrete rib columns, and outer frame cracking until the infilled silicate bricks desquamated in a big area, the wall degenerated into small frame, end of numerous rib beams came into being plasticity hinges, and local concrete of outer frame post root was crushed partly.

Figure 6 Failure phenomena of KZML-1

Although the failure of specimen KZML-1 is mainly because of occurring of bottom frame post root plasticity hinge bringing on serious deformation not being loading, but the structure did not collapsed. During later big displacement cycles loading stage, though infilled silicate bricks of second storey wall of specimen KZML-2, KZML-3, and KZML-4 desquamated in a big area, steel bars of rib beams yielded, and second storey multi-ribbed wall slab degenerated into beam-hinged frame only being composed of inner frame (made up of rib beams and rib columns) and outer frame, the specimens could still bear vertical load, did not arise collapsed, and displayed ductility failure characteristic.

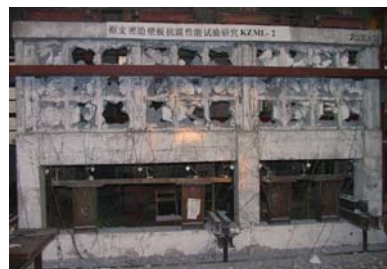
Figure 7 Failure phenomena of KZML-2

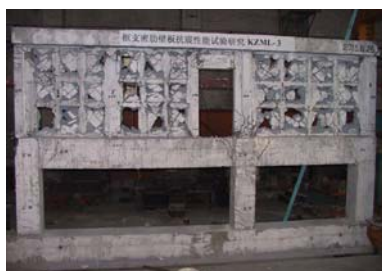
Figure 8 Failure phenomena of KZML-3

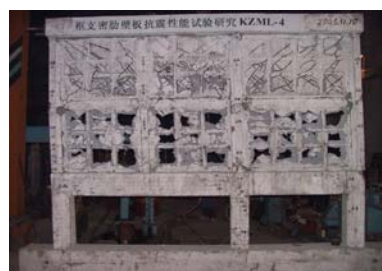
Figure 9 Failure phenomena of KZML-4

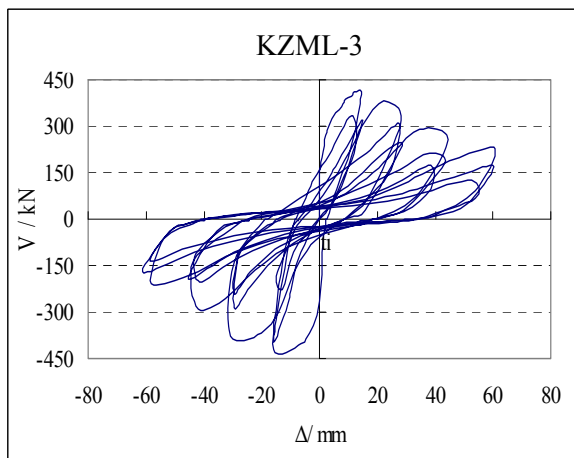
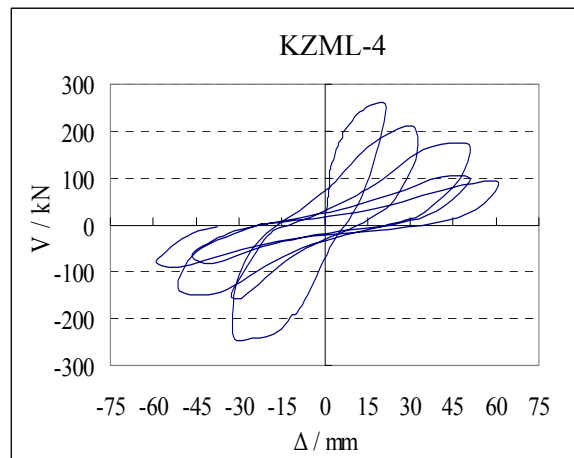
Figure 10 Hysteresis curves of the specimens

The hysteresis curves of the specimen KZML-2, KZML-3 and KZML-4 show some characteristics as follows (shown in Figure 10(b) (c) (d)): Before cracking of the wall, hysteresis curves appear approximately beeline, remainder deformation of the specimens is small, while specimens are basically in the elastic state; after cracking of the wall, the hysteresis curves appear shuttle shape, stiffness of the walls decline, but the bearing capacity of the specimen continues to increase, area of hysteresis loop gradually enlarges, lateral deformation increases rapidly, around ultimate loads hysteresis loop is plump; along with increasing of horizontal loads, cracking of the specimen multiplies, elongates, widens, and stiffness decays, after unloading remainder deformation of the specimens is apparent; over ultimate loads, hysteresis loop displays obvious slip pinching and appears arc since at this time inside the specimen cracks have widened, and after unloading stiffness of being opposite to loading can be represented only in the positive cracks have closed; as arriving at ultimate displacement, slip-pinching effect of hysteresis loop is more prominent, hysteresis loop appears reverse “s”, reflecting that shearing-slip of the specimen is big. As stated above, frame-supported multi-ribbed slab structure has good energy dissipation capacity and hysteresis performance.

Cracking, yielding, ultimate and failure loads of the specimens are shown in Table 5, in which cracking load is the load that the infilled silicate bricks of multi-ribbed wall slab appear numerous apparent cracks, failure load take about 85% of ultimate load. Hysteresis curves of the specimens are shown in Figure 10, in which V is horizontal loading acting on the top of the specimen while Δ is horizontal displacement at the top of the specimen.
