EXPERIMENTAL STUDY ON THE USE OF OLD TYRES FOR SEISMIC STRENGTHENING OF MASONRY STRUCTURES

ABSTRACT :

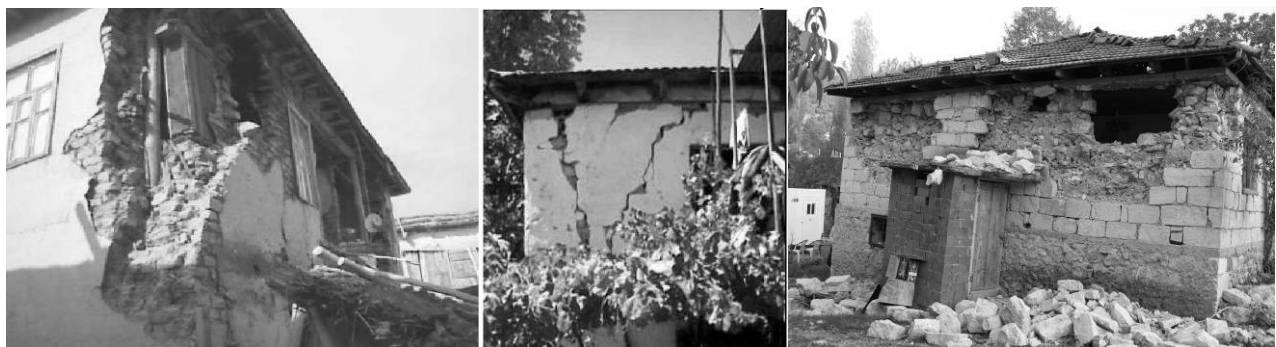
Figure 1. Damages observed in past earthquakes.

Unreinforced masonry (URM) structures showed poor performance during many past earthquakes. Performance of some of these buildings in recent earthquakes is shown in Fig. 1. Unfortunately, many of the URM buildings damaged or collapsed during the recent earthquakes in many countries (Bayraktar, et. al., 2007; Kaplan, et. al., 2008; Ramazi and Jigheh, 2006).

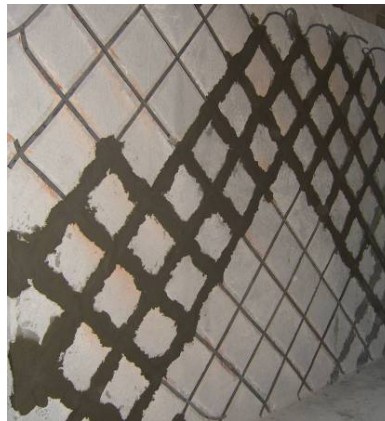
Figure 3. Strengthening by old tyre strips

Plastering is removed to form a canal for the strips after the construction of a standard masonry wall. Then, the strips are placed in the canals and covered by plastering or high quality mortar (Fig. 3). During the experiment, models were also exposed to the two different axial load levels. Specifications of the models are summarized in Table 1.

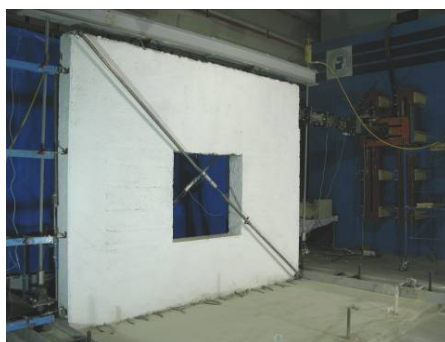
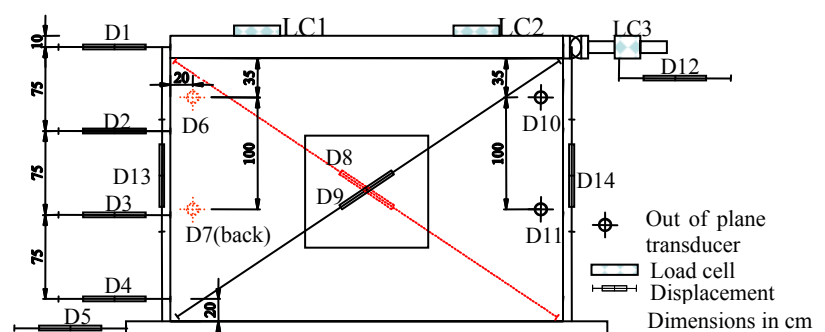
Figure 4. Test setup and instrumentation

Experimental setup is shown in Fig. 4. The system is consisted of the strong floor, reaction wall, actuator, actuator support, instrumentation, and control and data acquisition systems. Model walls were axially loaded before the application of lateral loads. Walls were instrumented to record axial-lateral loads and displacement changes. Instrumentation scheme of the specimens is given in Fig. 4.
