## CYCLIC BEHAVIOR OF SLENDER R/C COLUMNS WITH INSUFFICIENT LAP SPLICE LENGTH

S.Eshghi<sup>1</sup> and V.Zanjanizadeh<sup>2</sup>

<sup>1</sup> Assistant Professor of International Institute of Earthquake Engineering and Seismology (IIEES), Tehran, Iran

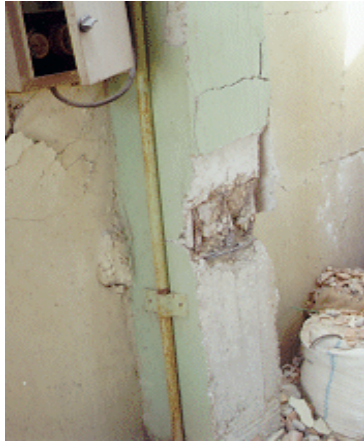
Figure 1 Damage in lap splice point caused by absence of adequate confinement and improper lap splice (Bingol, Turkey, 2003)

Two columns damages caused by lap splice deficiency and lack of confinement in plastic hinge zone are displayed in Fig.1 and Fig.2. Fig.2 demonstrates that such detailing deficiency how can cause extremely damage in R.C building.

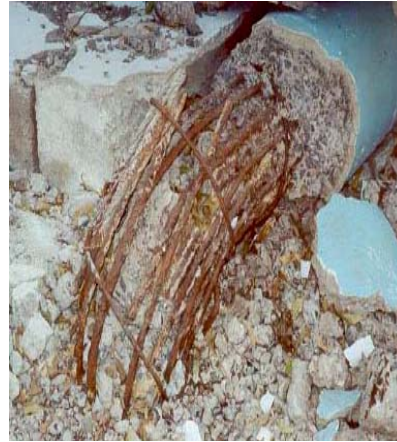
Figure 2 Collapsed column with inadequate lap splice length and widely spaced transverse bars (Gujarat, India, 2001)

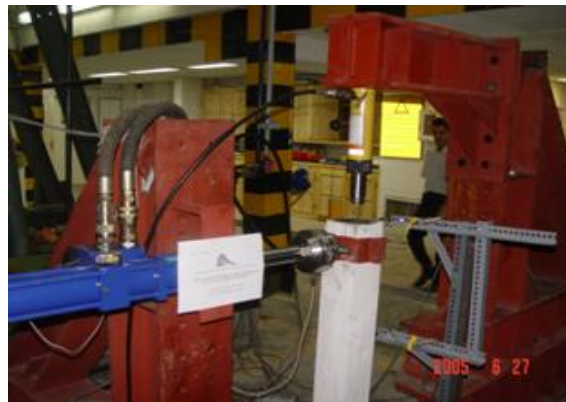
Figure 3 Photo of test set up

The cantilever specimens were subjected to combined shear cyclic displacement and constant axial loading at top level. Axial load was applied using a 100 kN capacity hydraulic jack through hinges at the ends of the specimens allowing in-plane end rotations. The reversed cyclic displacement was applied through a servo-controlled actuator having 60 kN load capacity and ±60 mm stroke capacity. Displacement control mode of the actuator was used to apply the predetermined displacement history. Axial load levels were approximately 5%, 10% and 15% of the assumed column gross axial capacity ( $A_g f_{c,c}$ ). The lateral reverse cyclic displacement imposed for each of the following peak drift ratios: 0.25%, 0.5%, 0.75%, 1%, 1.25%, 1.5%, 1.75%, 2.25%, 2.75%, 3.25%, 3.75%, 4.25%, 4.75%, 5.25%, and 5.75% as displacement increments with two cycles at each level of drift ratio. Photo of the test set up is displayed in Fig.3.

The longitudinal and transverse reinforcing bars and concrete of the specimens were instrumented with strain gauges to determine the steel and concrete strains at various locations and stages of the tests. A total of 6 linear variable differential transducers (LVDTs), 3 on one side, 3 on other side and 3 on the reaction wall, were mounted to measure the deformations of the columns.
