## QUASI-STATIC TESTS ON WALL ELEMENTS CONSTRUCTED DURING THE RECONSTRUCTION OF ST. ATHANASIUS CHURCH IN LESHOK

V.I. Sendova<sup>1</sup> and B. Stojanoski<sup>2</sup>

<sup>1</sup> *Assoc. Professor, PhD, Institute of Earthquake Engineering and Engineering Seismology, IZIIS, University of Ss. Cyril and Methodius, Skopje, Republic of Macedonia*

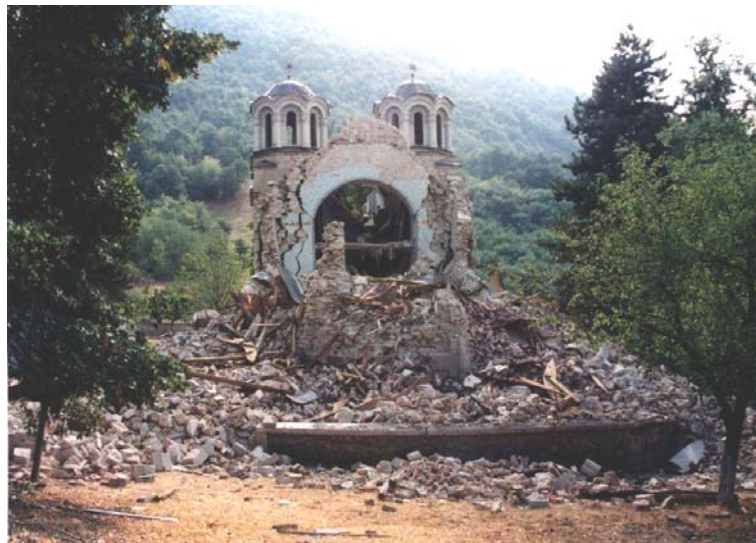
Figure 2 St. Athanasius church after detonation

On 21.08.2001, in the course of the armed conflicts of 2001, this monastic church was almost ruined to the ground by a strong detonation. The vaulted structure surmounting the gallery was destroyed, while only the timber beams of the floor structure remained with visible deformation of the wood. In the part of the two preserved belfries, there were visible large cracks with a width greater than 2 cm along the height of the bearing walls, in the staircase area, the walls of the tambours and the domes, (fig.2).

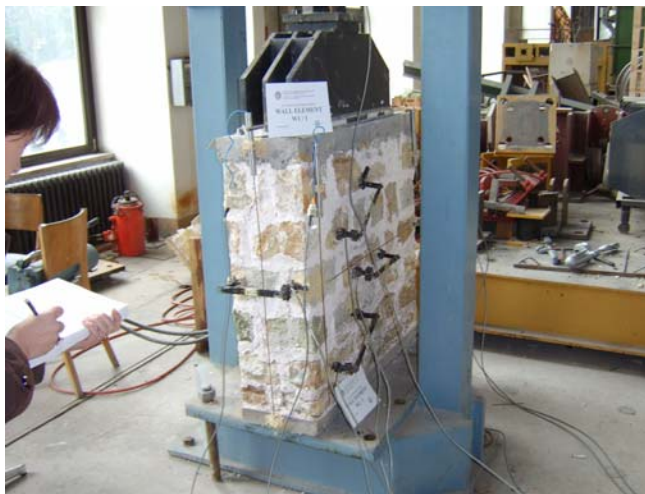
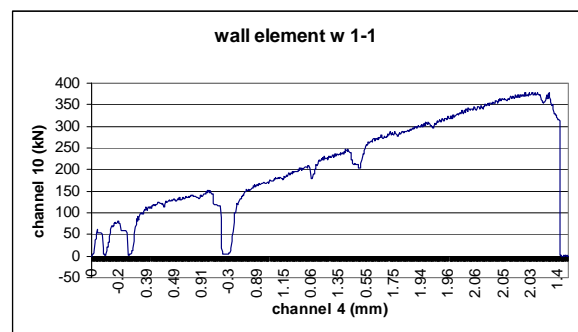
Figure 6 Testing of wall element W1-1

A total of three elements were tested under axial pressure by cyclic application of axial force of up to 400 kN (W1-1, W1-2, W1-3). With the instrumentation of the elements, in addition to the total force, the total displacement of the actuator in the direction of application of force and other quantities of concern as was the shortening of the element, (channels 1-4), the deformations of the element width (channel 5), the opening of cracks in the face of the wall element (channels 6, 7 and 9) and the lateral deformation – the swelling of the element (channel 8) were recorded. The difference between testing of W 1-1 and the remaining W 1-2 and W 1-3 consisted in different application of axial pressure. The first element was subjected to cyclic loading and unloading, while the second and the third were subjected to monotonous increase of the force amplitude up to total failure of the elements. The characteristic failure mechanisms and force-displacement diagrams were obtained for all the tested channels, (fig.6).

Disposition of the element W1-1

Force-displacement relationship

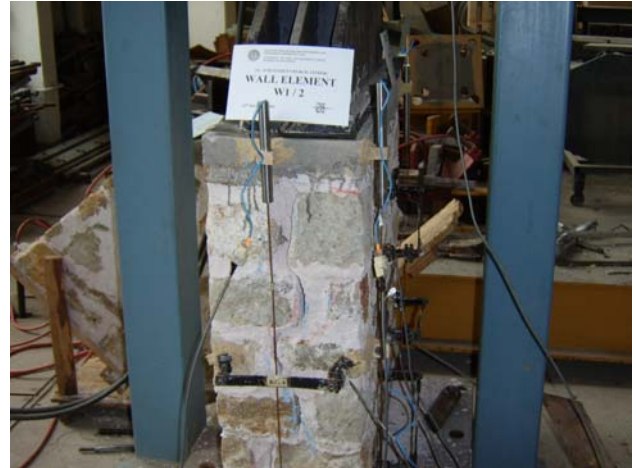
Figure 7 Characteristic failure mechanism

The characteristic of all the wall elements exposed to axial load was the occurrence of a crack along the middle of the wall thickness which ended with falling off material and complete separation of both wall faces, (fig.7). In the three tested elements, the first crack occurred under vertical stress of  $\sigma_o = 370 - 440$  kPa. More important results from these tests are presented in Table 3.1.

Wall element W1-1

Wall element W1-2

Wall element	Date of testing	Age of element (months)	Cross-section A (m <sup>2</sup> )	Maximal force P <sub>max</sub> (kN)	Compressive strength $\sigma_c = P_{max}/A$ (kPa)
W1-1	28.03.2005	4	0.243	372	1530
W1-2	31.03.2005	4	0.243	355	1460
W1-3	1.04.2005	4	0.243	292	1200

1. The agreed programme of quasi-static tests has thoroughly been realized and the necessary results have been obtained.
2. The experimentally obtained results on the compressive strength  $f_c$  of the built-in lime mortar prepared according to a special job mix formula range within 1.20 MPa to 1.53 MPa (Table 3.1) with which it can be confirmed that the design compressive strength of 1.0 MPa has been achieved by its considerable

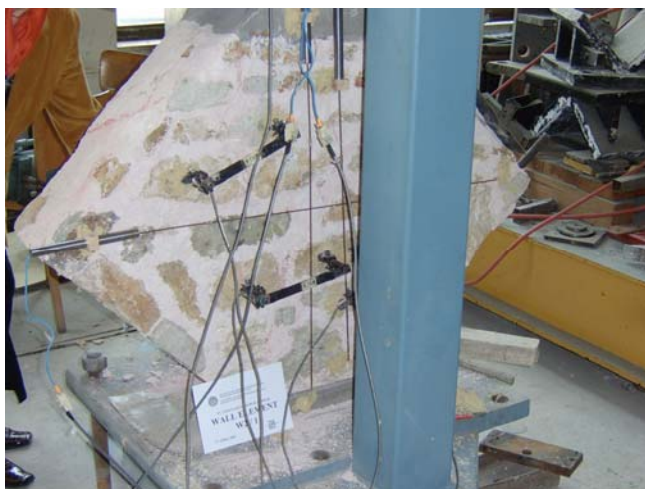
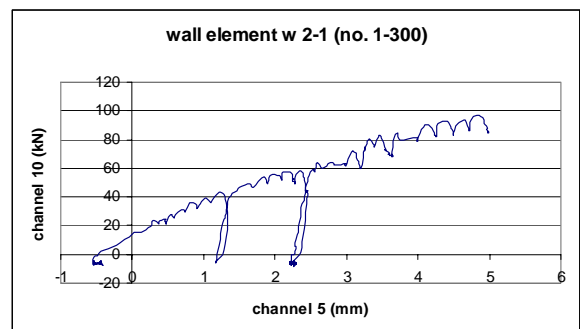
Figure 8 Testing of wall element W2-1

Disposition of the element W2-1

Force-displacement relationship

With the instrumentation of the elements, in addition to the total force, the total displacement of the actuator in the direction of application of the force as well as other quantities of interest as were the shortening, i.e., the elongation of both diagonals of the element, respectively and opening of cracks at places where these are expected were recorded, (fig.8).

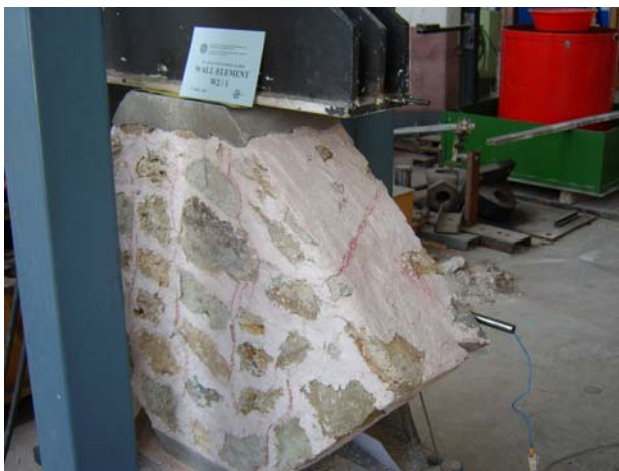
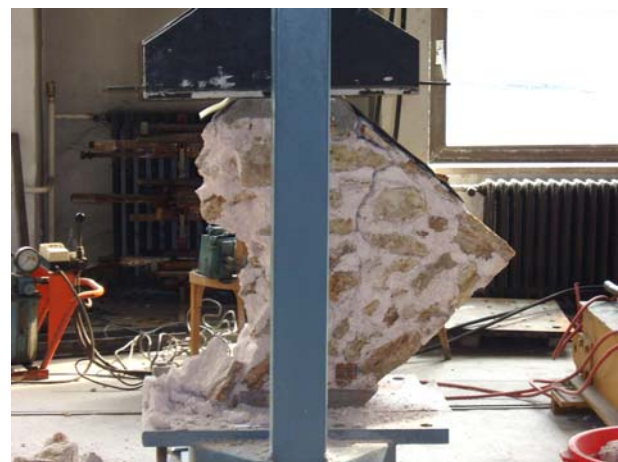
Figure 9 Characteristic failure mechanism

During the experimental testing of these elements, the force was applied monotonously under an angle of 45° in respect to the longitudinal joints of the wall until its failure. Development of diagonal cracks and shortening (elongation) of the diagonals was very characteristic, (fig. 9). A more important result from these tests was, in fact, the obtaining of the tensile strength of mortar (Table 3.2) which was computed on the basis of the maximum applied force that tears down the element by using the following expressions:

Wall element W2-1

Wall element W2-2

Wall element	Date of testing	Age of element (months)	Cross-section A (m <sup>2</sup> )	Maximal force P <sub>max</sub> (kN)	Tensile strength f <sub>t</sub> (kPa)
W2-1	07.04.2005	~ 4	0.344	98	127
W2-2	08.04.2005	~ 4	0.344	31	40
W3-1	26.05.2005	~ 6	0.344	92	120
W3-2	28.05.2005	~ 6	0.344	52	68

3. The experimentally obtained values of tensile strength  $f_t$  of the built-in lime mortar prepared by a special job mix formula ranges within 0.04 MPa to 0.127 MPa (Table 3.2) which is in compliance with the regulations and the recommendations on the tensile strength/compressive strength ratio of masonry, i.e.,  $f_t = (0.03 - 0.08) f_c$ .
