MINE-INDUCED SEISMIC EVENTS AND ITS EFFECT ON NEARBY SETTLEMENTS IN SOUTH AFRICA

ABSTRACT:

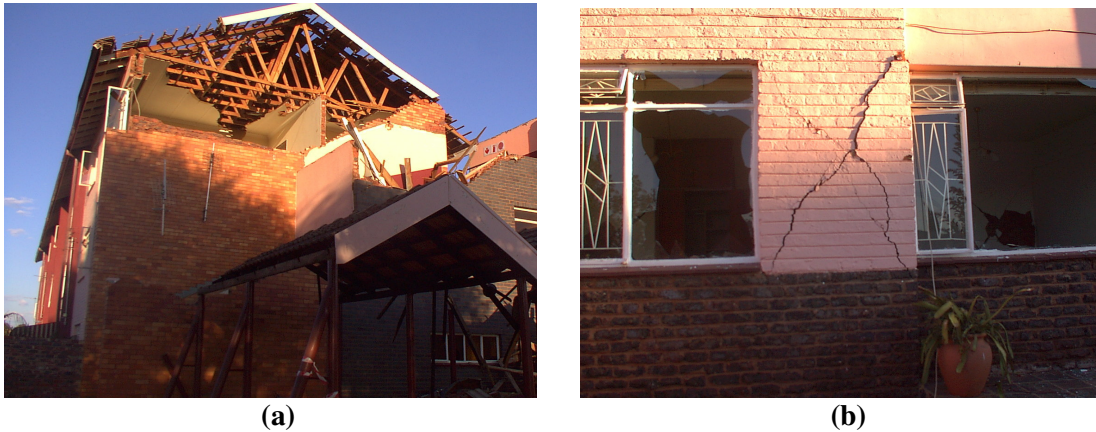
Most of the damage was centered on the city centre area in as Stilfontein. Two blocks of flats known as the Bal Eaton court were very extensively damaged (see Figure 3). Two schools, the Stilfontein High and the Driefonteine Primary school were also extensively damaged, especially the second/third floors. The main causes of the damages and possible design detailing to prevent such damages were investigated.

Figure 3: (a) In-plane and (b) out of Plane Response of the Bal Eaton Court building.

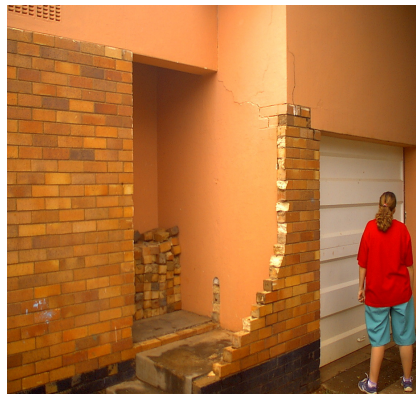
Figure 4: Failure of a cantilevered wall

- Figure 4 shows failure of a cantilevered wall and the need to tie to columns or intersecting wall
- Figure 5 shows typical failure observed in gable walls. The walls need to be strengthened by reinforced columns and by tying to roof structure.
- Fixed window glasses were broken while the movable windows remained intact (Figure 6).
- Collapses at wall intersections underlines the need to tie masonry to intersecting walls or columns as shown in Figures 7 and 8.
- The flexibility of Hydraform walling system was demonstrated by the absorption of the load without cracking through the masonry units as shown in Figure 9.

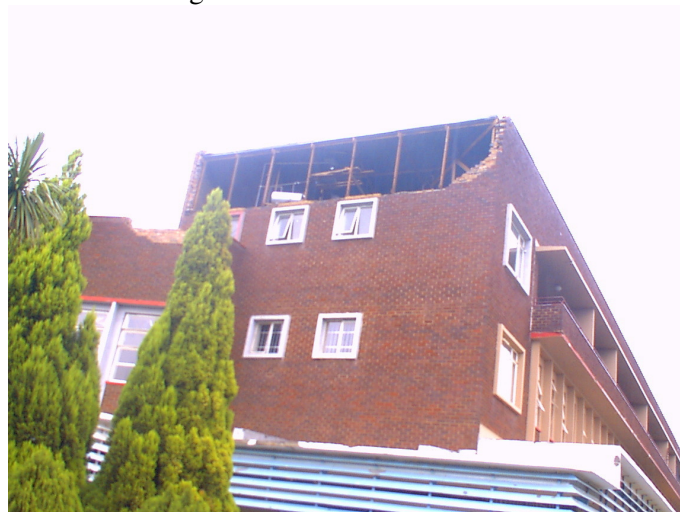
Figure 5: Out-of-plane failure of a gable.

This results in loss of stiffness in buildings in the E-W direction. The stiffness of the building in the N-S direction is much higher than in the E-W direction. In the Stilfontein earthquake of 9 March 2005, the earthquake forces were predominantly in the E-W direction, the weaker direction. Although 5.3 M is considered mild earthquake, it caused maximum damage as the shear walls were in N-S direction and were therefore hit in the out-of-plane (weaker) direction. A typical failure in a public building is shown in Figure 5.

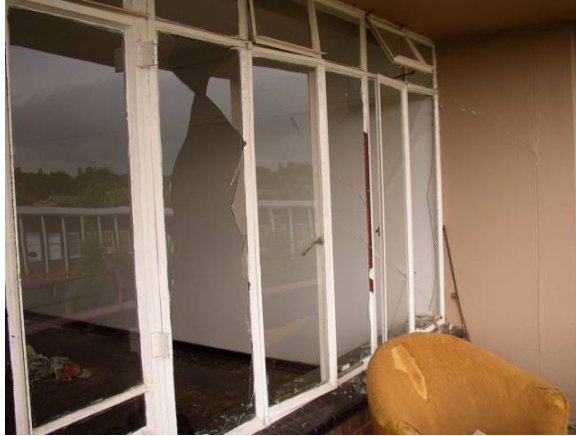
Figure 6: Responses of fixed and moveable windows.

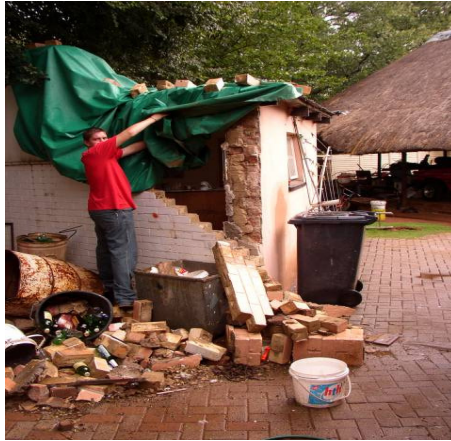
Figure 7: Failure at wall intersections without ties.

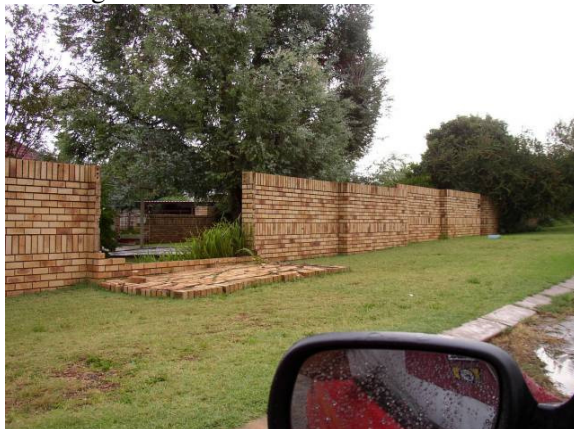
Figure 8: Collapse of an irregularly shaped wall section

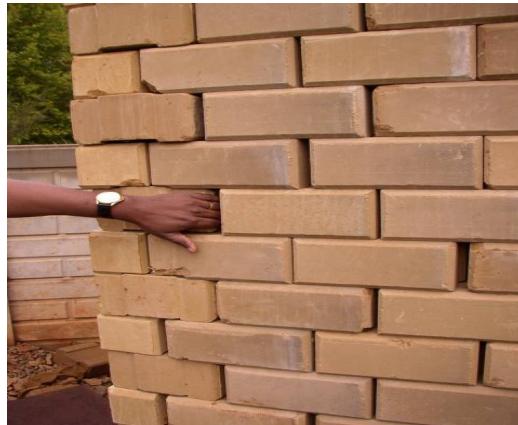
Figure 9: Behaviour of dry-stack walling system
