CURRENT STATE OF SEISMIC-ISOLATION DESIGN

N. Kani

*Executive Director, S.E., the Japan Society of Seismic Isolation, Japan
Email:kani@jssi.or.jp*

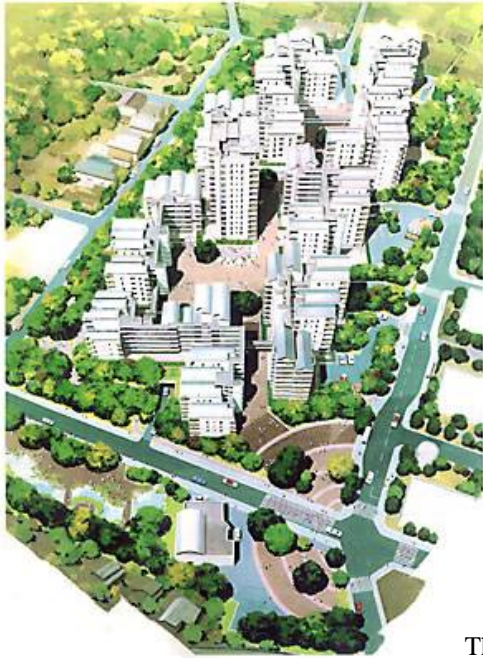
Figure 1 Kamikuzawa Condominiums in Sagami-hara city, Kanagawa prefecture

The largest SI Housing Estate in the country, site area (120 m by 300 m), is Kamikuzawa Condominiums in Sagami-hara city, Kanagawa prefecture in the Kanto area (shown in figure 1). Prof. T. Funakoshi and his partners planned and designed the huge housing site consisting of 21 buildings on an artificial base, seismically isolated by 242 isolators.

The largest SI Housing Estate was designed by ARCOM R&D Architects, Structural Design Group Co., Ltd. and Dynamic Design Inc.

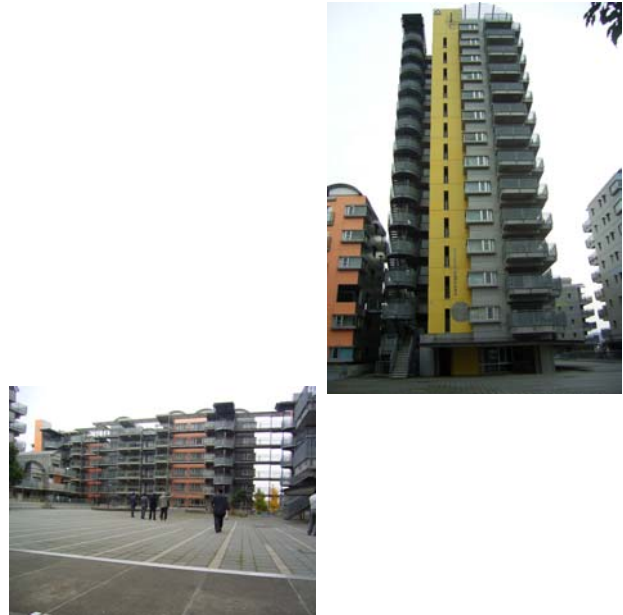
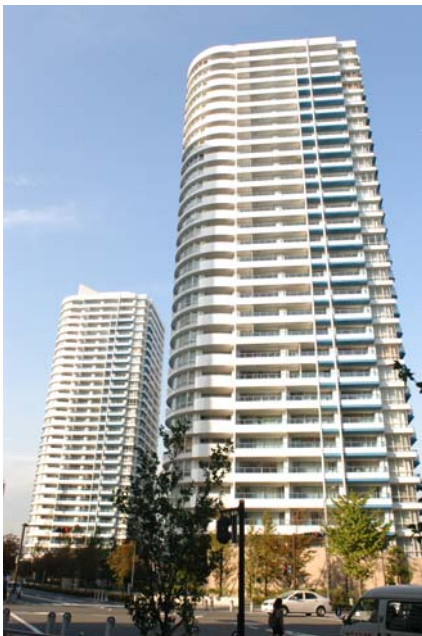
Figure 2 High-rise condominiums with SI, MM towers, Yokohama city, Kanagawa prefecture

The large isolators are installed as 28 NRB, 1,500 mm diameter, with 15 SD, and 44 LD, MM Towers were designed by Mitsubishi Jisho Sekkei Inc.

Business was conducted as usual in about half of these buildings during construction for retrofit.⁸⁾
A very significant trend is gradual increase in the use of SI systems in high-rise-condominiums (figure 2), over the last ten years. The ratio of SI high-rise-buildings constructed is shown in table 1.

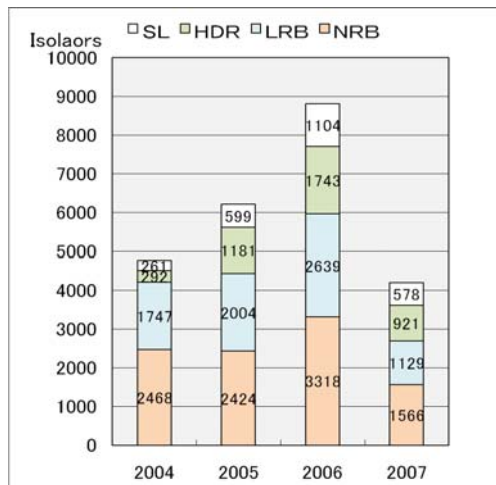
Figure 3 Number of isolators manufactured

Meanwhile, the usage of isolators and dampers produced recently is shown in figures 3 and 4. 6,000 isolators are manufactured annually, including high-damping rubber bearings (HDR) and sliders with elastomer and PTFE (SL), and 1,200 dampers are being manufactured annually, including oil dampers (OD). It is very common for structural engineers to use natural rubber bearings (NRB) as isolators. The usage ratio is 65 % including lead plug embedded rubber bearings (LRB), and hysteretic dampers as steel rods (SD) and lead rods (LD). The usage ratio of these is 50 % among structural engineers in Japan.

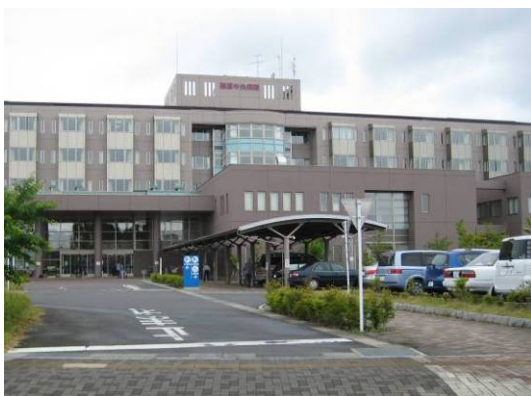
Figure 5 Kurihara city central hospital, Kurihara city, Miyagi prefecture

Activities of this hospital shown in table 8 and figure 5 did not cease at all during or after the severe earthquake. Many people felt a slow shifting of the building, but neither employees nor inpatients were injured. Doctors and nurses were able to cope with the treatment of the people injured in the earthquake. The commercial electrical service failed in the earthquake, but the backup power generation started automatically. The hospital served as the local disaster protection center. Response displacement was about 90 mm from traces of rod movements of oil dampers.

The hospital was designed by Seki Kukan Sekkei Architects, and Kozo Keikaku Engineering Inc., 183 NRB with 70 OD are installed.
