## EXPERIMENTAL INVESTIGATION ON THE BEHAVIOR OF SPANDRELS IN ANCIENT MASONRY BUILDINGS

The paper presents the main outcomes of experimental tests carried out to analyze the structural behaviour of masonry spandrels. They play a significant role in masonry walls of ancient buildings, as they guarantee an effective coupling between adjacent masonry piers so as to assure high in-plane strength and stiffness for the walls. The main aim of the research is to point out the actual response of such structural components under seismic loads. Two spandrels with different lintels are considered in the study, they have been subjected to a controlled vertical displacement history so as to simulate their response under seismic actions. Moreover the effect of a strengthening intervention for spandrels that consider the coupling between the masonry beams and steel ties has been pointed out. The results achieved make up for the lack of experimental data on the behaviour of these structural elements and constitute a valid reference to calibrate nonlinear numerical models for the assessment of the ancient masonry buildings seismic performance.

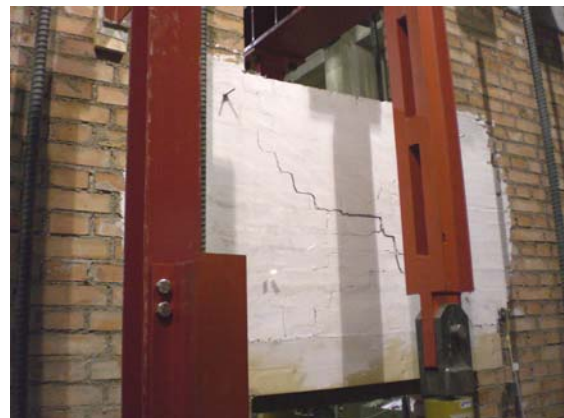
Figure 8. Specimen MS2: (a) shear load against displacement, (b) crack pattern in the spandrel.

such specimen differs from MS1 because it has a flat brick arch in parallel with a wooden element over the opening instead of a wooden lintel. The relationship between the shear load and the relative transversal displacement of the spandrel is shown in Fig. 8a considering the whole sequence of loading and unloading. A maximum value of about 50 kN was reached in one direction and 42 kN in the opposite direction. After the peak load a quite rapid reduction in shear capacity was observed and a residual strength value of about 40% of the maximum shear was reached at the end. Such a residual resistance was maintained up to the maximum displacement, which is about 5 times greater than that corresponding to the maximum capacity. In Fig. 8b the crack pattern in the spandrel's back face at the end of the test is shown. As it can be seen the main cracks are diagonal (shear cracks). The sequence of cracking is illustrated in Fig. 9. The diagonal cracks start from the four corners of the spandrel and then, increasing the load, the cracks propagate and for a value of the vertical displacement greater than 3 mm they meet in the middle of the spandrel. After that the shear capacity remains almost the same up to the maximum displacement ( $\pm 10$  mm).

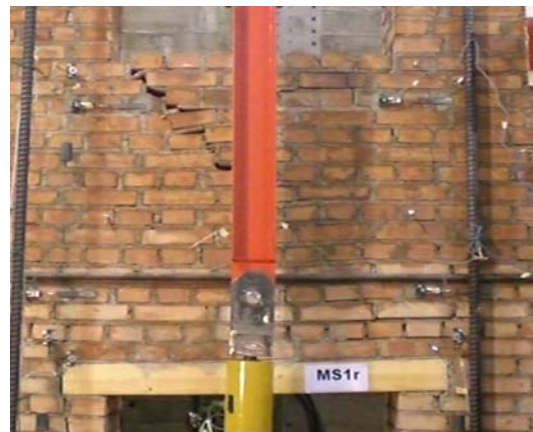
Figure 10. Specimen MS1r: (a) shear load against displacement, (b) crack pattern in the spandrel.

The relationship between the shear load and the relative transversal displacement of the reinforced specimen's spandrel is shown in Fig. 10a. A maximum value of about 100 kN was reached in one direction and 80 kN in the opposite one. As in the previous tests after the peak load a progressive reduction in shear capacity was observed. But in this case a residual strength value of about 60-70% of the maximum strength was measured. Such resistance values were obtained at displacements equal to 60-70 mm, which means about 5 times greater than that corresponding to the maximum shear capacity. Improvement in terms of shear capacity (40-50%) and even more in terms of ductility (ultimate drift equal to 1/15-1/20 of the spandrel length) was significant with respect to the

unreinforced spandrel (MS1). The reinforced spandrel collapse occurred when the wooden lintel beaks because of flexure at approximately 1/3 of its length. Sub-vertical cracks did not occur, but only diagonal cracks formed as visible in Fig. 10b, which refers to a loading step just before the collapsing of the spandrel.
