SEISMIC ASSESSMENT OF THE ARCHITECTURAL HERITAGE IN THE FATI H DISTRICT OF ISTANBUL

KEYWORDS: İstanbul, Fatih District, Survey, Historic Buildings, Seismic Vulnerability

2. ELEMENTS OF HISTORIC BUILDING EVALUATION

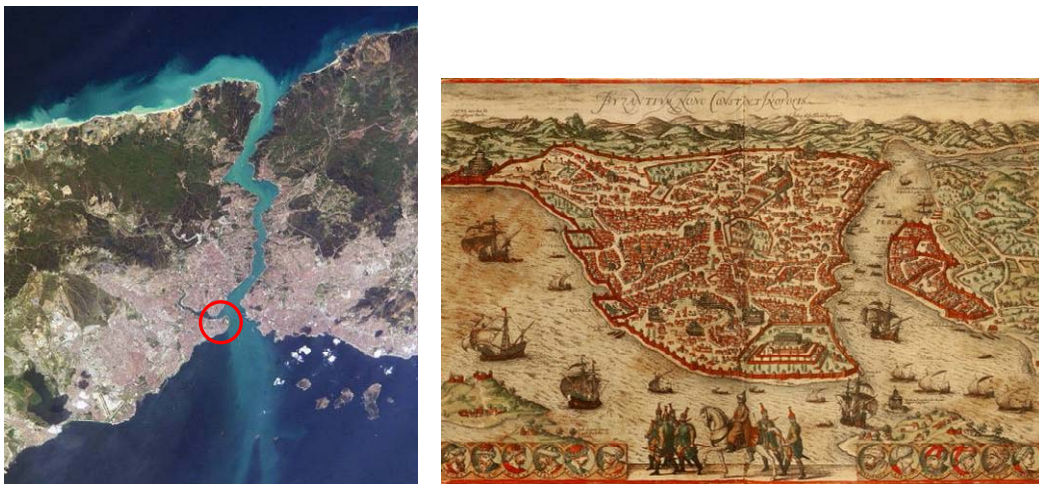
Figure 1 View of Istanbul Strait and Fatih (Circled, Left) and Historic Engraving (Right)

Istanbul sits astride the 30 km-long eponymous strait that connects the Black Sea with the Sea of Marmara (left frame in Figure 1). An engraving from the 16th century shows the Historic Peninsula from the east in the right frame of the same image. The walled city is separated from a smaller settlement on the north side of Haliç. A current space image is given in Figure 2.

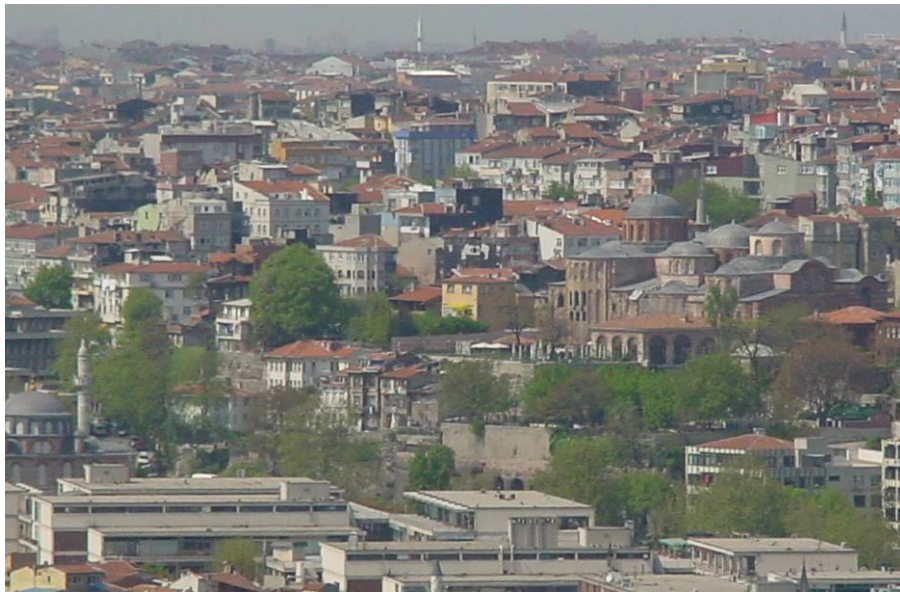
Figure 3 A Section of Fatih Viewed from the North

Fatih, shown in Figure 3, is a living city. Ancient, old and modern are intermixed, urban functions bustle. Many of the buildings are currently being actively used, or are guarded by their custodians even if they are idle. It was not easy to gain access and do lengthy measurements. Removal of material samples for testing required additional permit so it was not attempted at this stage. The program objectives did not include developing a building-specific information database for each building; such an undertaking would have been overwhelming because of the sheer number of buildings. Of the original inventory we first developed an 800-building subset, which was finally reduced to 223 entries listed in Table 1 covering a representative sampling. Even with this modest number, the Fatih Seismic Assessment Project represents a comprehensive attempt to assess the earthquake performance of the historic buildings in the historic core of Istanbul. The procedure is only a preliminary stage for ranking the buildings. Even detailed and lengthy analyses are beset by uncertainties; our objective was to create two bins, one for buildings that would likely survive and the other for those that would likely fail to achieve that objective. The dividing line can be a vague one.

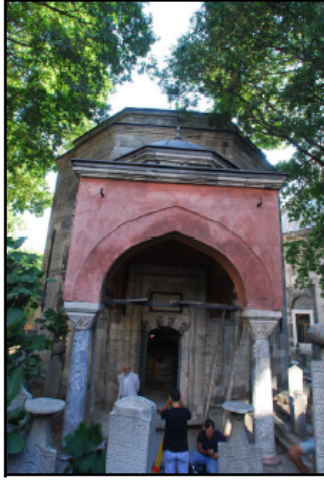
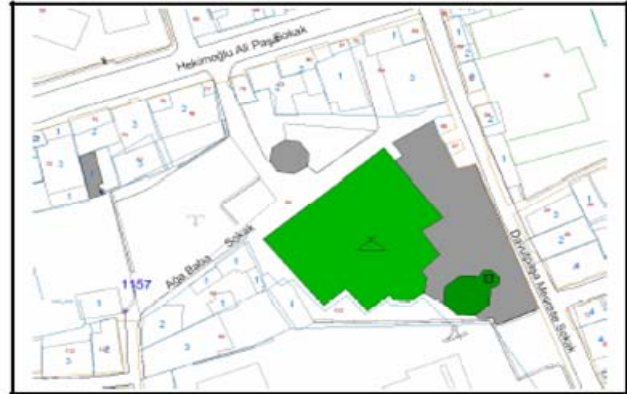
Figure 5 Selected Sheets for Assessment of a Tomb

Anıtın Adı : DAVUD PAŞA TÜRBESİ		Blok Adı:	
İmar No. :	Pafta No. :	Ada No. : 1157	Parçel No. : 53
Kadastro No. :		Harita No. :	
Adres : Mahalle / Mevki : Devletpaşa		Caddesi / Sokak : Davutpaşa Medrese Sk.	
Yapım Yılı :		Yapılan : Davud Paşa	
Yapım Kitabı : 1485		Yapın / Mimarlar : ---	
Orijin İlgili :		Türbe

Tespit Edilebilen Deprem Kayıtları	Tarih: 1509 Bilinen Hasar :	Tarih: 1766 Bilinen Hasar :	Tarih: 1894 Bilinen Hasar :	Tarih: 1999 Bilinen Hasar :
Yapının Halihazır Durumu	İyi Konumlu Orta Kötü Konumlu	Tepsiyi Dış / İç Duvar	Hasarsız Az Hasarlı Çok Hasarlı	Döğeme Sistemi Hasarsız Yüksek
Binede Oturma	Oluma Yok Kamen Var Çok Fazla var	Olumadan Kaynaklı Gözlenen Hasar	Var Çok Az Yok	Cebide Sistem Hicran Orta Yüksek
Malzeme Deneyleri	Yapıldı Yapılmadı	Sonuçlar Özet	Açıklama	
Mevcut Durum ile İlgili Diğer Gözlemler

KAGIR YAPILARDA BASİTLEŞTİRİLMİŞ HESAP METODU İLE PERFORMANS DEĞERLENDİRMESİ			
Referans No:	FA263	Anıtın Adı:	DAVUD PAŞA TÜRBESİ
Tavan İzdüym Alanı (m ²) =	78.62	Döğeme x _{max} (cm) =	490.9
Tavan Döğeme Kalınlığı (cm) =	70	Döğeme x _{max} (cm) =	483.1
w _{max} / h _{max} (m) =	7.43/4.27	Kubbe x _{max} (cm) =	490.9
Döğeme Özgü Ağırlığı (kN/m ³) =	20	Kubbe y _{max} (cm) =	485.0
TOPLAM BINA AĞIRLIĞI ΣW (kN) =	7673.35

DEPREM HESABI PARAMETRELERİ			
M _{basit} (ton) =	388.72	a _y (m/s ²) =	1.338
β _{ax} (m/s ²) =	2.32	T _x (sn) =	0.7145
β _{ay} (m/s ²) =	2.37	T _y (sn) =	0.7016
Deprem Yüğü F _x (kN) =	303.3	Deprem Yüğü F _y (kN) =	319.9

Duvar Malzemesi ve Emniyet Gerilmeleri	
Taş duvar	
σ _{tas} (MPa) =	0.9
τ _{tas} (MPa) =	0.18

With the complete information set comprising structural (materials, wall thicknesses, and state of cracking as opposed to architectural or conservation-relevant) features, local geology, estimated ground motion we built simplified SDOF models for each building in the inventory in the style shown in Figure 4. Ground motion was assumed to act in one of two principal horizontal directions, and separate stress analyses were made in- and out-of-plane wall capacities. Openings in walls were taken into account in estimating their stiffness, and roofs or domes were assumed as inert masses. Site-specific response spectra adjusted for distance to fault rupture and local soil characteristics were tools for estimation of the spectral acceleration. No force reductions were allowed, so wall stresses or out-of-plane strengths were based on values from limited coupon tests or triple their code allowables. This elementary exercise yielded good vulnerability estimates. A sample sheet is shown in Figure 5.
