METHODOLOGY FOR REHABILITATION AND SEISMIC STRENGTHENING OF ST. CLEMENT'S CHURCH, ST. PANTELEYMON -PLAOSHNIK – OHRID

The paper deals with application of an originally developed methodology for rehabilitation and seismic strengthening of St. Clement's Church, Plaoshnik, Ohrid. To renovate the structure based on the original foundation dating back to the IX century, complex multidisciplinary investigations were performed in the field of archaeology, conservation, engineering and construction. Presented in this paper are the investigations related to the design of the structural system based on elaborated architectonic floor plans that are to preserve the authenticity of the structure, performed geotechnical investigations of the site and defined input seismic parameters. A linear-elastic and nonlinear dynamic analysis of the structure was performed. Based on the obtained results, the concept of repair and seismic strengthening of the church was adopted. It consisted of incorporation of horizontal and vertical steel ties in the bearing walls of the structure. This method, which is based on the philosophy of "minimal intervention – maximal protection" has originally been developed at

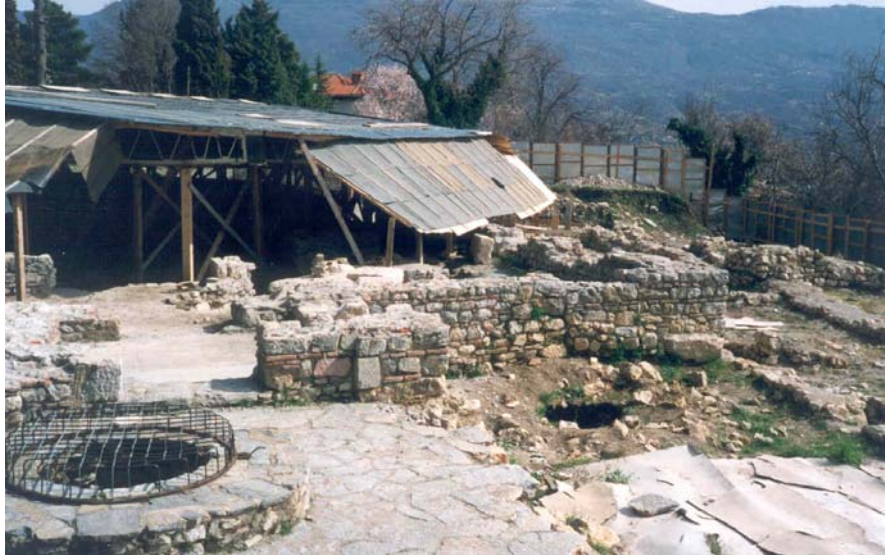
Figure 2. Existing state of the church (excavated material - 2001)

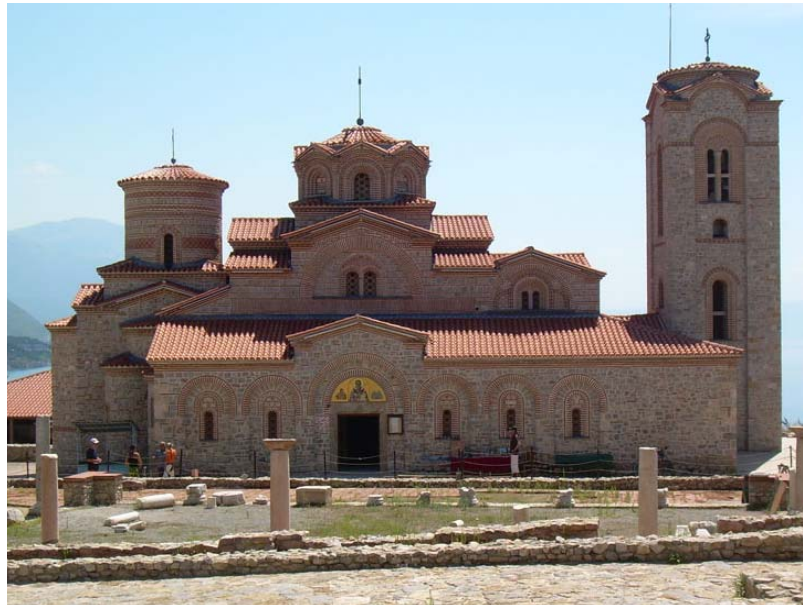
Figure 9. Present view of the rebuild church of St. Panteleymon

The rebuilding of the church of St. Panteleymon was finished in 2002, (fig. 9).
