An experimental study on full scale shaking table test of conventional wood house by E-defense

ABSTRACT :

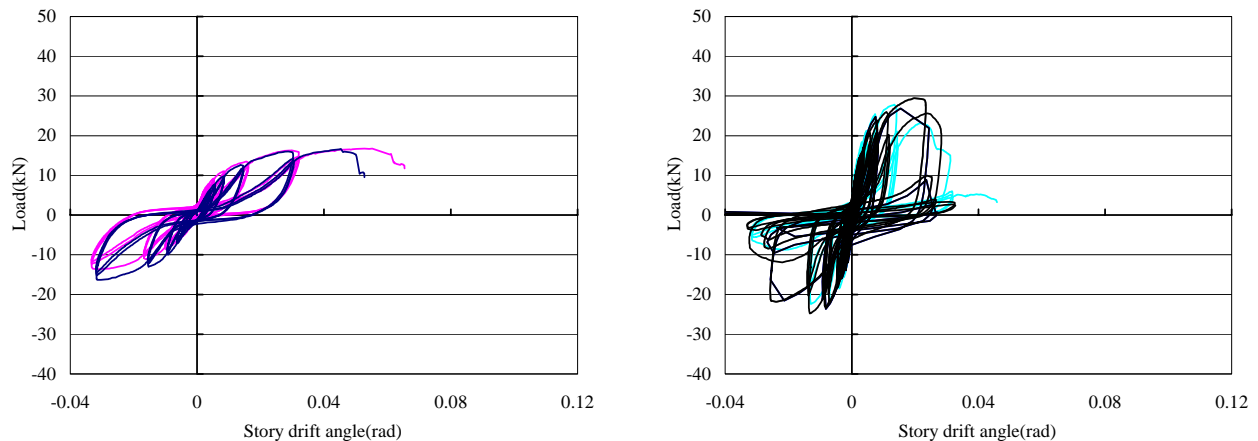
Figure 2 Relationships between Load and Story drift angle (Left: Single brace, Right: MOISS)

Table 1 showed the results of some important seismic walls. Figure 2 showed two examples of load-story drift angle curves. Based on these cyclic results, the load-deformation relations of all seismic elements were evaluated, and the seismic performance of the house was examined.

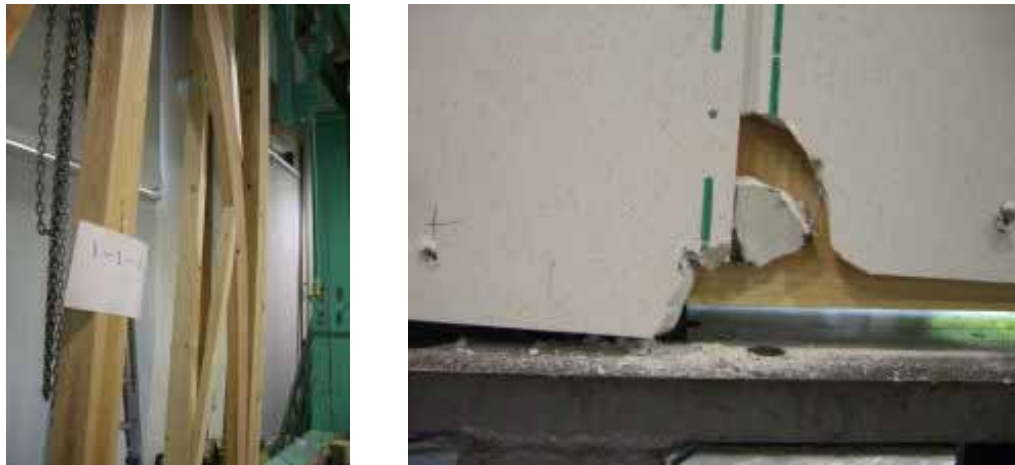
Photo 1 Failure mode (Left: Single brace, Right: MOISS)

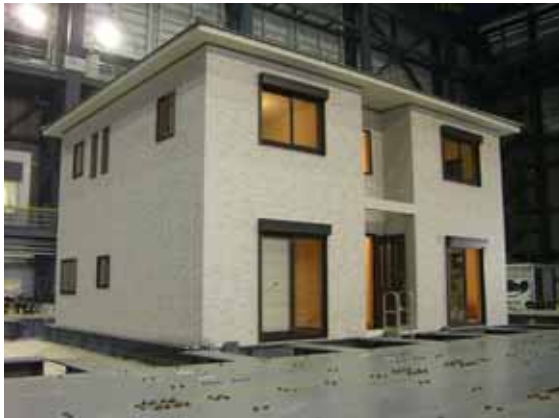
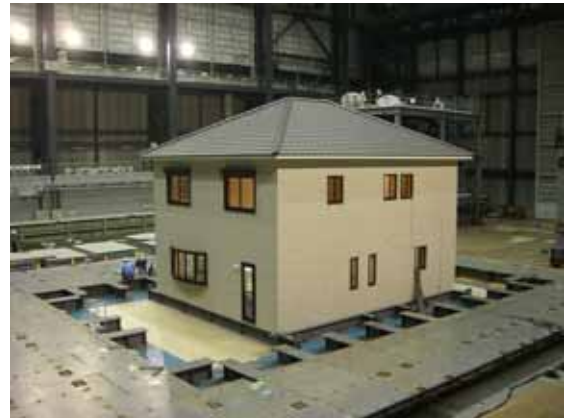
Photo 2 Specimen set up on shaking table (Left: View of Southwest, Right: View of Northeast)

On 8th and 10th January in 2008, a series of full-scale shaking table tests was done on a two-story modern wooden residential house at E-defense. On the first day, high seismic performance plan which was level three of Bill for Ensuring the Quality of Public Works was tested. The second day, standard seismic performance plan (level two) that was achieved by removing some wooden braces from high seismic performance plan was tested. Photo 2 showed the specimen. Fig.4 showed those floor plans. Table 2 showed the existing wall-length ratio and the eccentricity ratio. The dimension of specimen was 10,000 x 8,000mm for both 1st and 2nd floors. In this experimental specimen, all sashes, all glass, stairs, and some furniture were set up, but the bathtub was not placed. The seismic load was 322.9kN for the whole house, 165.6kN on the 1st floor and 157.3kN on the 2nd floor. In addition, the measured weight of this specimen was 359.5kN that included the live load.

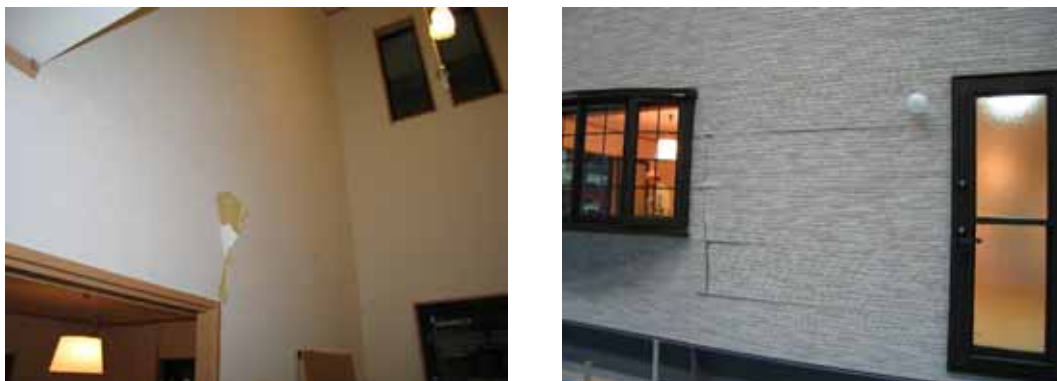
Photo 3 Damage of check third (Left: Inside, Right: Outside)

Check damage Third (Photo 3): The response story drift angle showed 1/50rad on the final wave. Both outside and inside had some amounts of damages. The external sheathing board slightly came off and the inside wall had large damage.

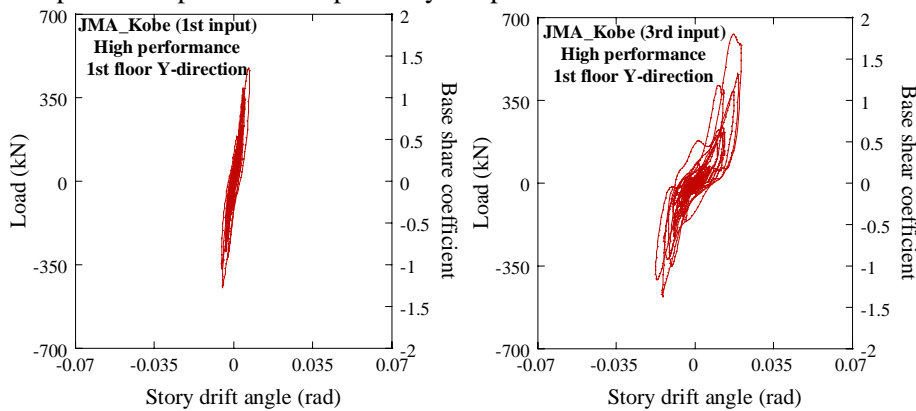
Figure 5 Comparison of 1st and 3rd times JMA Kobe of first day (High performance plan)

Figure 5 and 6 showed relationship between load and story drift angle for comparison of 1st and 3rd wave inputs of JMA Kobe. Maximum story drift and angle of each wave was shown in Table 4. The high performance plan showed a high natural frequency of 8.0Hz. And it was obvious from this comparison that the modern wooden residential house, which was designed so as to meet with required design criterion, was stronger and tougher than the prediction. For example, for the shaking JMA Kobe 100% input, the prediction value was 1/42rad but the experimental value was 1/145rad. The base shear coefficient showed about 1.4 times that of the standard plan. This conventional house had good seismic performance. Two reasons why actual response was higher than that of prediction were deduced. One reason might be the weight. As there were, however, not big difference between measured weight and calculated weight, we thought that other reason such as non-structural members might affect on the higher performance. In this study, we examined the shear resisting performance of all elements by static loading test including the external walls, but did not include stairs and a sash. We thought that this point was important to predict more precisely the performance of the whole house.

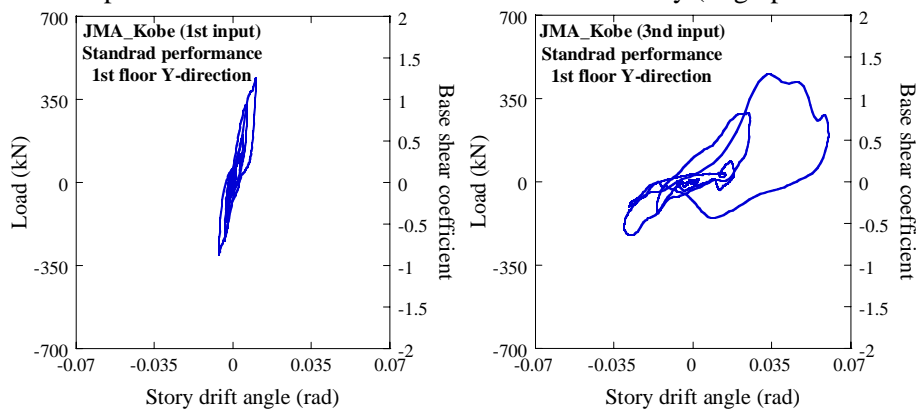
Figure 6 Comparison of 1st and 3rd times JMA Kobe of second day (Standard performance plan)
