AXIAL LOAD FAILURE OF SHEAR CRITICAL COLUMNS SUBJECTED TO HIGH LEVELS OF AXIAL LOAD

A.B. Matamoros¹, Lisa Matchulat², and Charles Woods³

¹ Associate Professor, CEAE Dept., University of Kansas, Lawrence, KS, USA

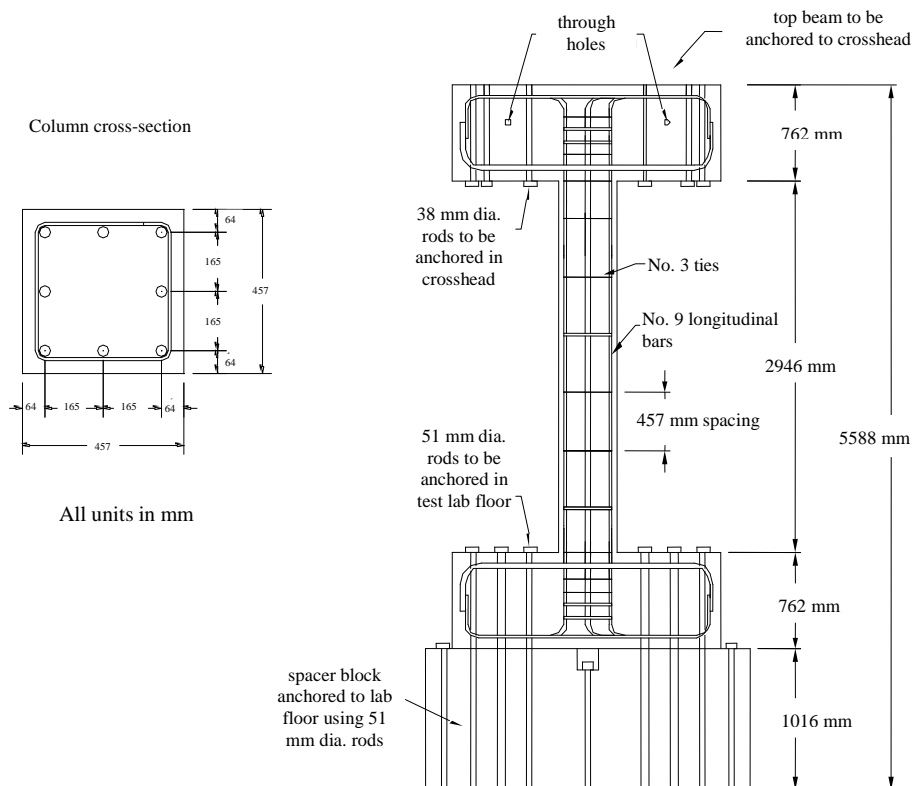
Figure 1 Specimen dimensions

The two columns had a height of 2945 mm and cross section of 457 x 457 mm. The longitudinal reinforcement ratio was 2.5% and the transverse reinforcement consisted to No. 3 bars (9.5 mm diameter) spaced at a distance equivalent to the column size (457 mm). The loading protocol consisted of cycles with increasing maximum lateral displacement under constant axial load. It was found that the behavior of the two columns at drift demands higher than the drift at axial failure was significantly different. The lateral stiffness and the residual axial load capacity of the columns were found to be related to the axial load prior to axial failure.

The experimental program consisted of two full-scale columns with square-cross-section. Columns (Fig. 1) were tested at the NEES-MAST Laboratory at the University of Minnesota. A full description of the capabilities of the testing system may be found elsewhere (University of Minnesota, 2008). Both specimens had a length of 2945 mm and cross-section dimensions of 457 x 457 mm, for a shear-span to depth ratio of 3.75. The longitudinal reinforcement consisted of 8 No. 9 bars (28.7 mm diameter) made of ASTM A706 steel with a measured yield strength of 445 MPa. Transverse reinforcement consisted of No. 3 bars (9.5 mm diameter) made of ASTM A615 steel with a yield strength of 372 MPa. Transverse reinforcement consisted of closed hoops with 90 deg. bends spaced at 457 mm. Compressive strength of the concrete measured on the day of the test for the two specimens was 33 MPa.

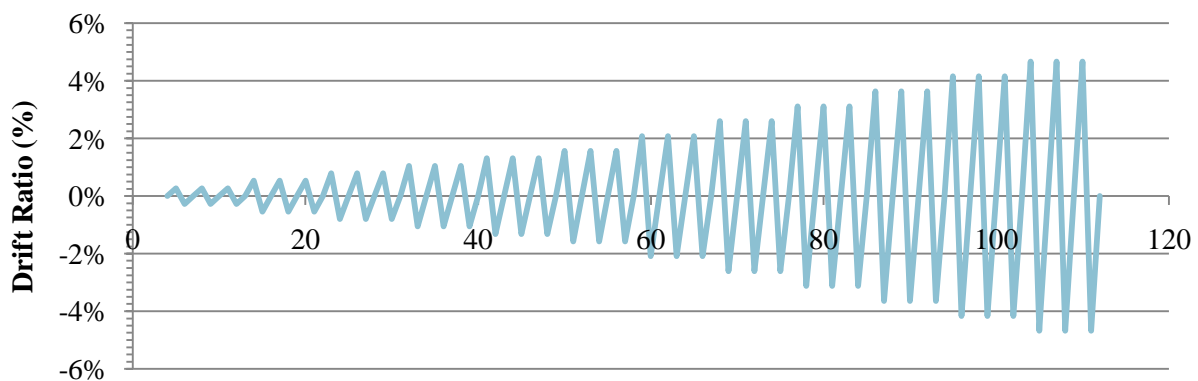
Figure 2 Lateral displacement protocol

Specimens were subjected to sets of three cycles with increasing displacement (Fig.2). The amplitude of each set of cycles was increased by 0.25% up to a drift ratio of 1.5%, and by 0.5% increments after that. Axial load remained constant with values of 2225 KN and 1510 KN for specimens 1 and 2, respectively. These values correspond to axial load ratios of 0.32 and 0.21.

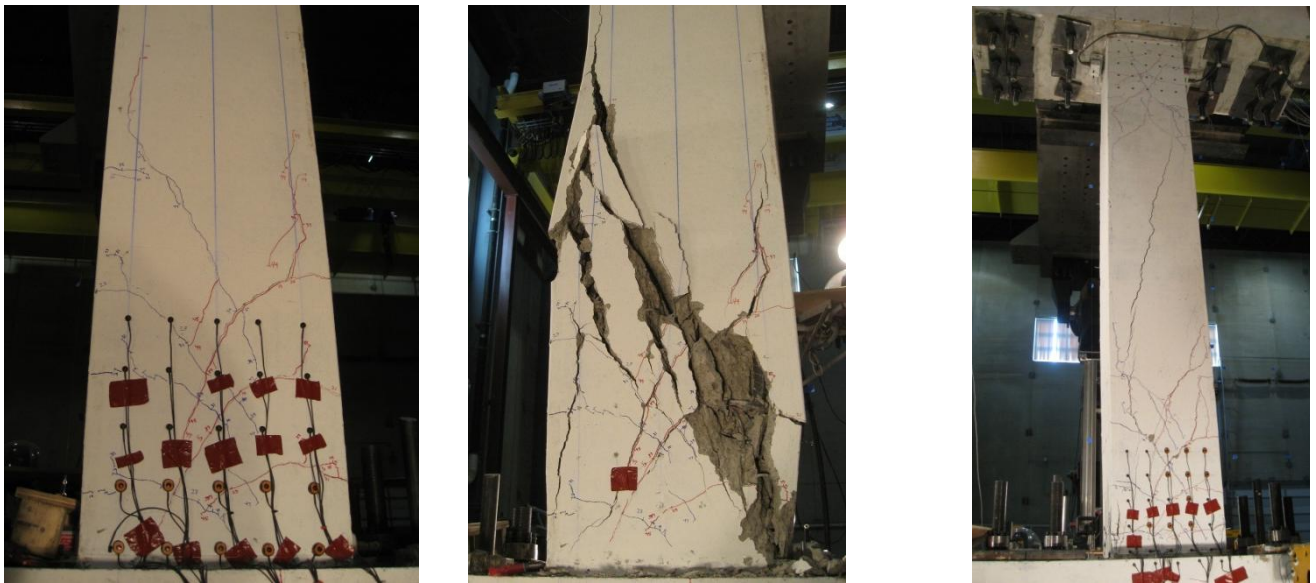
Figure 3. (a) Specimen 1 prior to axial failure (b) Specimen 1 after axial failure (c) Specimen 2 after axial failure

The behavior of both specimens was very brittle in nature. For specimen 1 axial failure occurred at a drift ratio of 1.07%. Failure occurred after rapid widening of an existing shear crack (Fig. 3a and 3b), followed by sudden loss in axial capacity. The inclined crack associated with axial failure formed in the maximum moment region, on the bottom side the specimen, and formed an angle of approximately 28 deg. with respect to the vertical axis of the column. Failure of specimen 2 was similar in nature. Axial failure was recorded at a drift ratio of 1.2% and it was precipitated by the appearance of a previously inexistent inclined crack in the middle section of the column (Fig. 3c). In the case of specimen 2 the crack formed a much shallower angle of approximately 14 deg. with respect to the vertical axis (Fig. 3c).

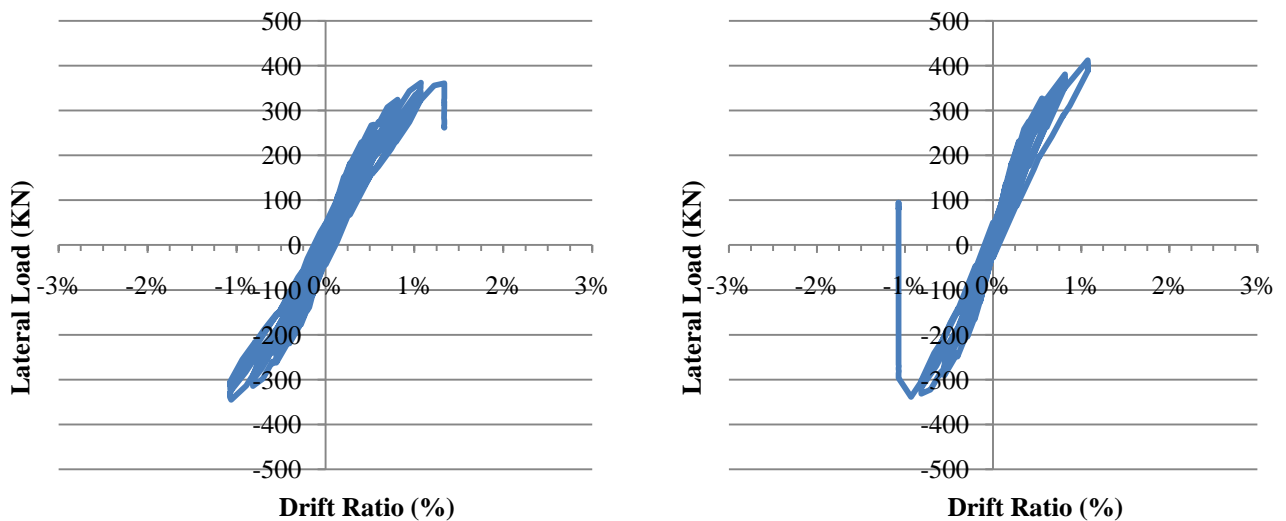
Figure 4. Load-Deflection relationship for Specimens 1 and 2

Hysteresis curves for both specimens are presented in Fig. 4. The hysteretic response shows that both specimens failed prior to any significant yielding in flexure and that the ability to dissipate energy was negligible. Although the hysteresis curves show similar behavior for both columns, there were important differences in terms of the axial deformation, lateral stiffness, and residual strength that will be discussed in latter sections.

Specimens 1 had a maximum shear force of 412 KN in the positive direction of loading (North) and 340 KN in the South direction, while specimen 2 had a maximum shear force of 355 KN in the North direction and 320 in the South (Fig. 3). Measured shear values show that the ratio of nominal shear strength to V_y was close to 1.0.

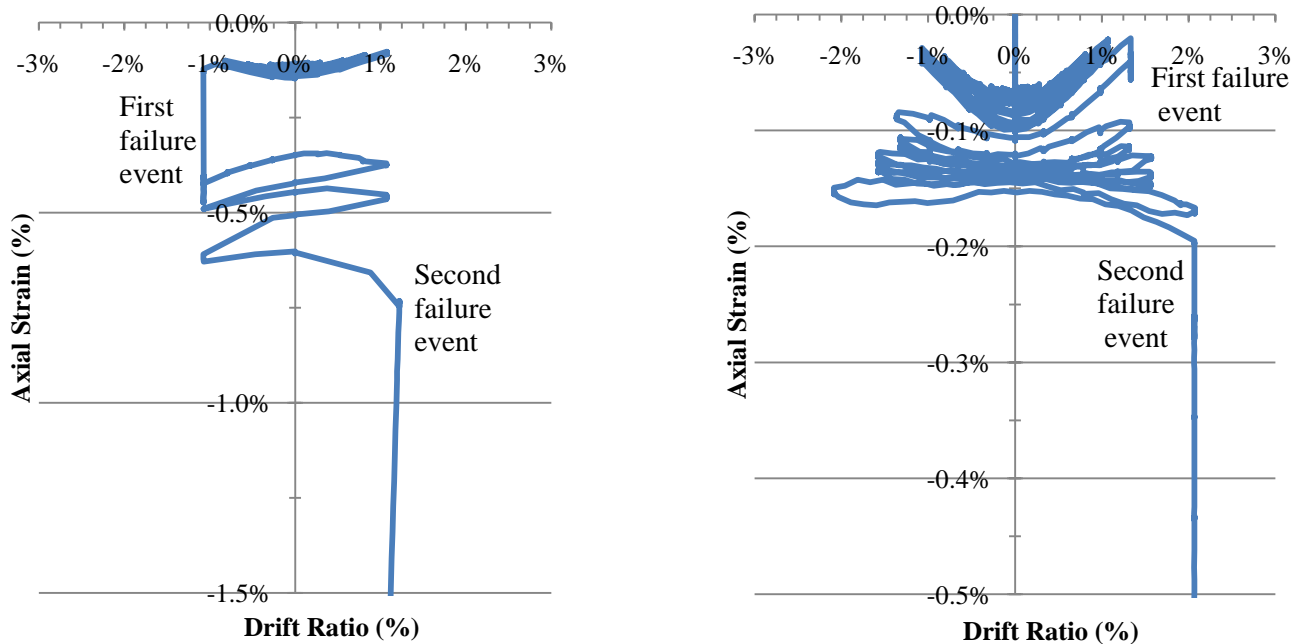
Figure 5. Axial strain vs. drift ratio for specimens 1 and 2.

The relationship between drift ratio and axial strain was significantly different for both columns. Both relationships are shown in Fig. 5.

Figure 5 makes reference to multiple failure events which are tied to events in the loading protocol. As indicated before the control system was set to detect a reduction of 10% or greater on the load carried by the columns. When the trigger limit was exceeded the control system for the vertical actuators shifted from load control to displacement control. This is designated as an axial load failure event. After such an event took place the control system of the vertical actuators was transitioned back to load control, but at the reduced level of axial load at the end of the failure event, and the lateral displacement history resumed. After the second failure event was recorded the columns were loaded monotonically to measure the residual axial capacity.

Figure 5 shows that there was a significant difference between the behavior of the two specimens. Specimen 1, subjected to an axial load of 2225 KN, had a much higher increase in axial strain associated with the first failure event than specimen 2. Furthermore, after the first failure event specimen 1 was able to sustain the reduced level of axial load for a much smaller number of cycles than specimen 2, and the increase in axial strain per cycle was significantly larger than that observed in specimen 2.

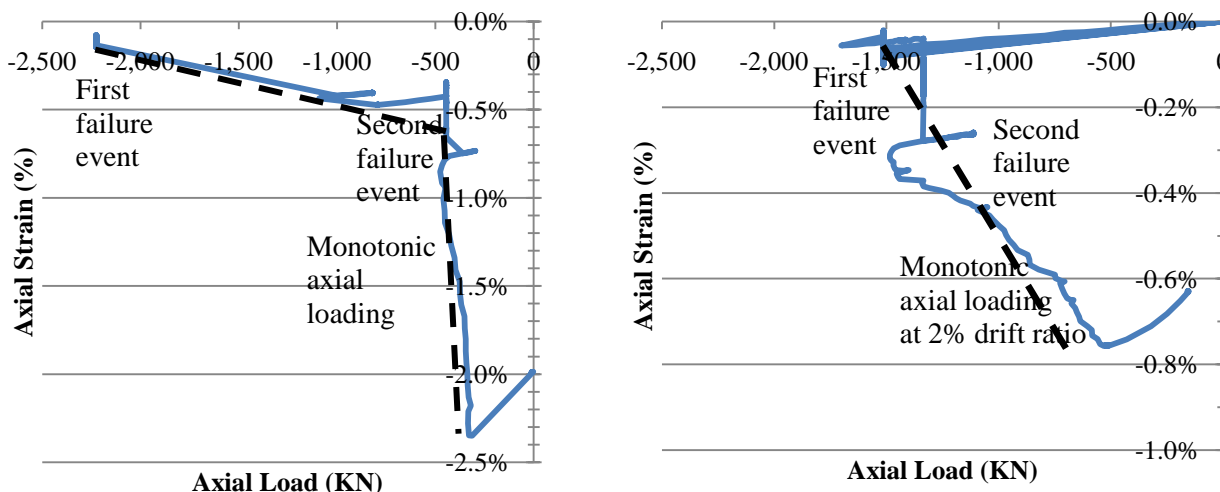
Figure 6. Axial strain vs. axial load for specimens 1 and 2

Figure 6, which shows the relationship between axial strain and axial load for the two specimens, also indicates that there were significant differences in the behavior of the two specimens after the first failure event. The dashed line in both figures represents an approximate failure line for the axial load observed during the tests. In specimen 1 there was a very large reduction in axial load capacity associated with the first failure event. After the first failure event took place in specimen 1, and the control system shifted to displacement control in the vertical actuators, a first attempt was made to increase the axial load in the column. As soon as the axial load reached the failure line, a second failure event occurred. After that, the lateral displacement history was continued at an axial load below the observed failure line. As the column was subjected to deformation cycles in the lateral direction, axial strain continued to increase under constant axial load due to further damage to the column. When the axial strain reached the failure line another failure event took place. At this point damage in the column was so severe that the column was loaded monotonically to measure the residual axial capacity.

A similar line is shown in Fig. 6 for specimen 2. A comparison between the two failure lines shows that the slope of the line was significantly higher for specimen 2. Specimen 1 had a very large reduction in axial load capacity associated with the first failure event and maintained a very small residual capacity for subsequent increases in axial strain. In specimen 2 the loss in axial load capacity was much more gradual. After the second failure event the specimen still maintained a significant fraction of its load carrying capacity.

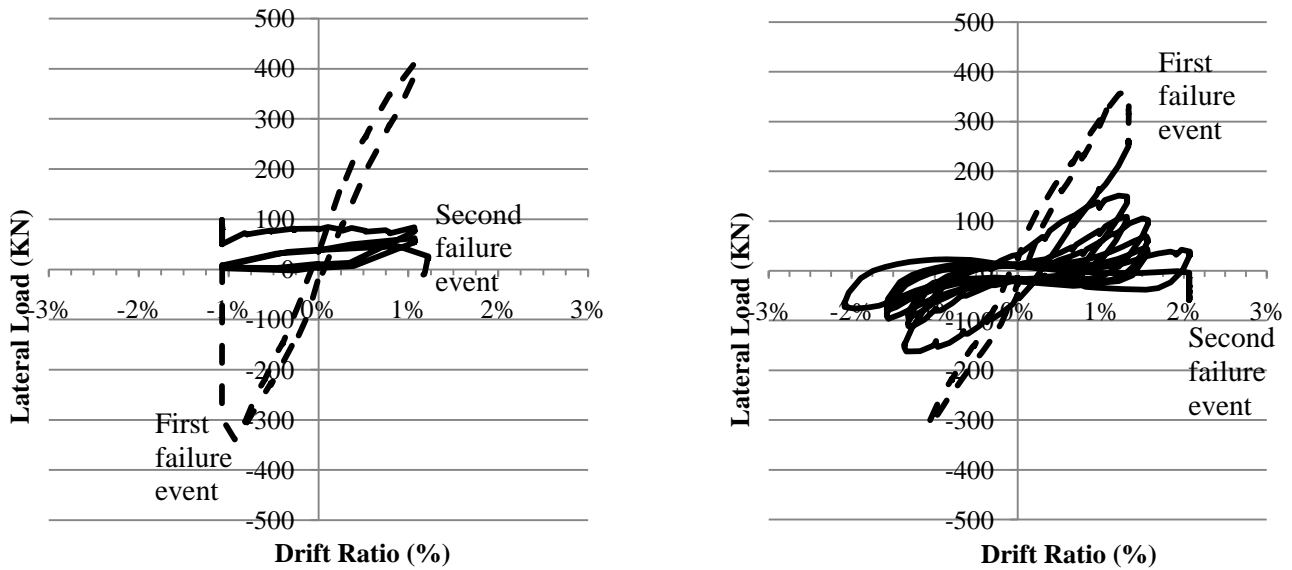
Figure 6. Load-deformation response for specimens 1 and 2 at drift demands beyond axial failure

One of the goals of the experimental was to improve the ability to simulate the behavior of column elements at drift demands larger than the drift associated with axial failure. The load-deformation response of the two specimens at drift demands beyond axial failure is shown in Fig. 6. The last load cycle prior to axial failure is shown by the dashed lines. The solid lines represent the response of the specimens after axial failure.

Figure 6 shows that the behavior of the two specimens was significantly different. Specimen 1 had negligible stiffness after the first failure event, and there was a relatively small increment in lateral drift ratio (to 1.2%) before the column lost its ability to carry the reduced axial load. In the case of specimen 2, the specimen had a very significant reduction in lateral stiffness after the appearance of the shear crack that caused axial failure, but the lateral stiffness was not negligible. Furthermore, there was a very significant increment in the lateral drift ratio before the ability to carry the reduced axial load was lost.

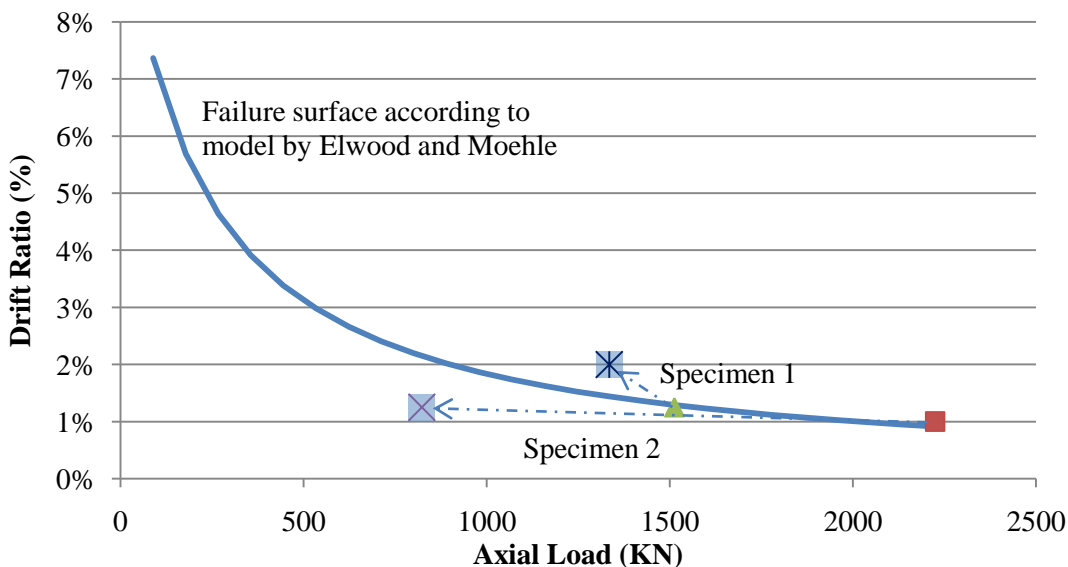
Figure 7. Relationship between drift ratio at axial failure and axial load for multiple failure events.

The drift ratio measured at each failure event was compared with estimates obtained using the failure model developed by Elwood and Moehle (2005). Results are shown in Fig. 7.

While the model by Elwood and Moehle (2005) provided a very close match for the first failure event, results were not as good for subsequent failure events. Furthermore, behavior beyond the first failure event was very sensitive to the axial load on the specimen. While the model by Elwood and Moehle overestimated the drift ratio corresponding to the second failure event of specimen 1 (higher axial load), it significantly underestimated the drift ratio corresponding to the second failure event of specimen 2 (lower axial load).
