USED CAR TYRE STRAPS AS SEISMIC REINFORCEMENT FOR ADOBE HOUSES

A.W. Charleson¹ and M. A. French²

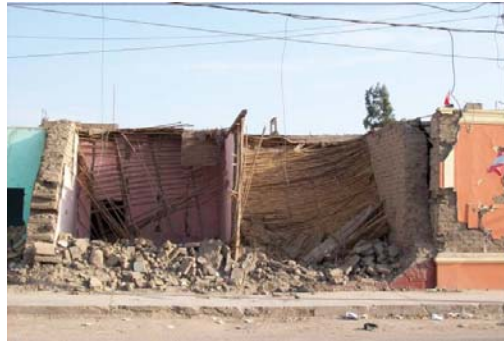
Figure 1 Partially collapsed adobe house. (D. C. Hopkins)

These failure modes were again observed as recently as August 2007 after the Pisco, Peru earthquake. In Pisco, the city closest to the epicentre, more than 80% of the adobe houses collapsed or sustained heavy damage (EERI, 2007) (Figs 1 and 2).

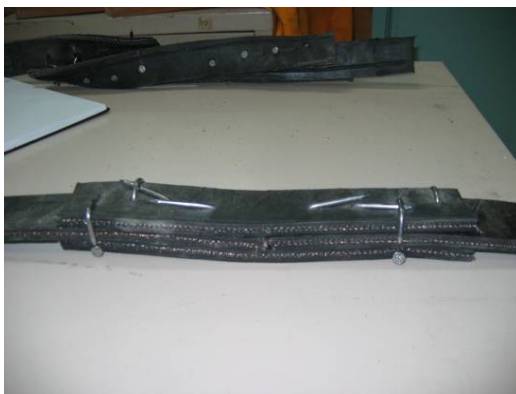
Figure 5 A completed nailed joint showing the bent nails that prevent premature nail pull-through.

The length of 40 mm wide strap that can be cut from car tyre treads depends on the tyre diameter and tread width. Typically it varies from between 4 m to 6 m, so there is a need for a reliable and straightforward on-site connection. Two connection options were investigated – bolts and nailing, but nailing proved to be the most effective. Two straps are butted together and connected via two short lengths of strap overlapping each side of the butt joint. A joint where nails on each side of the joint were bent carefully in certain directions provided the highest tension load, even though a nail pull-through failure mechanism still occurred (Figs 5 and 6). Nails had to be bent both parallel to and normal to the strip length for optimum performance. This connection, almost as strong as the strap itself, failed at 11.8 kN with four 3.15 mm diameter by 70 mm long nails through each strap on each side of the butt joint.

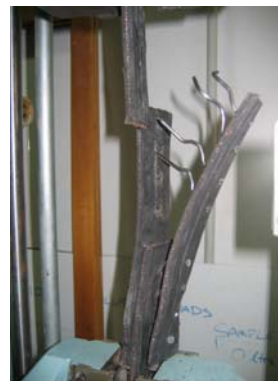
Figure 6 A failed connection where the originally bent nails have pulled-through.

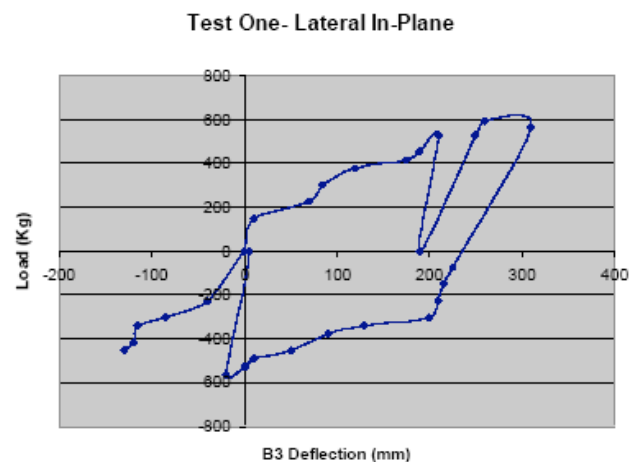
Figure 8 Load-deflection graph of the in-plane laden wall.

Analysis of the hysteretic loop (Fig. 8) indicates the damping of the wall to be approximately 15% of critical damping. The natural period of vibration of a typical wall supported by return walls in an adobe house is calculated to be in the range of 1.3 to 2.6 secs. Both the relatively high damping and long period of vibration reduce the seismic demand upon such in-plane laden walls.

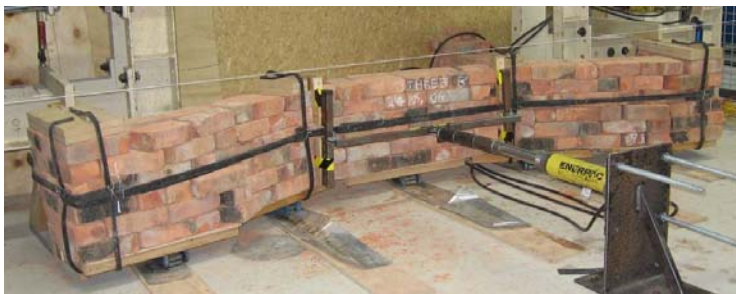
Figure 10 The out-of-plane test set-up with the wall pushed towards its supports.

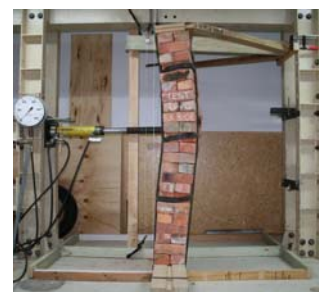
Figure 11 Out-of-plane load transferred vertically.

In order to resist out-of-plane forces acting on walls in the vicinity of window and door openings a vertical load-path is required. For this reason a dry-stacked wall reinforced with two pairs of vertical wrapped straps was tested (Fig. 11). When the hydraulic jack reached its maximum extension, the point load equivalent to 0.4 g, had caused a mid-height deflection of 120 mm. In a typical adobe house lacking a roof or ceiling diaphragm the vertical straps will span from the foundations to horizontal straps spanning between return walls.
