SHAKING TABLE TEST OF MODEL HOUSE OF BRICK MASONRY FOR SEISMIC CONSTRUCTION

T. Hanazato¹, C. Minowa², T. Narafu³, H. Imai⁴, Qaisar Ali⁵, K. Kobayashi⁶, Y. Ishiyama⁷
and T. Nakagawa⁸

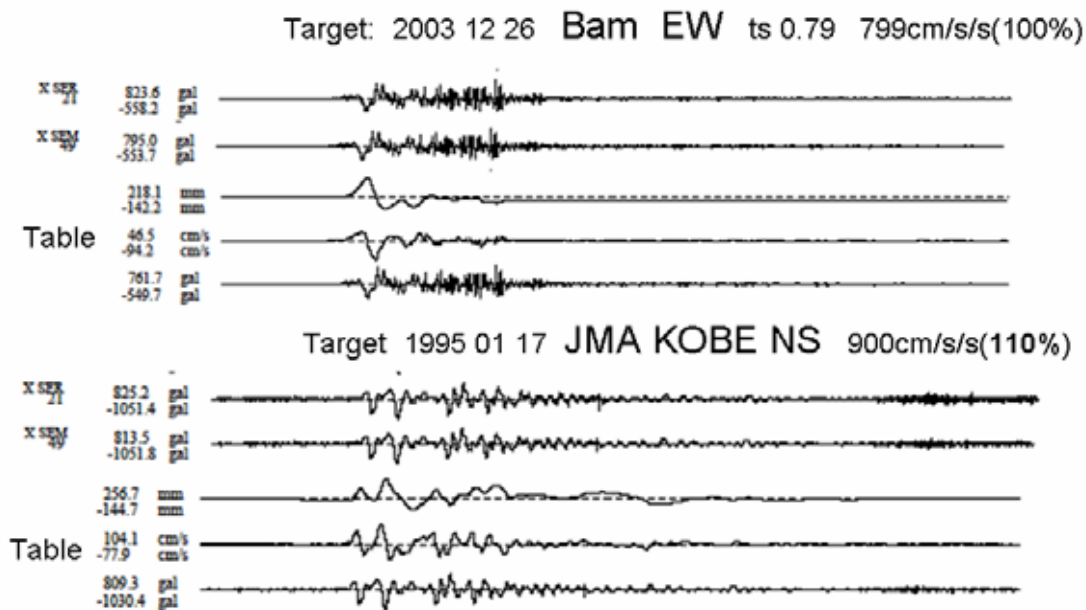
Figure 3. Responses of Bam No.2 and JMA KOBE No.3

At first, in order to check the vibration characteristics of the test house, amplitude 1mm rectangular wave of period 10sec were inputted into the shaking table. There was no natural frequency in the region of less than 20Hz. Table 1 is the input wave list of shaking table tests. In Bam(No.1 and 2) and JMA KOBE(No. 3) excitations, no damages occurred in the test house. The actual amplitude of time-scale reduced Bam excitation 94cm/s was less than the expecting amplitude 100cm/s. However, the actual amplitude of JMA KOBE 104cm/s was stronger than the expecting; 100cm/s as shown in Figure 3. The response accelerations of the test house at the roof

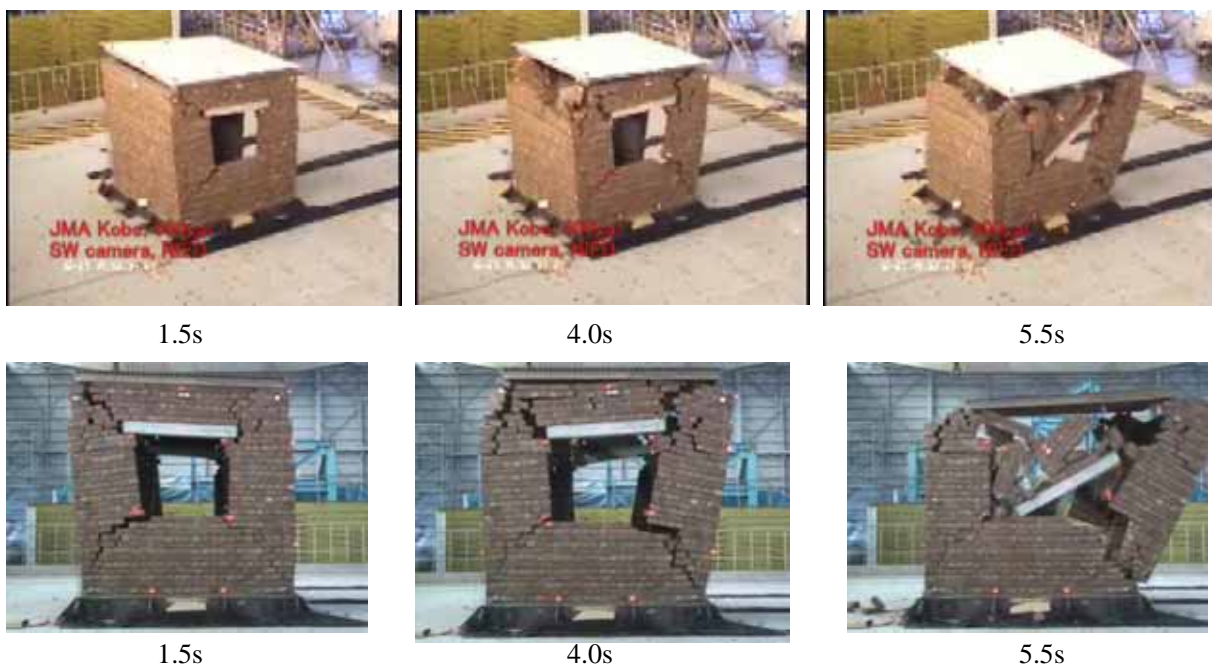
Figure 7. Continual Video Copies in JMA KOBE Excitation No.10

Next, the shaking table was excited by JMA KOBE No.10. In less than 10 second, the test house collapsed. Figure 7 are video copies of west and south walls, and the close video copies of south wall cracks. The collapse pattern of the shaking table test was similar to the collapse of Japanese brick building heritage in 2007 Niigata Off Chuetsu Earthquake.. Adhesion Tests indicated that the bond of cement mortar had the adhesive strength of 0.32MPa.

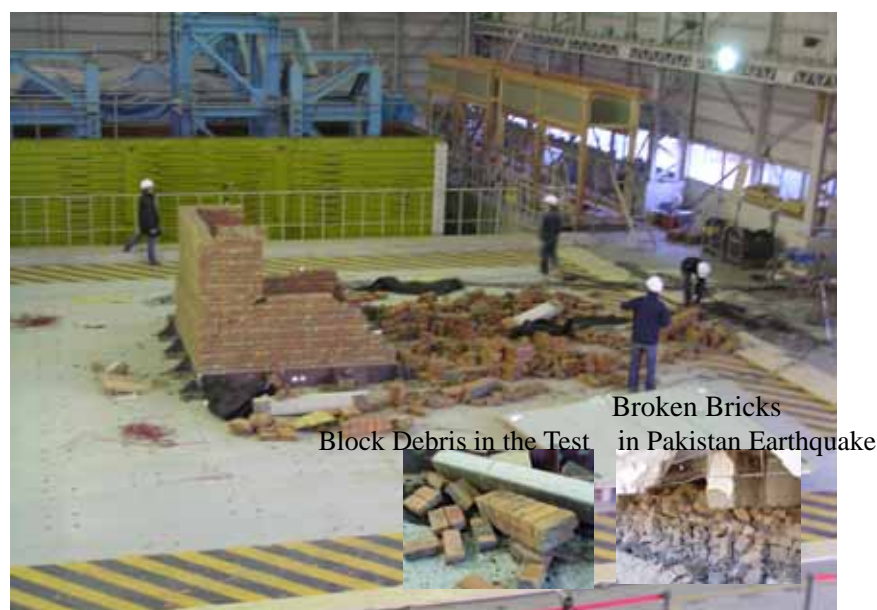
Figure 12. Collapsed Test House

In this shaking table test, one of outlines of masonry house collapse process was shown. Careful construction work would make a strong house. We carried out the collapsing process simulations of brick masonry structure that has tested at the shaking table tests by using newly developed DEM program. Our analysis program is under development, but the crack pattern of the numerical analysis was similar to the shaking table results qualitatively. By improving our analytical method, it proved to be promising for measuring seismic design of masonry structure. Collapse modes of shaking table test and numerical simulation are something different from actual collapse modes as shown Figure 12. Further study on masonry structures is necessary.
