Disaster Protection Technology of Traditional Wooden cultural Buildings

Yasuhiro Araki¹

¹ Research fellow, Earthquake Disaster Mitigation Research Center, NIED, Japan

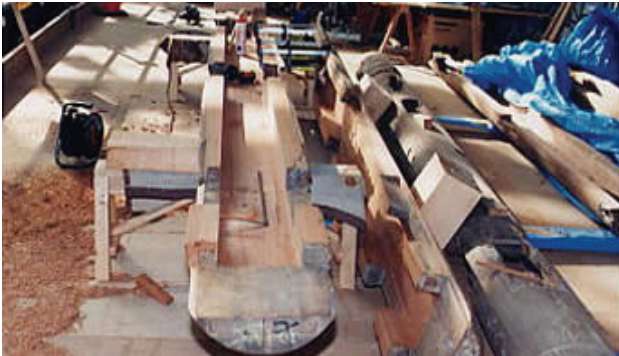
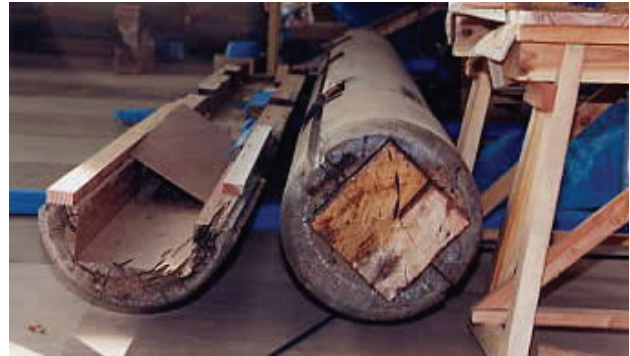
At the time of replacing materials, maximum reuse of members of buildings (= timber) and minimum replacement of damaged members are considered as much as possible. For example, when the inside of a column is found out damaged at the time of dismantlement, the inside part, where the member is damaged, will be removed, and a new material substitutes for the part removed. Therefore, outside of the columns don't change (Figure 2.1).

Figure 2.1 Example of maximum reuse and minimum replace

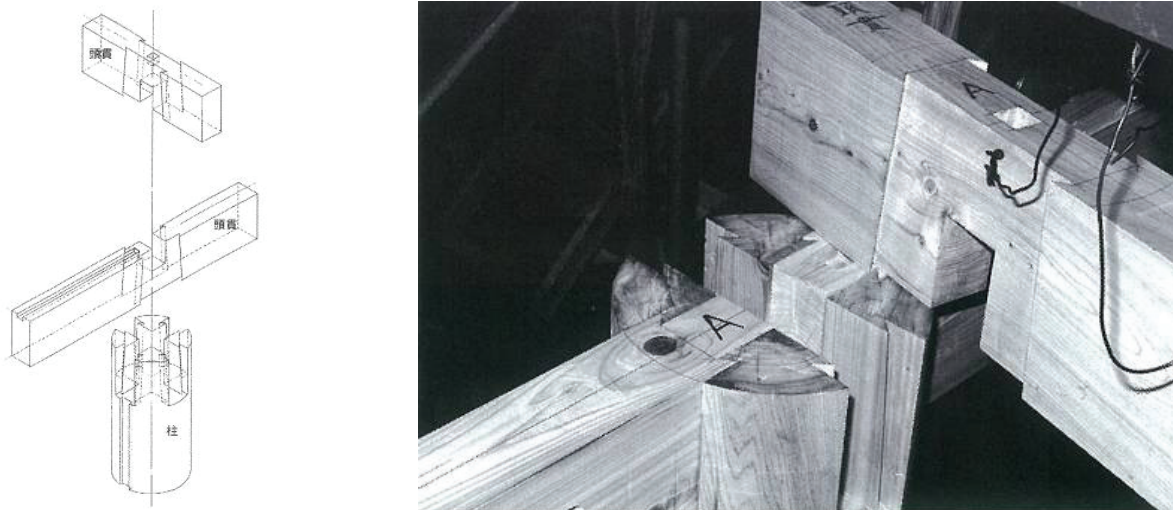
Figure 2.4 Example of “nuki” (= a kind of joint of column and beam)

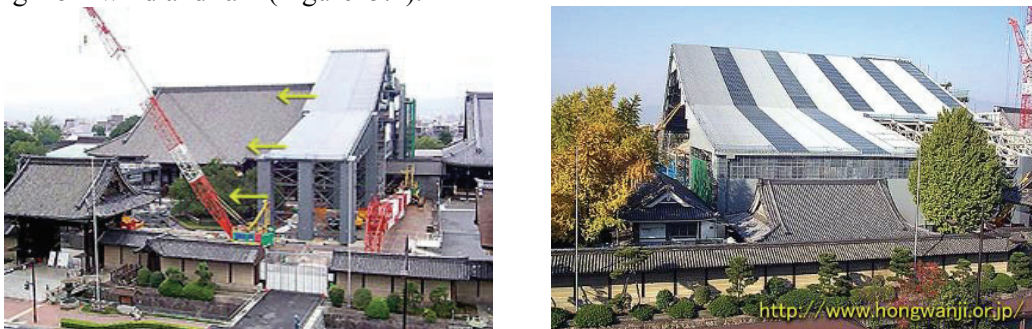
Usually at the time of dismantlement of the buildings like temples, temporary housing is needed to protect the entire building from wind and rain (Figure 5.1).

Fig.5.1 Examples of temporary housing

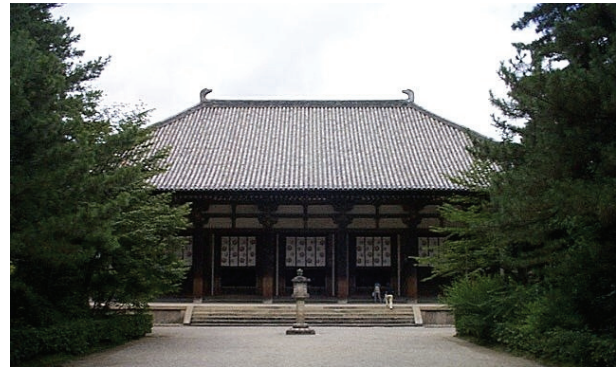
Figure 6.1 Toshodaiji Kondo

Because of the damages of Hyogo-ken Nanbu Earthquake in 1995, this temple needs large scale of repairs with dismantlement and improvements of structural performances. This time the latest structural analysis technologies are applied to this temple.

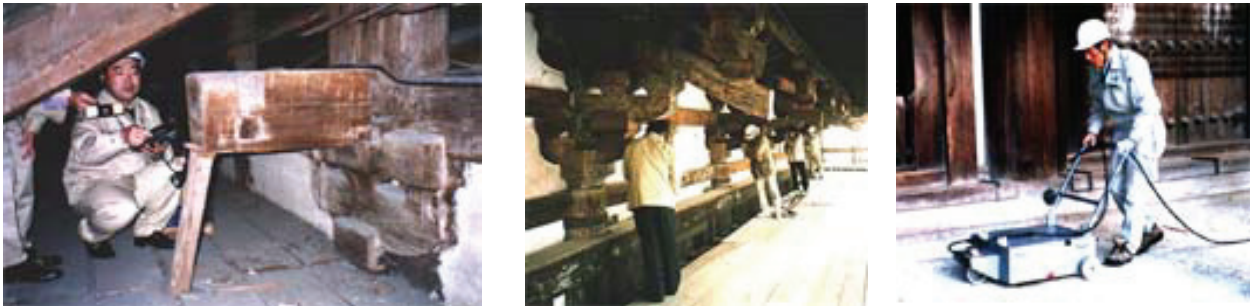
The deterioration and structural investigation enable designers to evaluate deterioration and structural performances of the temple and propose the repair plans considering for maximum reuse of members and

Figure 6.2 Example of deterioration and structural investigation

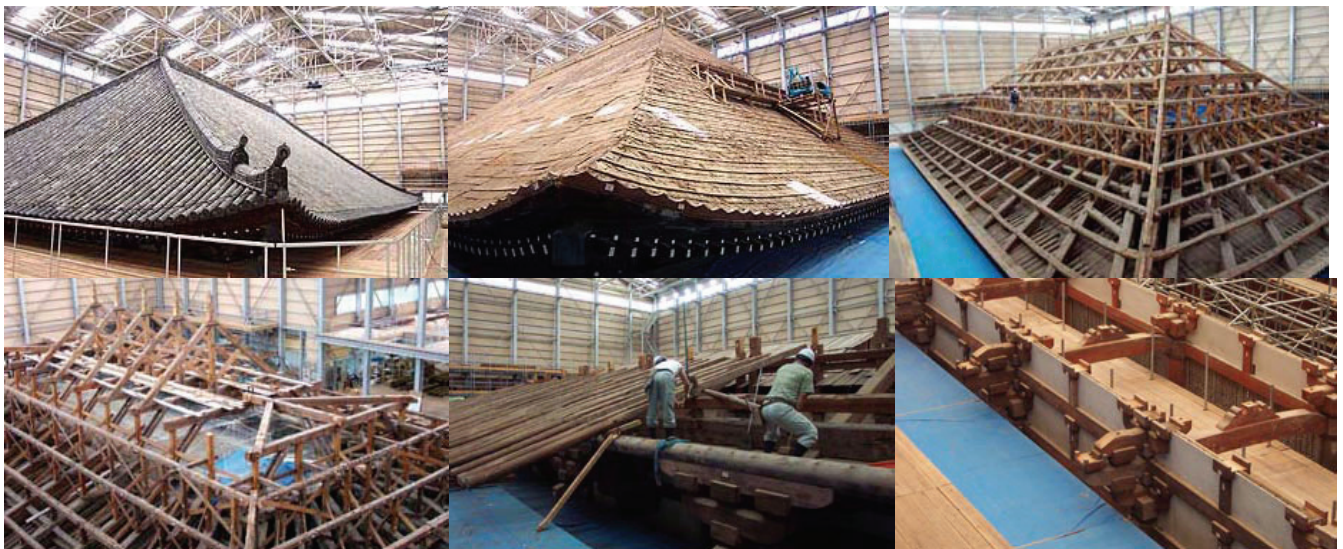
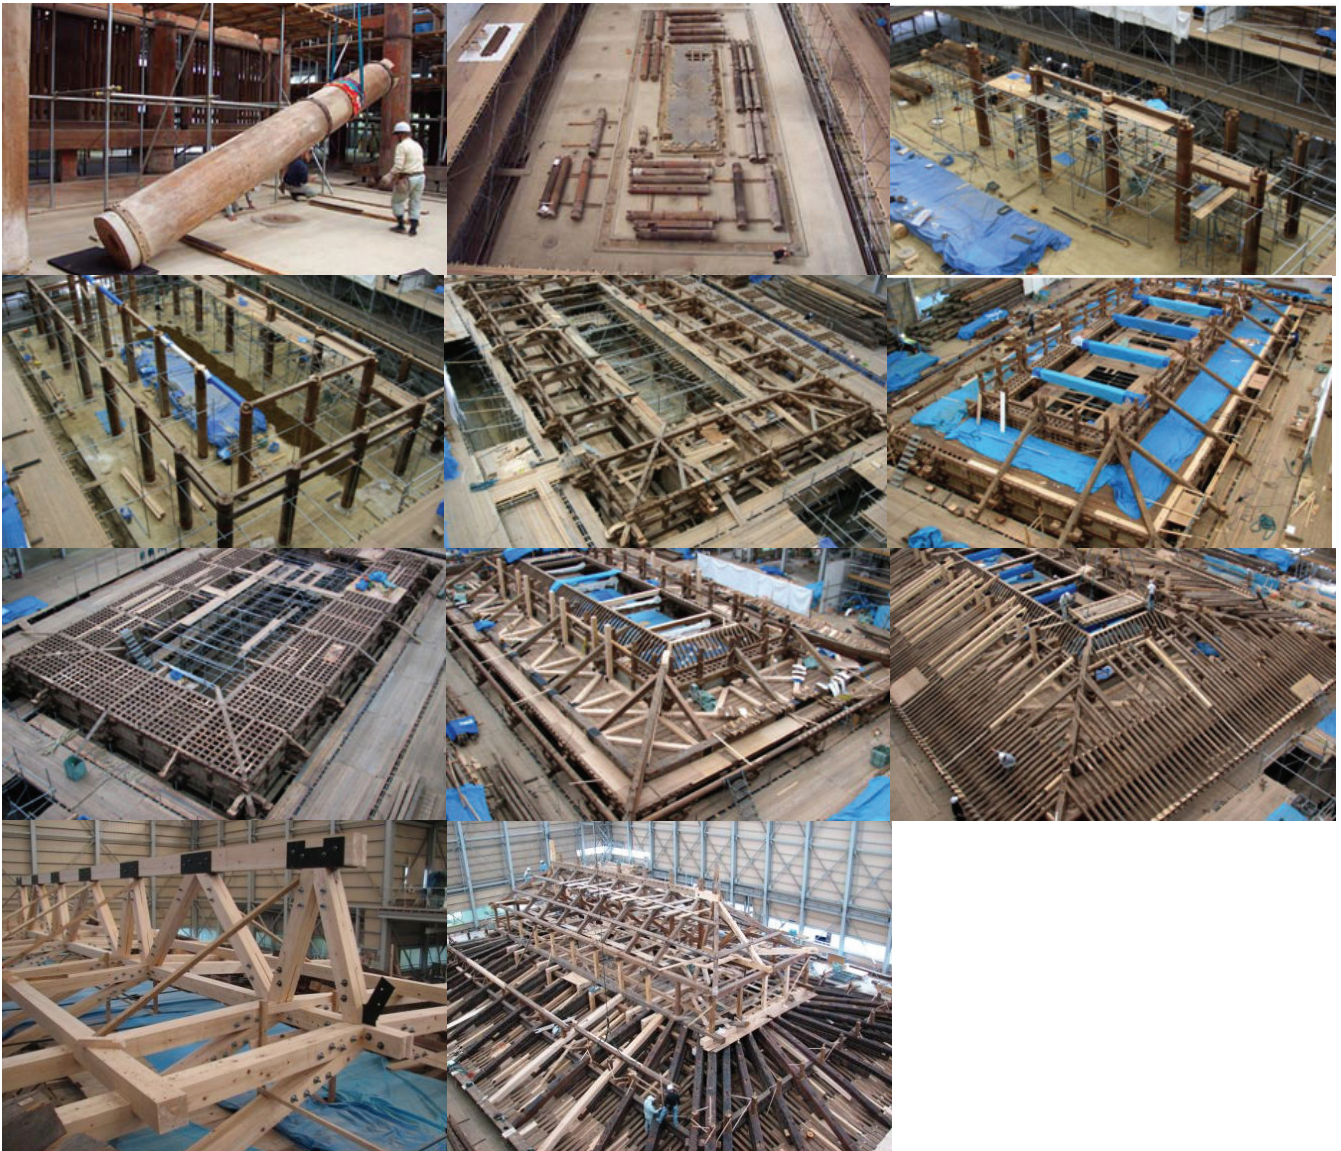
Preservation technologies such as “Regular maintenance with appropriate intervals” and “Maximum reuse of members of buildings” are considered to be connected with sustainability of buildings (Figure 6.4)

Figure 6.4 Example of repair with dismantlement(1)

Figure 6.4 Example of repair with dismantlement(2)
