THE SEISMIC DAMAGE OF THE RURAL DWELLING BEARING WALL AND ITS IMPROVEMENT MEASUREMENTS

ABSTRACT :

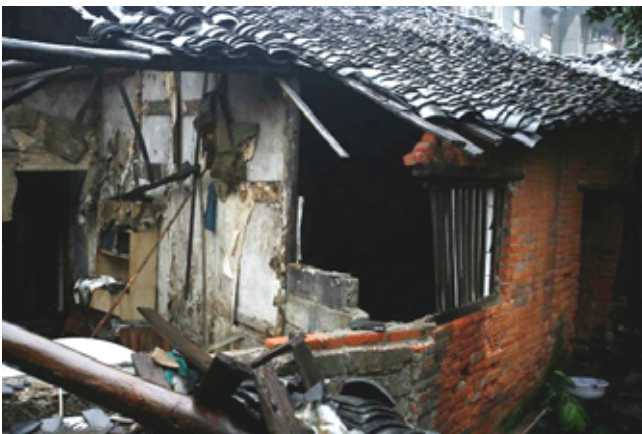
Figure 7 Brick-wood structure, Ms 8.0 Wenchuan Earthquake

Brick-wood structure is a mixed structure that the both of brick wall and wood stud bear the whole building weight. Hereinafter some designed and constructional problems would be found. Fortunately, brick-wood structure decrease gradually because of forest protection

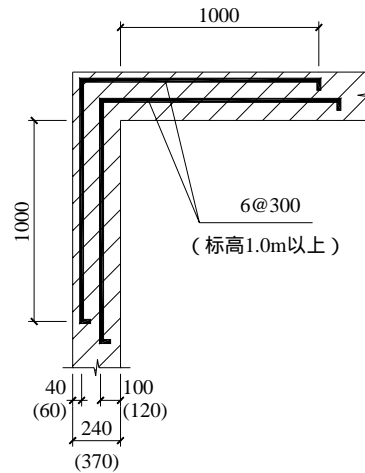
(a) Reinforcing steel bars in outside wall joint under intensity 6

Figure 15 One of the strengthen methods at masonry wall joint with “L” type

One of the strengthen methods at “L “ type joint of masonry walls with two reinforcing steel bars is demonstrated in Figure 12. Figure 12 (a), (b) and (c) show deferent length and diameter of steel bars under intensity 6, 7, 8 and 9, respectively.

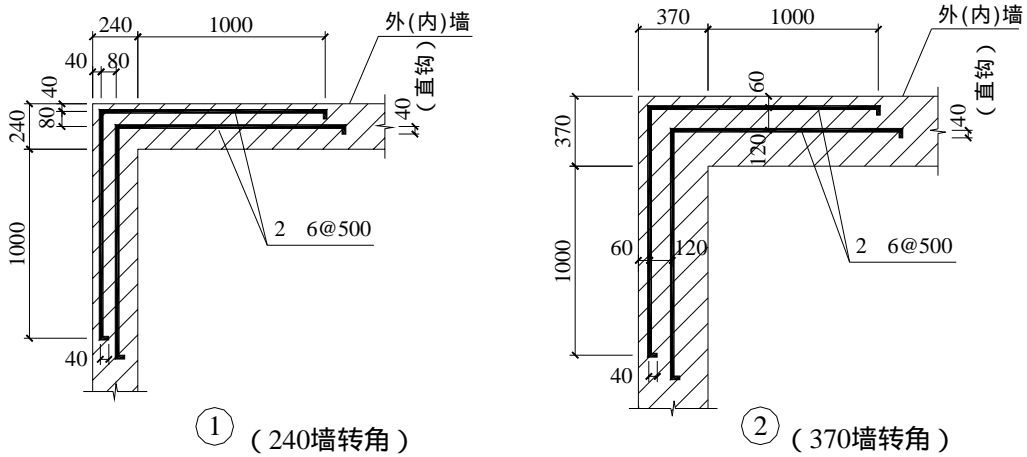
(b) Reinforcing steel bars in outside (interior) wall joint under intensity 7 to 9

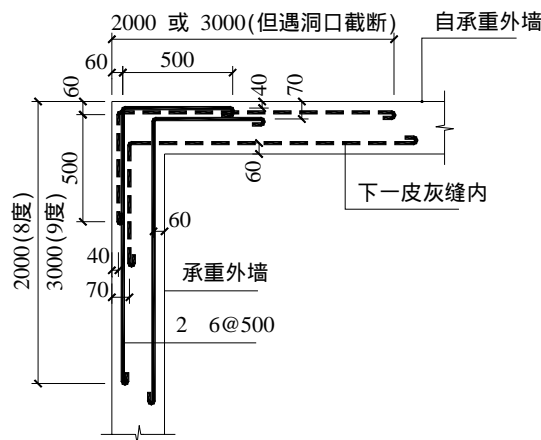
(c) Reinforcing steel bars in outside wall joint under intensity 8 to 9

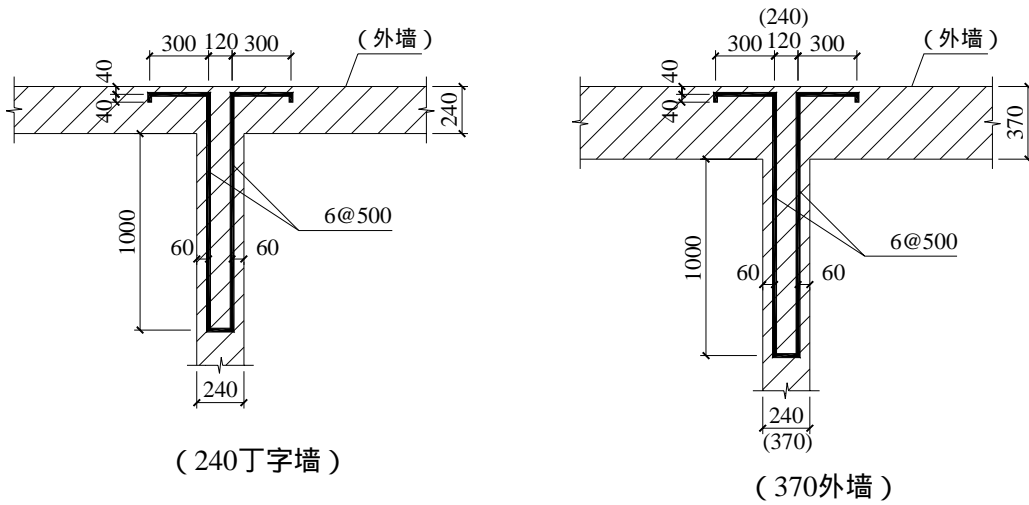
(a) and (b) Reinforcing steel bars in interior and outside walls with thickness 240 and 370 mm respectively

Figure 16 One of the strengthen methods at masonry wall joint with T type

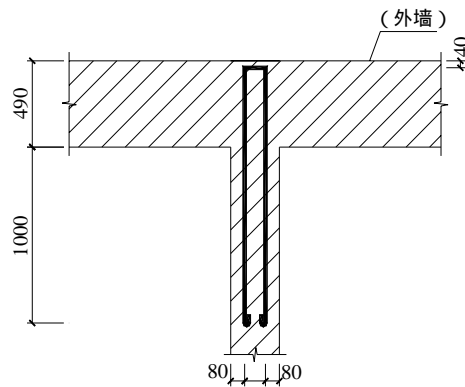
(c) Reinforcing steel bars in outside wall with thickness 490 mm

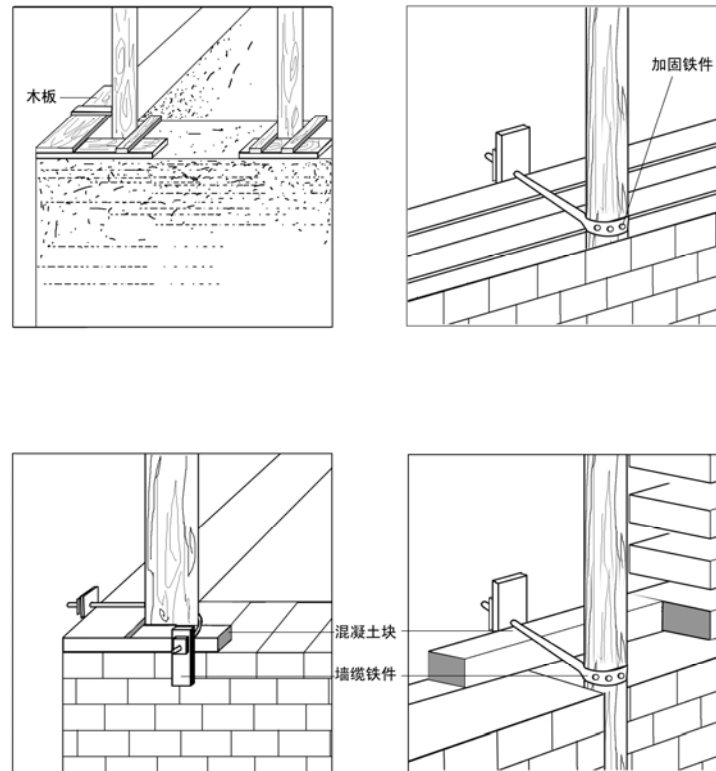
Figure 15 4 ways connected with brick wall and wood stud

Because the both of brick wall and wood stud bear the whole building weight for brick-wood structure, it is necessary to connect brick wall and wood stud by suitable ways. 4 ways connected with brick wall and wood stud are displayed in Figure 15.
