LESSONS LEARNED FROM WENCHUAN EARTHQUAKE: TO IMPROVE THE SEISMIC DESIGN OF SCHOOL BUILDINGS

Z.H. XIONG

*Engineer, Ove Arup & Partners Hong Kong Ltd, Hong Kong SAR, CHINA
Email: david.xiong@arup.com*

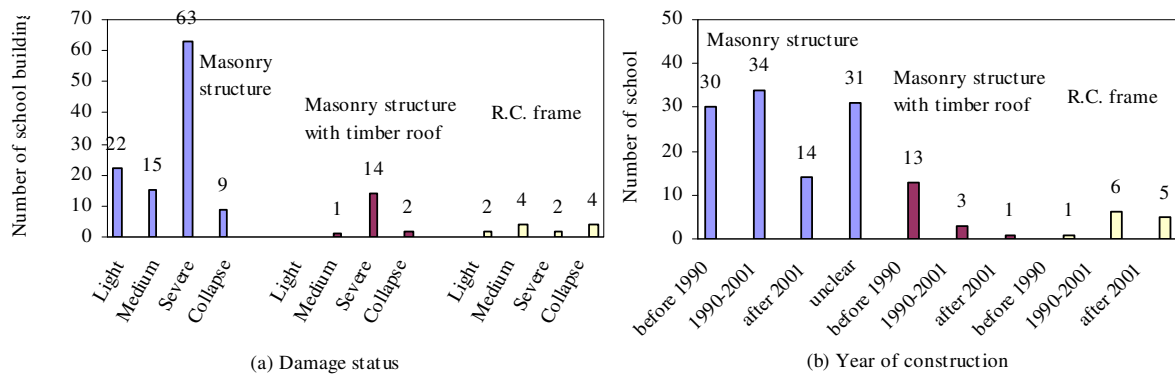
Figure 1 Survey results of damaged school buildings in Wenchuan earthquake

The death of so many students and teachers and the collapse of large number of school buildings in the earthquake have attracted a social-wide attention. The data of the survey result which provides the information of collapsed and damaged school buildings is shown in Figure 1.

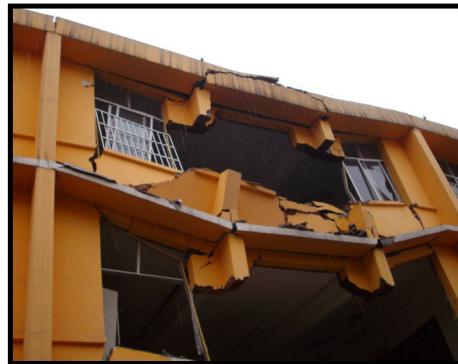
Figure 3 The collapse of the external wall of the teaching building of Hanwang Town Secondary School

The importance of tying all components of the structure is illustrated by Figure 3. The collapse of the upper part of the brick walls on the sidewalk is due to the lack of proper connection with the roof. A building should be tied at the roof and floor levels continuously from exterior to exterior walls.

The ring beam and the structural/seismic column can not only significantly increase the strength and ductility of brick masonry wall before the damage but also prevent collapsing and scattered after cracking. The significant contribution of the ring beam and structural column on improving seismic performance of school buildings can be found from many cases. For example, one major reason that a school building in Xiang'e primary school did not collapse was the structural columns arranged in brick walls. A three-storey school building in Hanwang town secondary school was seriously damaged and the external wall fell down but the building was not collapse because of the contribution of ring beams (Figure 3).

- Spandrel wall in-plan damage is mainly shear damage (Figure 2c).
- Out-of-plane bending damage/collapse. The out-of-plan collapse of longitudinal brick masonry wall is also very common in this earthquake particularly the walls supporting cross beams. Figure 3 shows the damage of the main teaching building of Hanwang Town Secondary School. The longitudinal wall collapsed although Special-Shaped brick columns were designed to support the cross beams and increase out-of-plan stiffness of external wall. Two conclusions can be drawn from this damage: the out-of-plan stiffness of longitudinal wall is weak although the special-shaped brick columns have been designed; the RC beam did not work well with brick column because it was made of different materials and the connection was not carefully optimized (no tie bar to connect these two elements together).

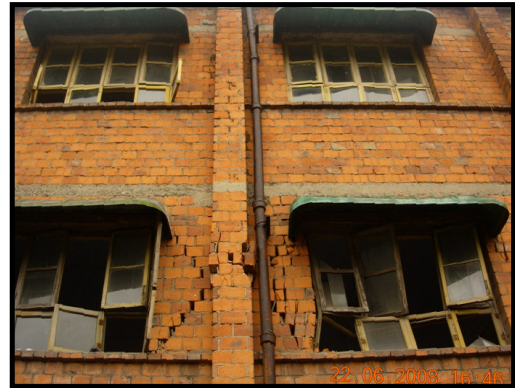
Figure 4 The collapse of the external wall

- Wall pier in-plan shear damage (Figure 4). According to the Chinese code GB99-86, clause 5.3.2, 'the standard width of the wall between the windows should not exceed 1.2 m'. Such a requirement is based on only considering the light and the ventilation. However, from the structural point of view, the in-plan stiffness of longitudinal wall will be significantly reduced by applying such a restriction. The width of the wall pier is too small to sustain both the longitudinal in-plan shear force and the vertical pressure during earthquake; it led to short column shear failure. In some cases, there is no concrete bearing block beneath the main cross beam. The load from the beam could not spread to the brick masonry wall evenly and that may cause local compressive failure of the brick wall. It further induced beam and floor slab collapse.

Based on the seismic performance of external wall and design code requirements, it is not practical to increase the width of the wall pier between the windows to increase its shear capacity and it is not effective to use special-shaped brick column to enhance out-of-plan stiffness. Therefore, it is recommended to use restrained brick masonry wall to replace the traditional masonry wall with a ring beam and a seismic column (structural column). This means seismic column should be arranged not only at the conjunction of horizontal and longitudinal walls but also under the cross beam and other locations such as both sides of openings. Also, it is recommended to provide an additional RC structural beam beneath the window if it is too large. These structural columns and beams will effectively restrain masonry walls and work together with them. The restraint masonry structure has much better seismic performance than dose the traditional masonry structure. Comparing with RC frame structure, the restraint masonry structure can save up to 20% construction cost.
