LIQUEFACTION, LATERAL SPREADING, SLOPE AND EMBANKMENT FAILURES DURING THE MARCH 13 EARTHQUAKE OF ERZINCAN, TURKEY

ABSTRACT

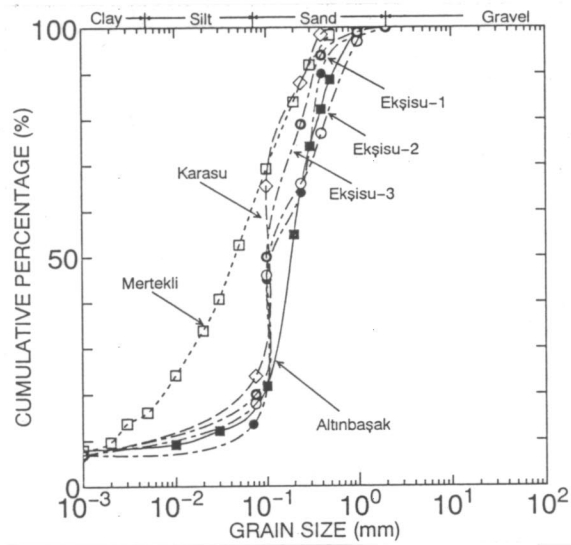
Fig. 5 Grain size distributions of liquefied soil samples

Severe liquefaction and liquefaction induced lateral spreading of ground were observed at Ekşisu, Karasu, Mertekli and Altınbaşak. (Photos 1-4). These localities are the old marshlands which were dried through an extensive network of drainage canals in the basin. Figs. 5 and 6 show particle size distribution curves of liquified ground at various locations and their porosities vs. unit weights. The samples were collected from sand volcanoes. In-situ explorations at Ekşisu showed that the top 4 m soil layer was silty sand or sandy silt with an SPT value ranging between 2-7 and with shear velocity V_s of 80-156 m/s. The ground water level is 0.5-2m below the ground surface which makes the ground to be susceptible to liquefaction (Erken et al. 1995).
