## **STRUCTURAL PROJECT OF THE REINFORCEMENT OF TWO BUILDINGS WITHOUT SEISMIC DAMAGES**

**RAUL J. IZQUIERDO and HERIBERTO IZQUIERDO**

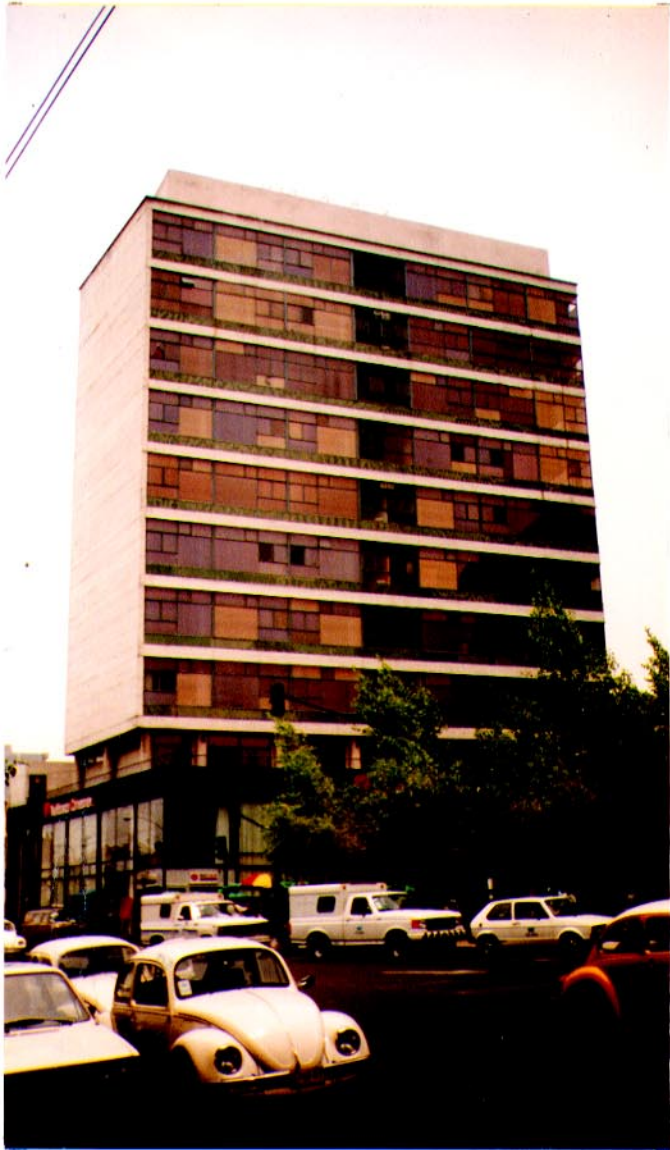
Original

Through the years this structure suffered no structural damage to the frames, but a lot of non-structural problems, such as crackings in the walls and broken windows.

After making the tridimensional analysis, design of the reinforcement and review of the capacity of the existing sections, it was found that the whole system worked. The technical information of the initial building and the actual one is shown in table form after the conclusions.

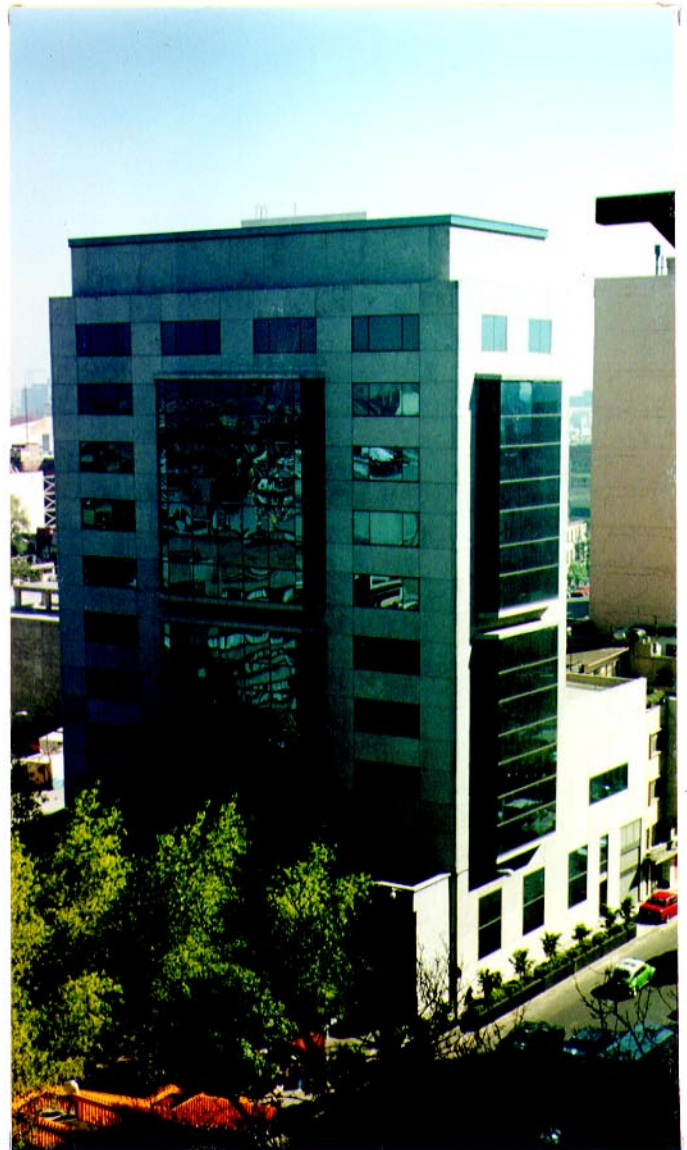
Actual

The reinforcing was finished in late 1994, matching the time and cost schedules. The vertical movement registers ( Fig.3 ) show that the performance of the structure has been according to the expectations and the aspect of the building is of a new one.

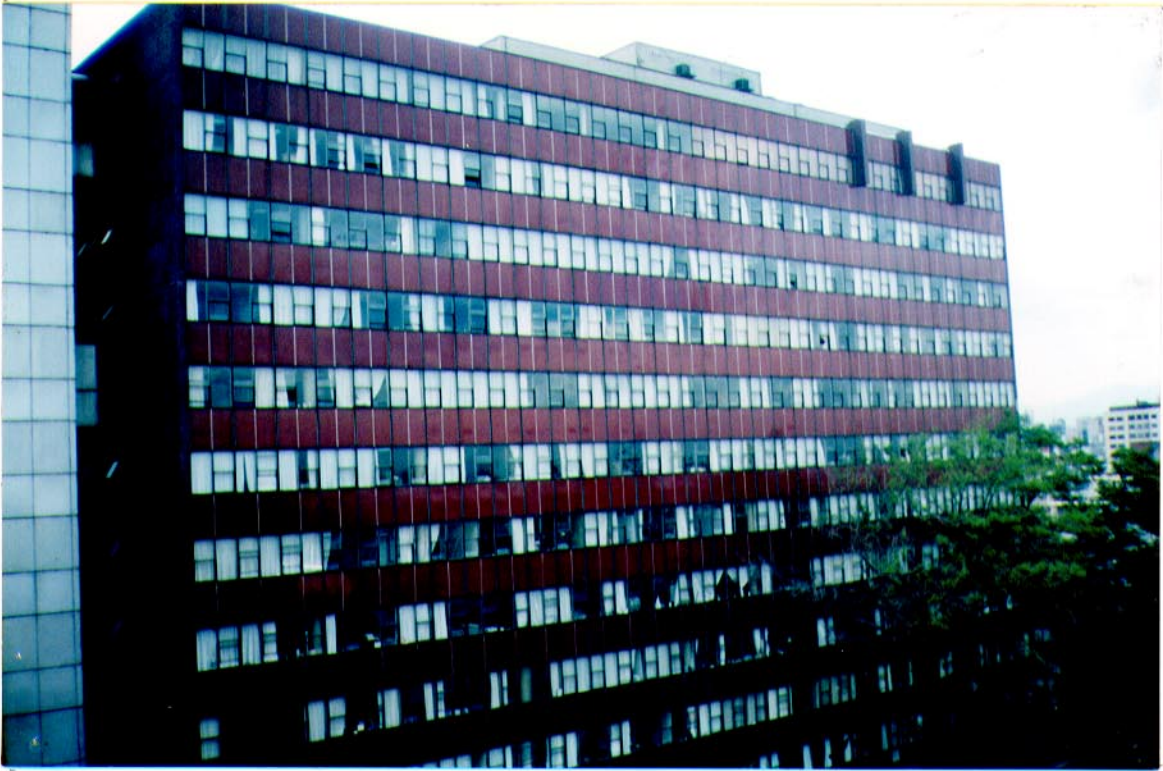
**Original**

The building did not have any structural damage, having only the "normal" non-structural problems in partition walls caused by the earthquakes because of its low lateral stiffness.

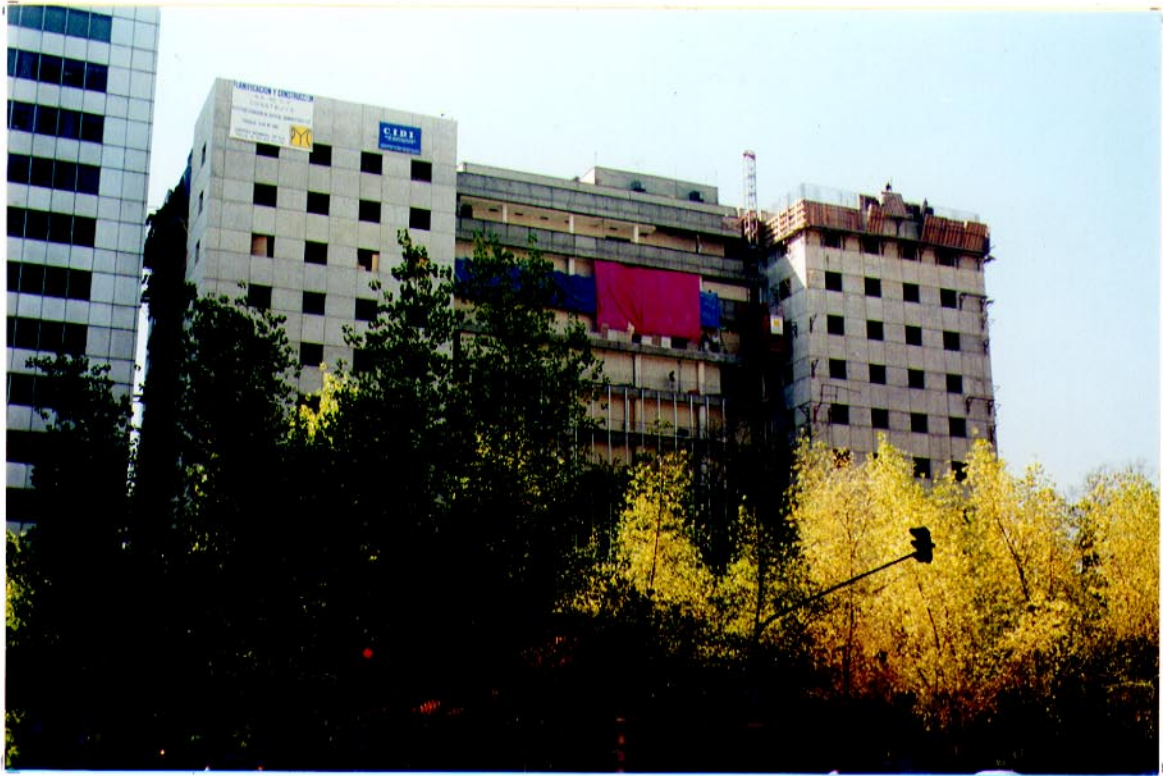
**Actual ( January 1996 )**

During the earthquakes of Sept.14 and Oct.9 1995 the reinforcement was up to the fifth floor. No damage resulted from the ground to that level, but in the upper ones some crackings in the partition walls were found.
