INVESTIGATION OF SPREAD FOUNDATIONS ON LIQUEFIED RECLAIMED GROUND AFTER THE 1995 HYOGOKEN–NANBU EARTHQUAKE

Y. Hirai, M. Kakurai, M. Maruoka, K. Yamashita and M. Aoki
Research & Development Institute, Takenaka Corporation, Chiba, Japan.

Copyright © 1996 Elsevier Science Ltd
Paper No. 1689. (quote when citing this article)
Eleventh World Conference on Earthquake Engineering
ISBN: 0 08 042822 3

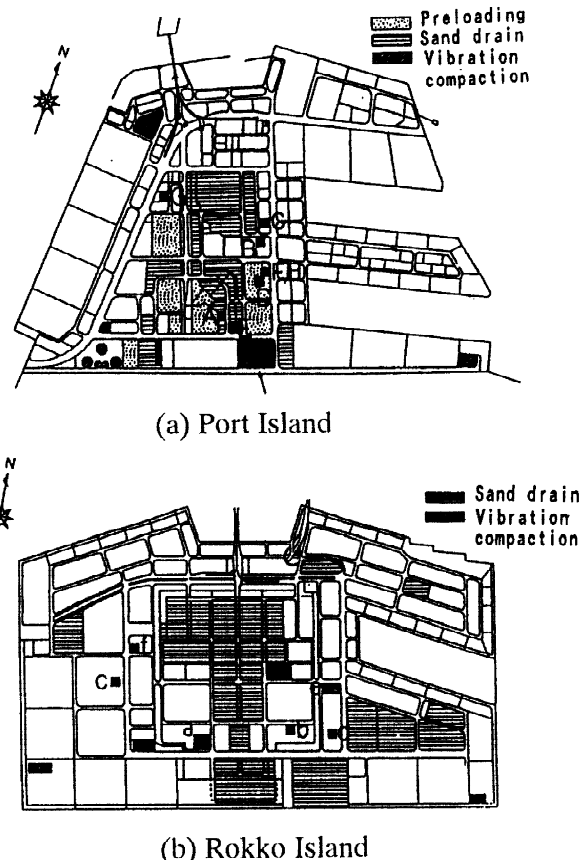
Fig.4. Ground improved area and location of investigated buildings.

employed at the center of the reclaimed area to promote consolidation of the alluvial clay layer and in some buildings sites sand compaction pile method was applied to the reclaimed layer. The soil improvement methods and the improved areas are illustrated in Fig. 4.

In Port and Rokko Islands eight and six selected buildings with spread foundations were surveyed respectively. The locations of the buildings are shown in Fig. 4. The buildings were first investigated externally. Then leveling was conducted at points which could be safely assumed to have been horizontal before the earthquake such as the upper end of the first floor tile joints on external columns of the buildings.
