SEISMIC RETROFITTING OF STONE HOUSES IN MARATHWARA AREA, INDIA

ANAND S. ARYA

Professor Emeritus, University of Roorkee
Roorkee, INDIA

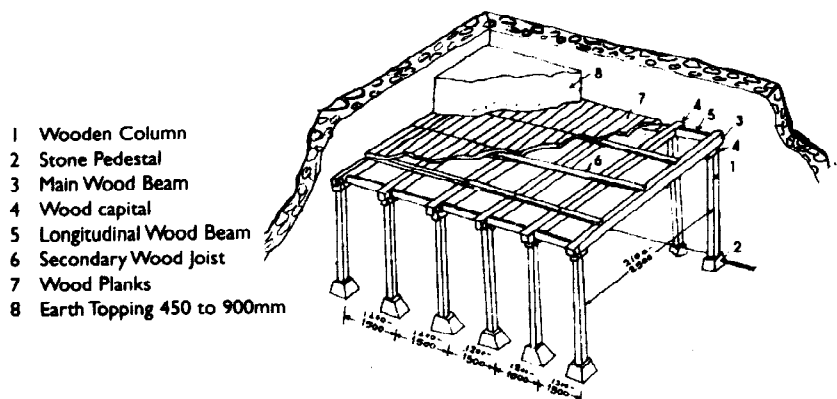
Fig. 1 Typical House Details (Arya, 1994)

The predominant traditional houses (80 percent of total housing stock) are generally single storeyed and have the following features (See Fig. 1, Arya, 1994)

Roof : Wood beams, wood plank deck, earthfill on top 450 to 900 mm in thickness

Walls : Random rubble laid in clay mud, facia stones semi-dressed, walls generally thick 600 mm to 1100 mm, built in two wythes with hearting filled with small stones and clay mud.

Wood posts : Local wood 150 mm x 150 mm in cross-section, spaced about 1.2 m apart abutting the long stone walls, supporting the main beams of the roof. They rest on stone pedestals at base and connected to beams with mortise-tenon joints.
