EFFECTS OF THE HANSHIN-AWAJI GREAT QUAKE DISASTER ON THE AKASHI KAIKYO BRIDGE

SHOICHI SAEKI, Executive Director, HSBA
KAZUO TADA, Director-General of Second Operation Bureau, HSBA
MAKOTO KITAGAWA, Manager of First Design Division, HSBA
ATSUSHI NITTA, Manager of Third Design Division, HSBA
TOSHIHIRO KURIHARA, Deputy Manager of Third Design Division, HSBA

Honshu-Shikoku Bridge Authority (HSBA)
Toranomom 45 Mori Bldg., 5-1-5 Toranomom, Minato-ku, Tokyo 105, Japan

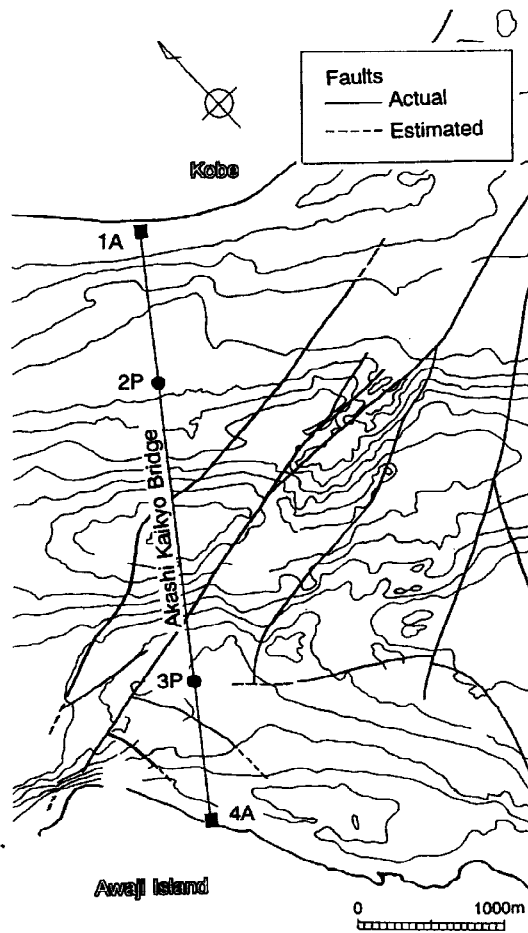
Fig. 2. Submarine geography and estimated fault lines near the Akashi Kaikyo Bridge

Borehole surveys and sonic prospecting indicated the presence of east-west faults centered on F1, F6, and F7 as well as perpendicular south-north faults (see Fig. 2). All of these faults are within the Kobe strata or deeper layers, and they do not extend into the alluvium, upper diluvium, and Akashi layers. This indicates that these faults have not moved for at least the last two million years; that is, they are not active faults.

The east-west faults, including F1 — which as noted do not enter the Quaternary layers, were very seen in sonic prospecting around the center of the straits. However, they were less clear in the east and west extensions. In choosing locations for the bridge foundations, the positional relations between the extension of F5, one of the south-north faults, and 3P, and those between the extension of F11 and 4A were surveyed by sonic prospecting and other methods. This work confirmed that neither fault extended into the area earmarked for the foundations. Thus, the foundations of the Akashi Kaikyo Bridge were placed so as to avoid the faults existing in the straits. The status of seabed faults after the Southern Hyogo Earthquake has been surveyed by the Maritime Safety Agency. The new faults located in this survey are shown in Fig. 3. There are apparently no new seabed faults in the vicinity of the bridge.
