A CASE STUDY FROM THE NORTHRIDGE EARTHQUAKE

M. ALA SAADEGHVAZIRI

Dept. of Civil Engineering, New Jersey Institute of Technology
Newark, NJ 07102-1982, USA

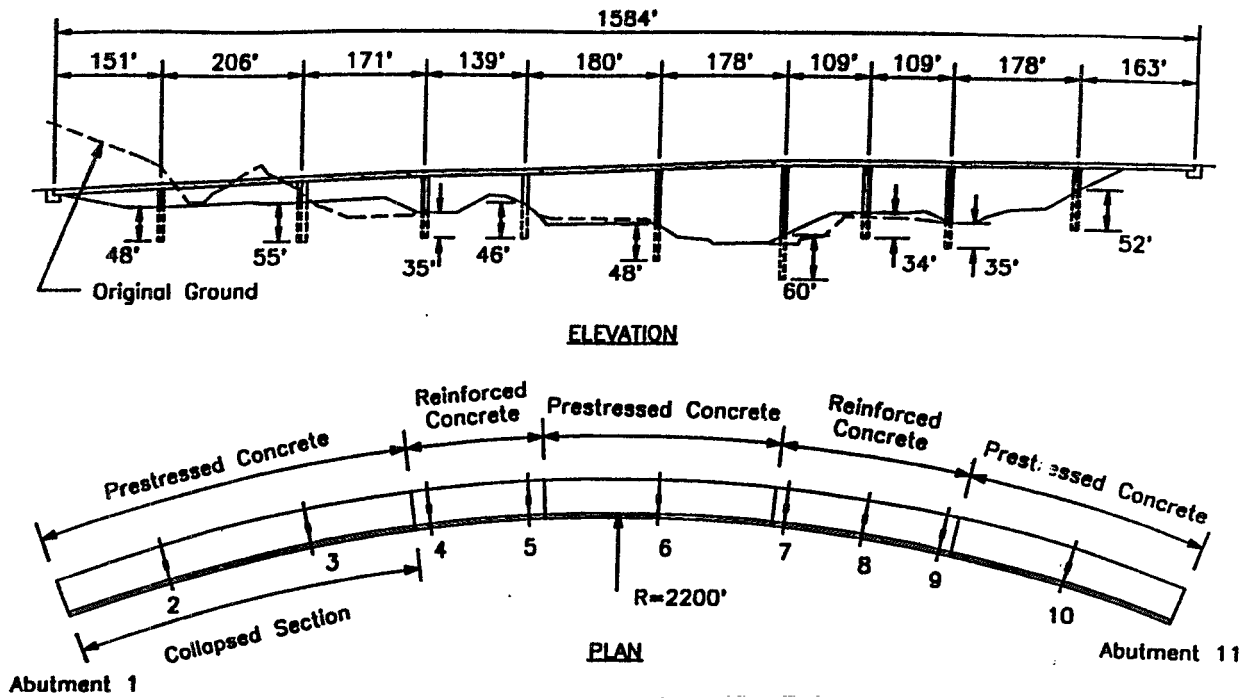
This is a 10-span structure with five frames connected to each other through expansion joints. The general elevation and plan of the bridge are shown in Figure 1. The ends and central frames have cast-in-place prestressed box girder superstructures. The other two frames (i.e. frames 2 and 4) have reinforced concrete box girder superstructures. The depth of the superstructure is 7', and the hinge seat width is 14". The superstructure is supported on elastomeric bearing pads on 3' wide seat abutments at each end. The abutments are founded on spread footings. All bents consist of single rectangular columns of 12'X4' to 12'X6' which flare to a 26' width

FIG. 1. General Elevation and Plan (from Priestley *et al.*, 1994)

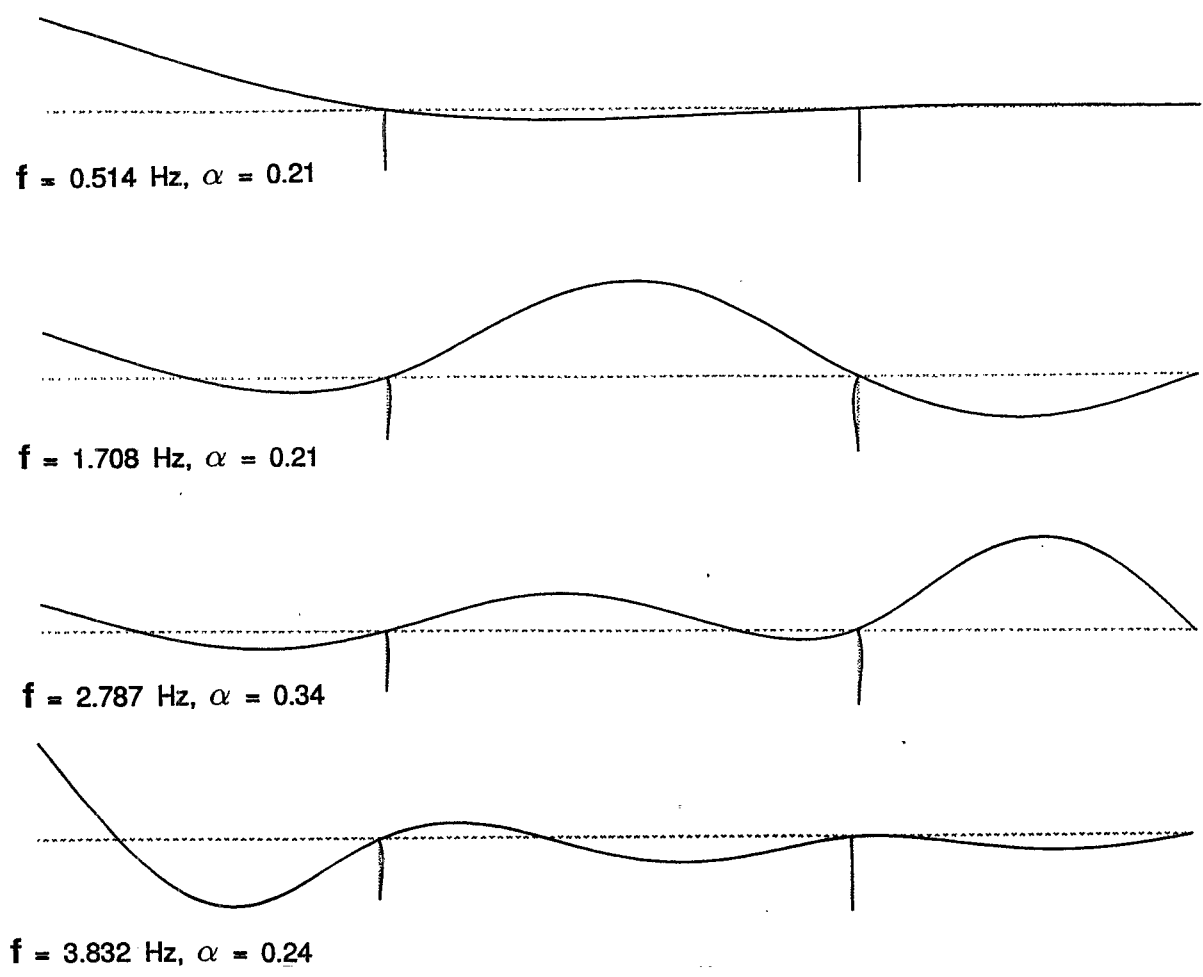
Due to nonlinear boundary condition at the abutment, the mode shapes, frequencies and participation factors will be different in the downward direction from those in the upward direction. Therefore, to determine the dynamic properties of the system two linear cases are considered. In one case the abutment is assumed pinned and in the second case the abutment is assumed to be free. The former will correspond to motion in the downward direction and the latter to motion in the upward direction. In the downward direction the response is dominated by only one mode shape which is shown in Figure 3. The dominant mode shapes, frequencies, and participation factors for upward motion are shown in Figure 4. As it can be seen from these figures, the dynamic response of the system in the upward direction will be significantly different than its response in the downward direction.

FIG. 4. Dominant Mode Shapes in the Upward Direction
