SEISMIC REHABILITATION OF A LARGE MANUFACTURING PLANT

STEVEN P. SHEKERLIAN, AND ERIC C. WICKSTROM

EQE International, Inc.
18101 Von Karman Avenue, Suite 400
Irvine, California 92715-1032
USA

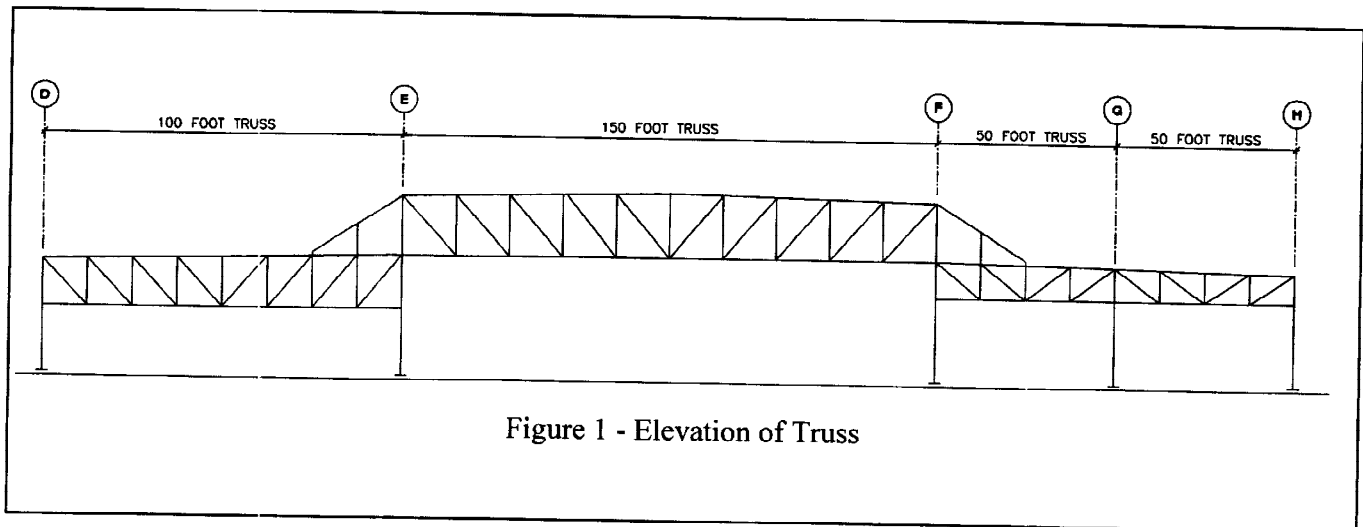
structures to minimize thermal stresses and allow for expansion. There are a total of 84 transverse timber moment frames divided into four bays spanning up to 150 feet (see Figure 1). The structural system consists of trussed moment frames in the transverse direction and braced frames in the longitudinal direction. The building was originally designed to the 1940 Uniform Building Code (UBC).
