SEISMIC EVALUATION OF BELEN CHURCH IN MERIDA, VENEZUELA

A. I. UZCATEGUI and P. J. MONTILLA

Departamento de Estructuras, Facultad de Ingeniería, Universidad de Los Andes,
Av. Tulio Febres Cordero, Mérida, Venezuela.

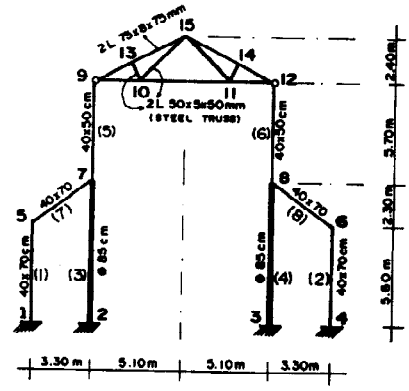
(a) Frame A. With central columns continued to ground level.

columns do not reach the ground. In Fig. 4 the collapse mechanisms are shown for transverse frames under the selected earthquakes. For both earthquakes failure is produced by the formation of a lateral mechanism at the top level. In Frame A collapse is produced under the El Centro scaled at 30.3% of g at time $t = 1.0$ sec, and under the Monay scaled at 31.1% of g at time $t = 5.1$ sec. In Frame B collapse is produced for El Centro scaled at 11.5 of g and $t = 1.6$ sec, and for Monay scaled at 16.2% of g and $t = 3.9$ sec. It can be seen that the most probable failure mechanism occurs in Frame B, with non continuous columns, which indicates that this frame is the most vulnerable of the structure; the church will have behavioral problems in these frames for moderate levels of seismic actions and in general, El Centro earthquake is more destructive than Monay. This is due to the fact that although both earthquakes were registered on hard soil, their frequencies content is different. Table 2 shows the interstorey drift obtained in Frame B for both scaled earthquakes. According to the Venezuelan Seismic Code (Norma Venezolana, 1982), for severe earthquake the allowable drift is 0.015, and it is considered in this study that for moderate earthquakes with an assumed ductility of 2 for the structure, the lateral drift is of 0.0075. Comparing these values with those obtained in cases 2 and 3 of the Table 2, it is concluded that they are not surpassed; therefore the lateral drift is not a determinant factor in the seismic behavior of the frame. The values of lateral drift for Frame A are smaller than those of Frame B.

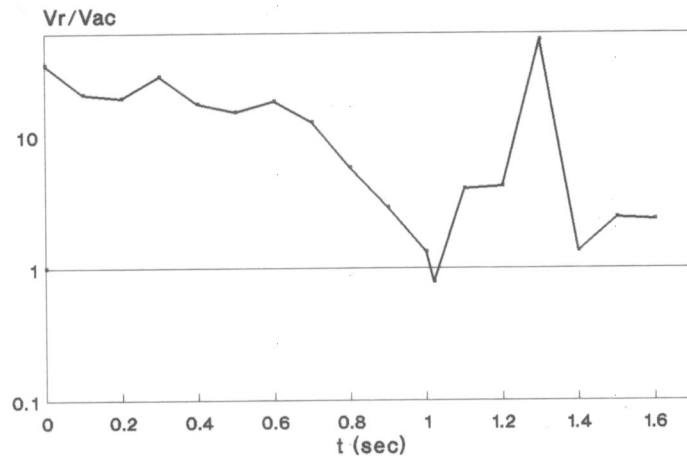
Fig. 6. Shear ratio history for the El Centro earthquake.
